Historic Structures Report
Renwick Courthouse, Wallace Library, and Old Jail
City of Fredericksburg, Virginia

Created / Last Revised:

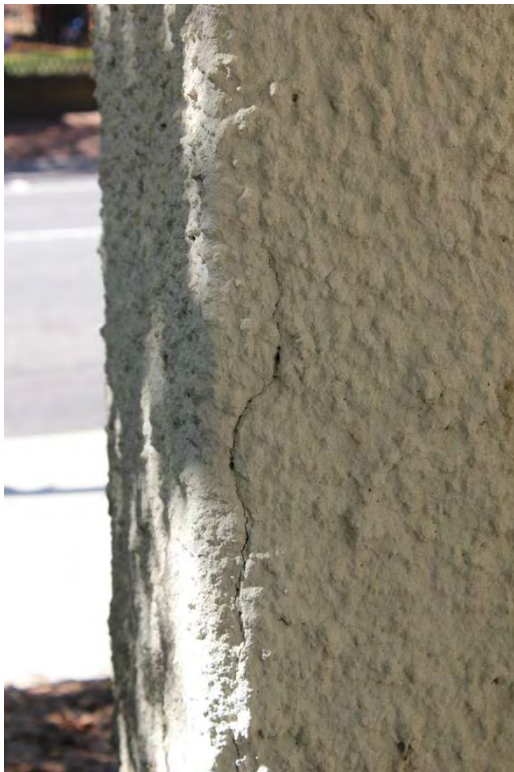
Figure 1.1, Renwick Courthouse, detail of exterior stucco. Note hairline cracks that result in moisture infiltration. Photograph 2015.

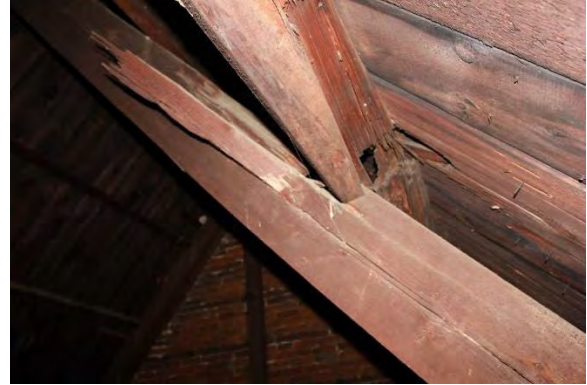
Figure 1.2, Fredericksburg Courthouse, North attic. Shifting of and damage to structural members. Photograph 2015.

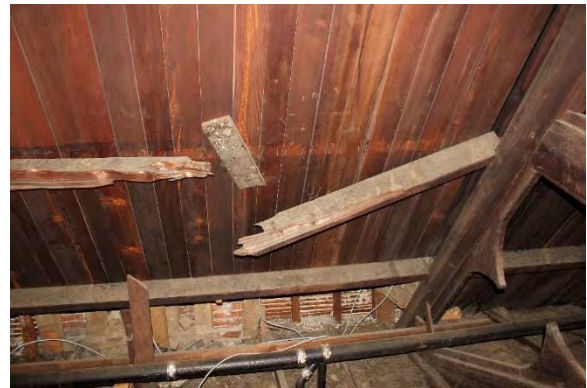
Figure 1.3, Fredericksburg Courthouse, North attic. Broken truss. Photograph 2015.

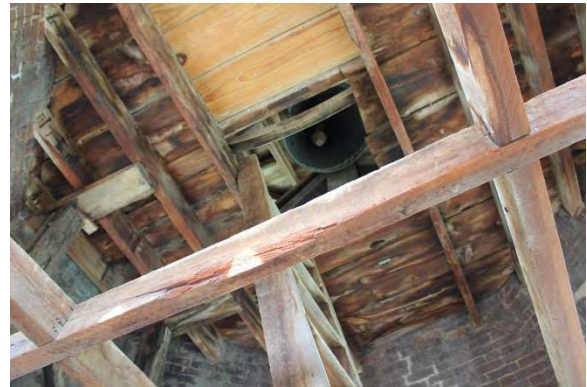
Figure 1.4, Fredericksburg Courthouse, bell tower. Moisture infiltration into the bell tower. Photograph 2015.

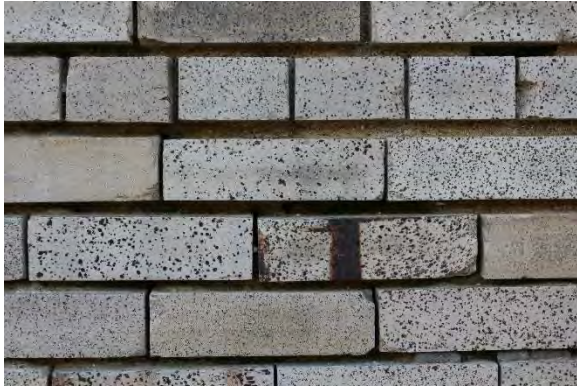
Figure 1.9, Wallace Library. Extensive mortar loss in the north elevation. Photograph 2015.

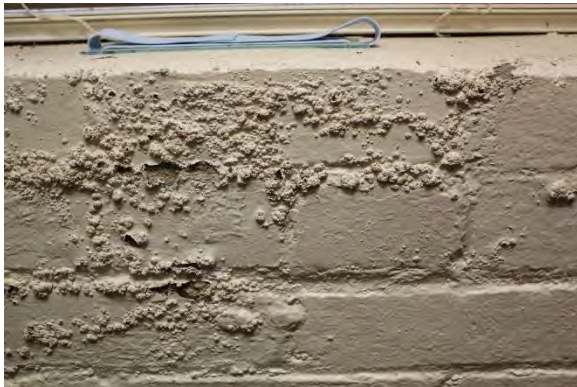
Figure 1.10, Wallace Library. Persistent moisture infiltration in the basement. Photograph 2015.

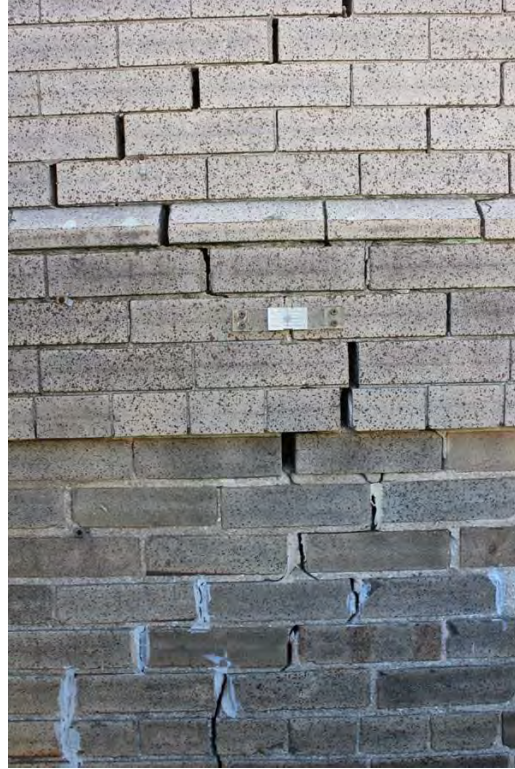
Figure 1.11, Wallace Library. Pervasive shifting and cracking of brick in the north elevation. Photograph 2015.

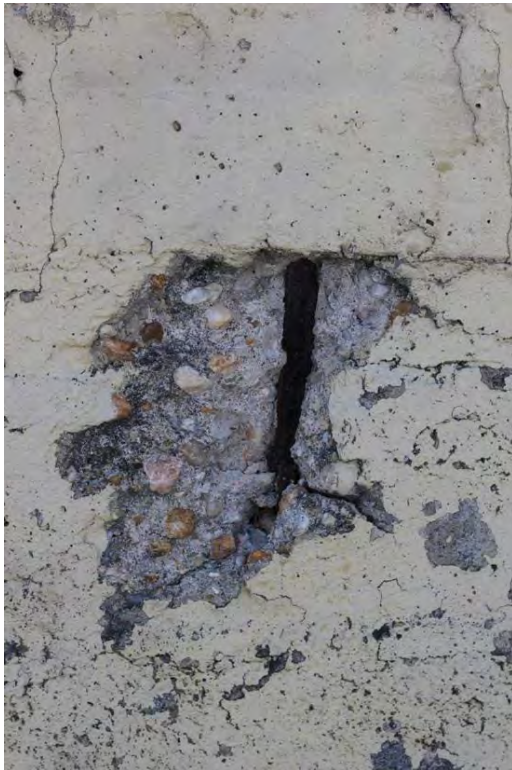
Figure 1.15, Old Jail. Rust-jacking and spalling of the exterior concrete wall surfaces. Photograph 2015.

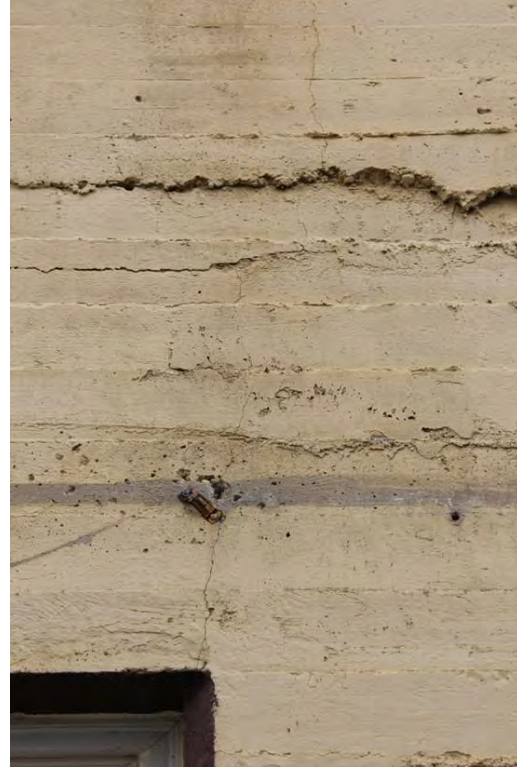
Figure 1.16, Old Jail. Cracking of the exterior concrete wall surfaces. Photograph 2015.

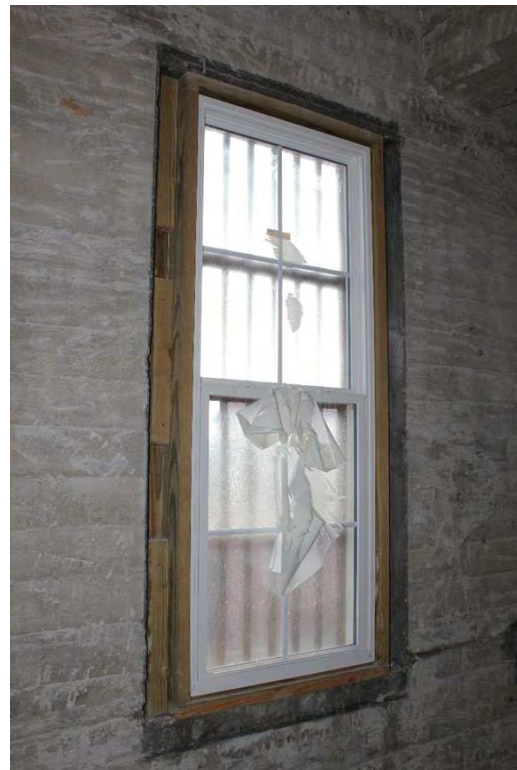
Figure 1.17, Old Jail. Nonfunctional window. Photograph 2015.

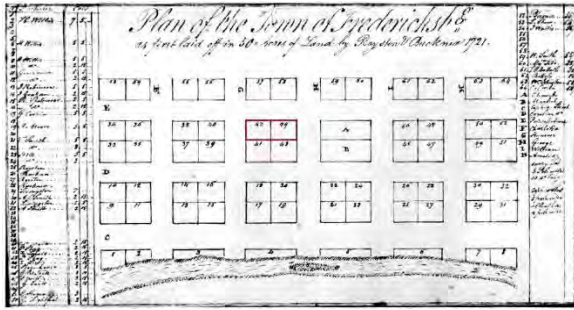
Figure 2.4, 1721 Plan of the Town of Fredericksburg. The location of the Historic Courthouse, Jail, & Library is outlined in red. Courtesy Historic Fredericksburg Foundation.

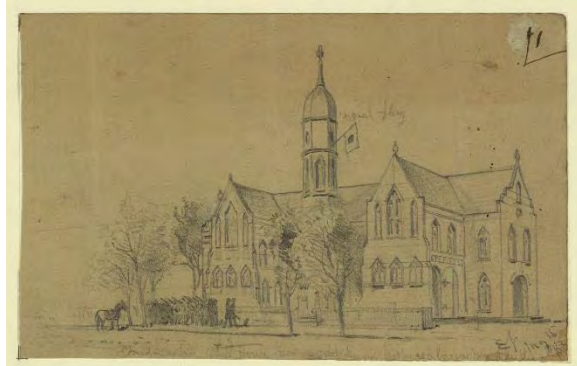
Figure 2.5, Fredericksburg Courthouse, Sketch, Edwin Forbes, 15 May 1862. Courtesy Library of Congress.

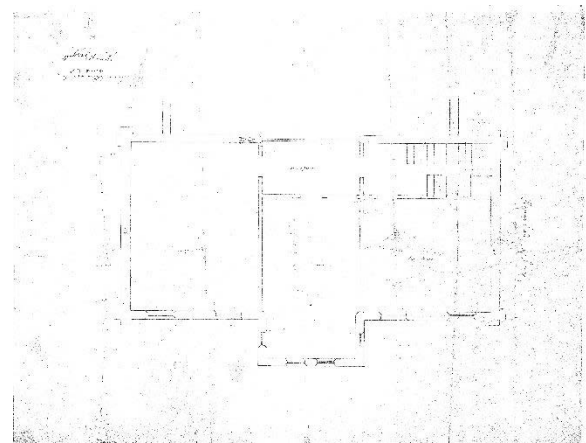
Figure 2.11, Fredericksburg Courthouse, original James Renwick Jr. plan of second story of north wing, 1851. Courtesy City of Fredericksburg.

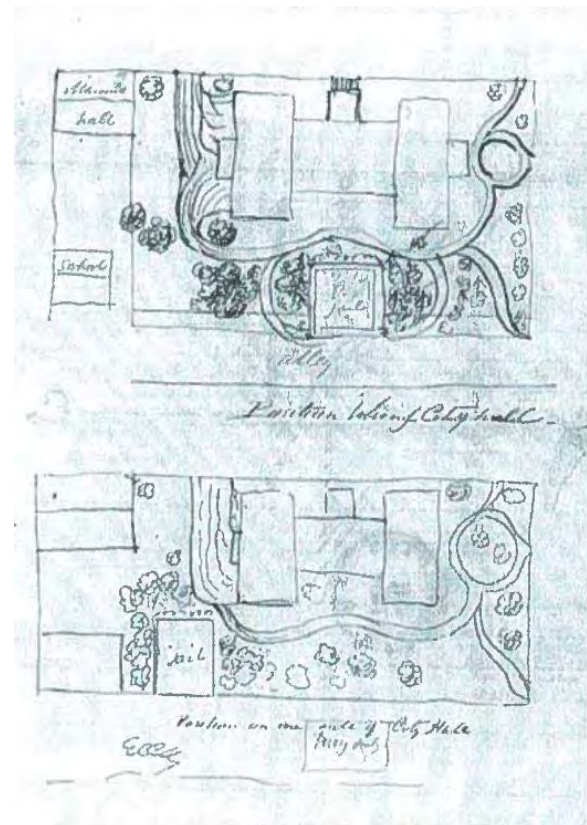
Figure 2.14, Fredericksburg Courthouse, sketch plans identifying possible jail locations, James Renwick Jr., 1851. Courtesy Fredericksburg Courthouse archives.

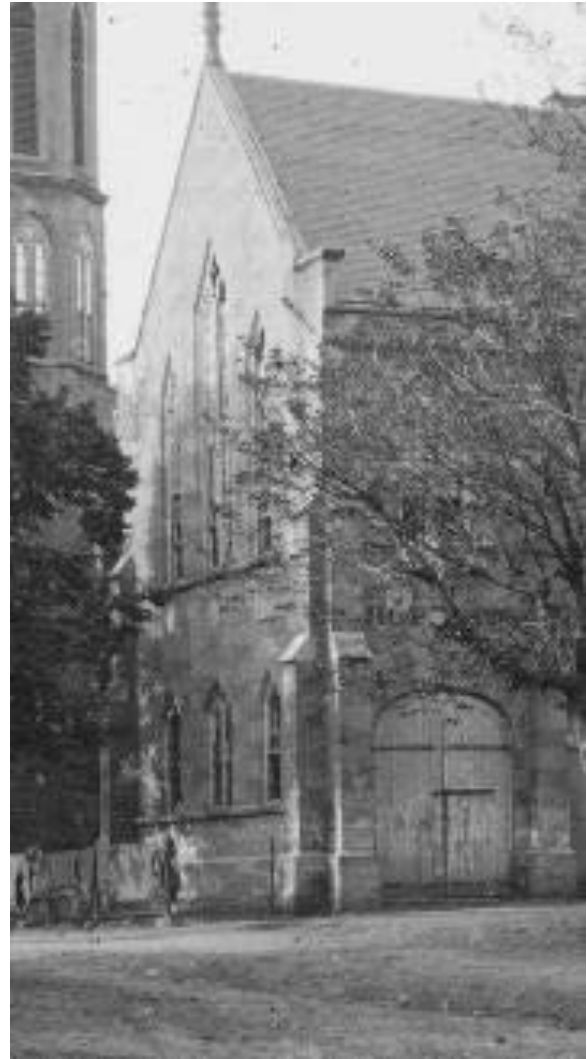
Figure 2.17, Detail of Fredericksburg Courthouse south wing, detail of photograph by Alexander Gardner, 19 May 1864. Courtesy the Library of Congress.

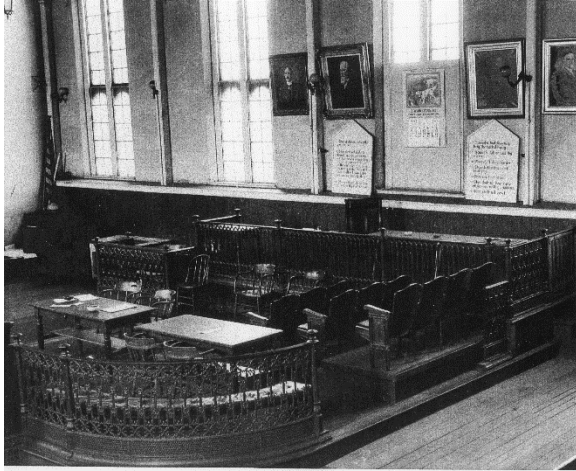
Figure 2.21, Fredericksburg Courthouse, view looking east in the historic courtroom just prior to division into two floors, 1948. Courtesy Central Rappahannock Heritage Center.

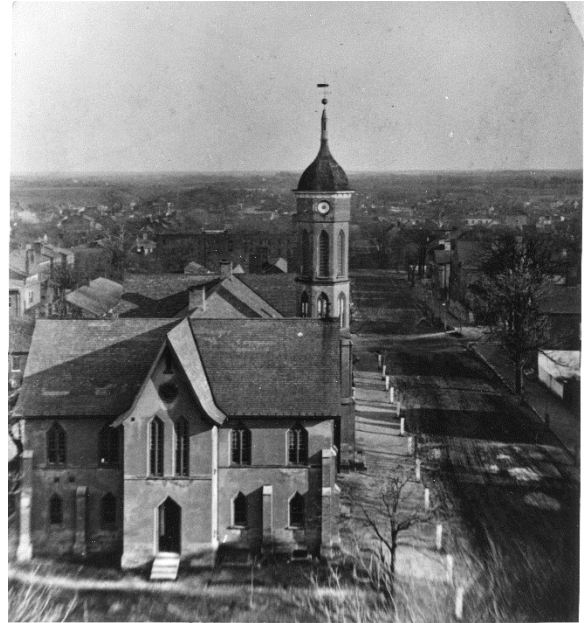
Figure 2.23, Fredericksburg Courthouse, 1881. Photograph taken from the steeple of St. George’s Episcopal Church. Courtesy of Historic Fredericksburg Foundation.

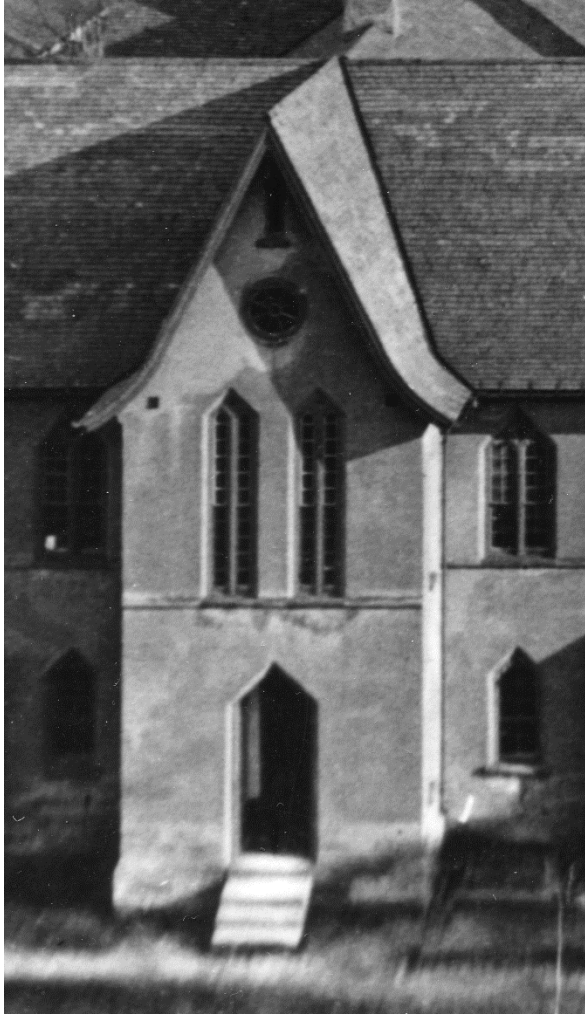
Figure 2.24, Detail, Fredericksburg Courthouse, 1881. Photograph taken from the steeple of St. George's Episcopal Church. Note that at this time, the north entry was pointed. Courtesy of Historic Fredericksburg Foundation.

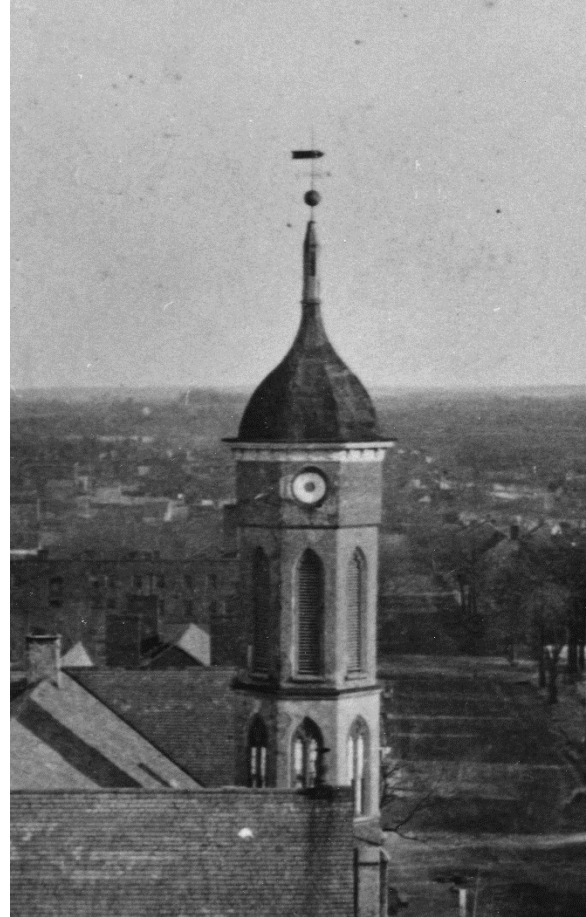
Figure 2.25, Detail, Fredericksburg Courthouse, 1881. Photograph taken from the steeple of St. George's Episcopal Church. Note the cornice and weather vane. Courtesy of Historic Fredericksburg Foundation.

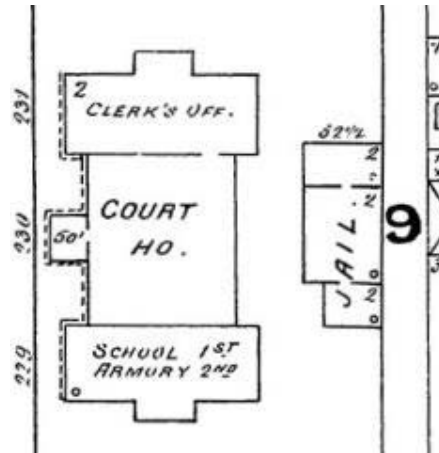
Figure 2.29, Detail of Renwick Courthouse and Jail, from Sanborn Fire Insurance Map, 1891. Courtesy ProQuest.

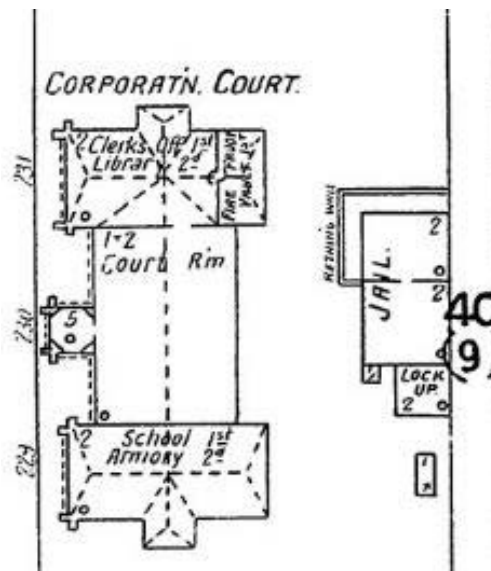
Figure 2.30, Detail of Renwick Courthouse and Jail, from Sanborn Fire Insurance Map, 1902. Courtesy ProQuest.

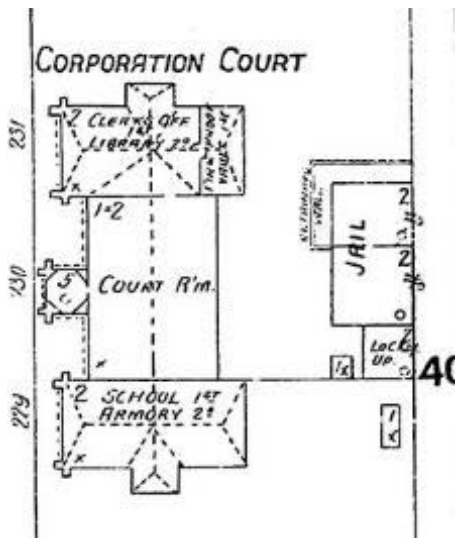
Figure 2.31, Detail of Renwick Courthouse and Jail, from Sanborn Fire Insurance Map, 1907. Courtesy ProQuest.

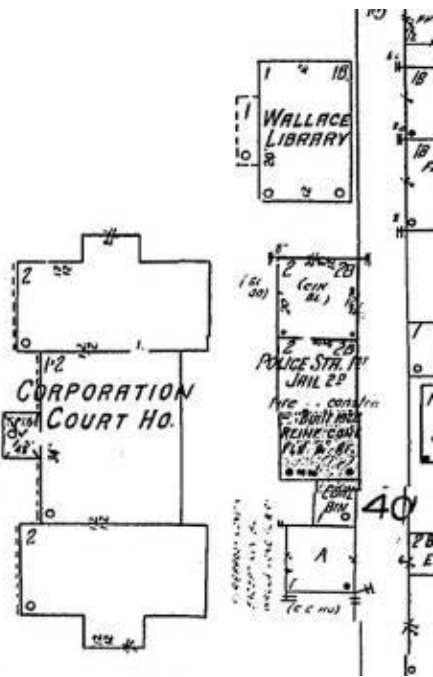
Figure 2.36, Detail of Renwick Courthouse, Jail, and Wallace Library, from Sanborn Fire Insurance Map, 1927 (revised 1928-47). Courtesy ProQuest.

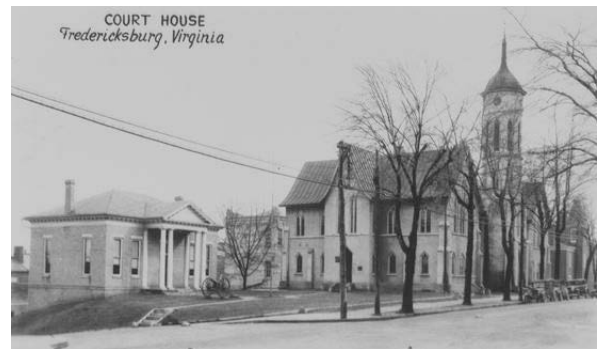
Figure 2.37, Circa-1937 photo of courthouse complex looking southeast. From Sue K. Gordon, “Court House,” in *Works Progress Administration of Virginia Historical Inventory*.

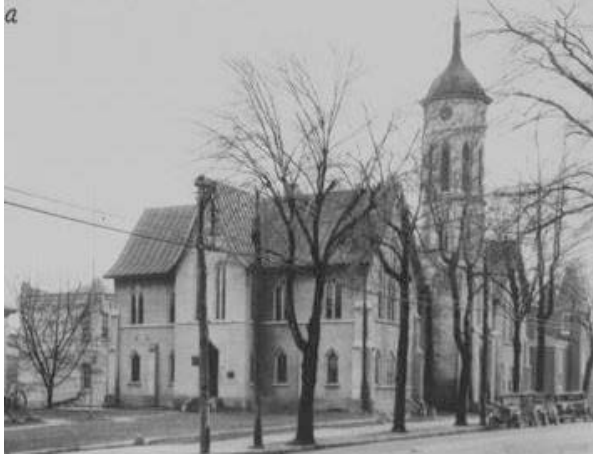
Figure 2.38, Circa-1937 photo, detail, view to southeast. Note the standing-seam copper roof. From Sue K. Gordon, “Court House,” in *Works Progress Administration of Virginia Historical Inventory*.

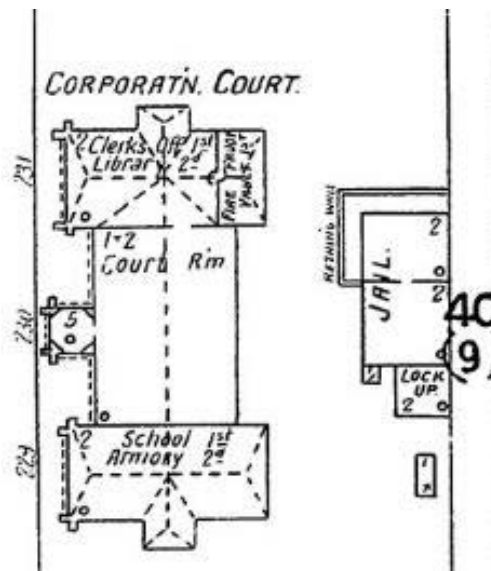
Figure 2.52, Detail of Renwick Courthouse and Jail, from Sanborn Fire Insurance Map, 1902. Courtesy ProQuest.

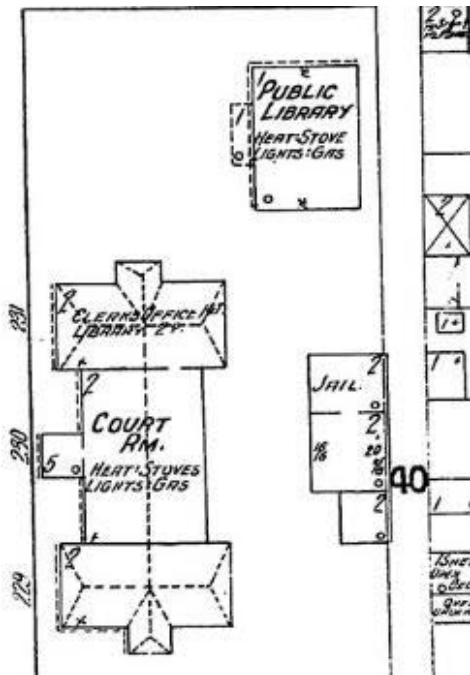
Figure 2.53, Detail of Renwick Courthouse, Jail, and Wallace Library, from Sanborn Fire Insurance Map, 1912. Courtesy ProQuest.

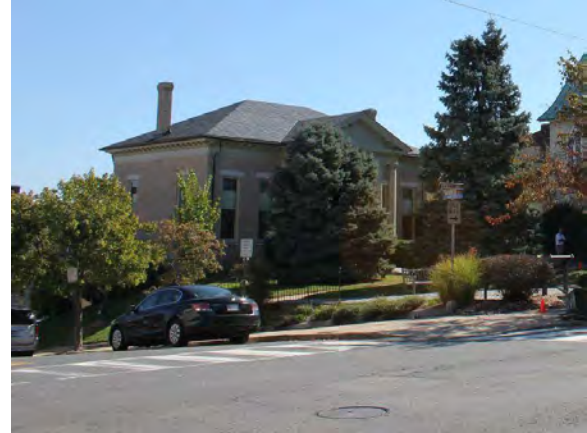
Figure 2.59, Wallace Library 2015, compare with figures 2.56 and 2.57.

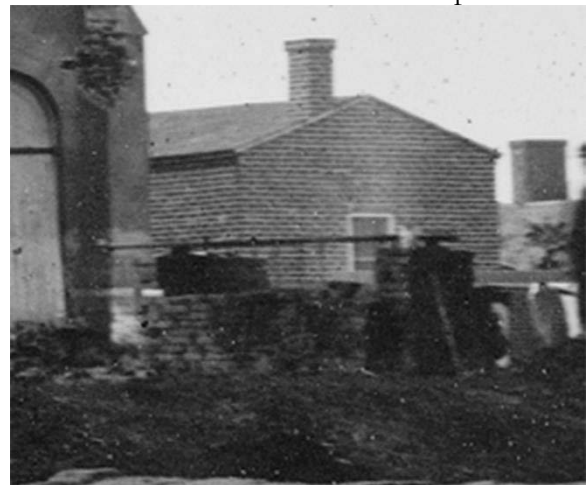
Figure 2.61, Detail of Figure 2.5, cropped on jail behind Fredericksburg Courthouse, photograph by Alexander Gardner, 19 May 1864. Courtesy the Library of Congress.

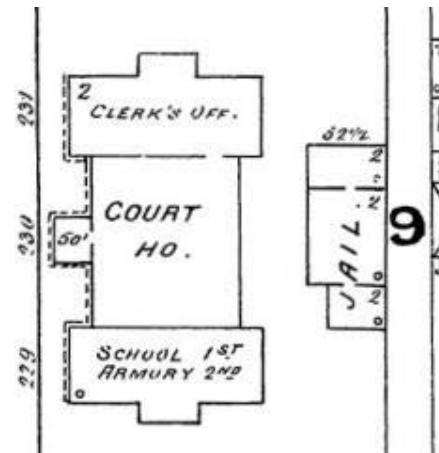
Figure 2.63, Detail of Renwick Courthouse and Jail, from Sanborn Fire Insurance Map, 1891. Courtesy ProQuest.

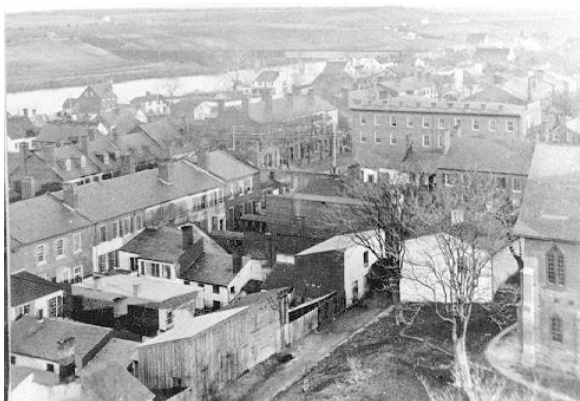
Figure 2.68, Jail and other buildings behind Fredericksburg Courthouse, 1881. Photograph taken from the steeple of St. George's Episcopal Church looking southeast. Courtesy of Historic Fredericksburg Foundation.

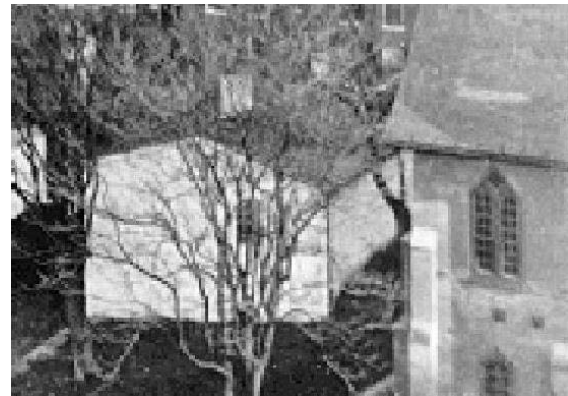
Figure 2.69, Detail of Figure 2.44, detail of jail, 1881. Courtesy of the Historic Fredericksburg Foundation.

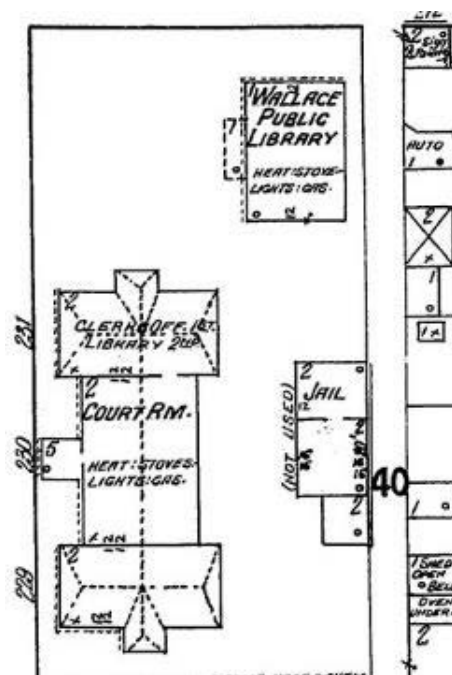
Figure 2.70, Detail of Renwick Courthouse, Jail, and Wallace Library, from Sanborn Fire Insurance Map, 1919. Courtesy ProQuest.

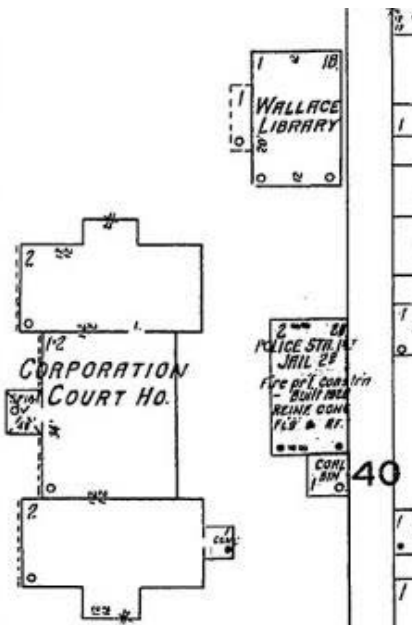
Figure 2.71, Detail of Renwick Courthouse, Jail, and Wallace Library, from Sanborn Fire Insurance Map, 1927. Courtesy ProQuest.

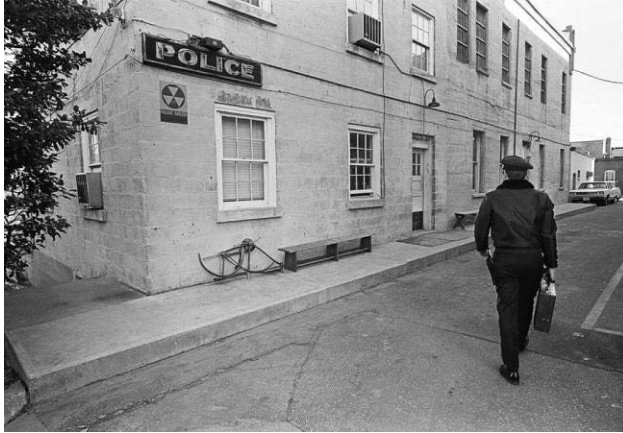
Figure 2.74, Jail, west (front) elevation, ca. 1970.
Courtesy Keith Rodgers.

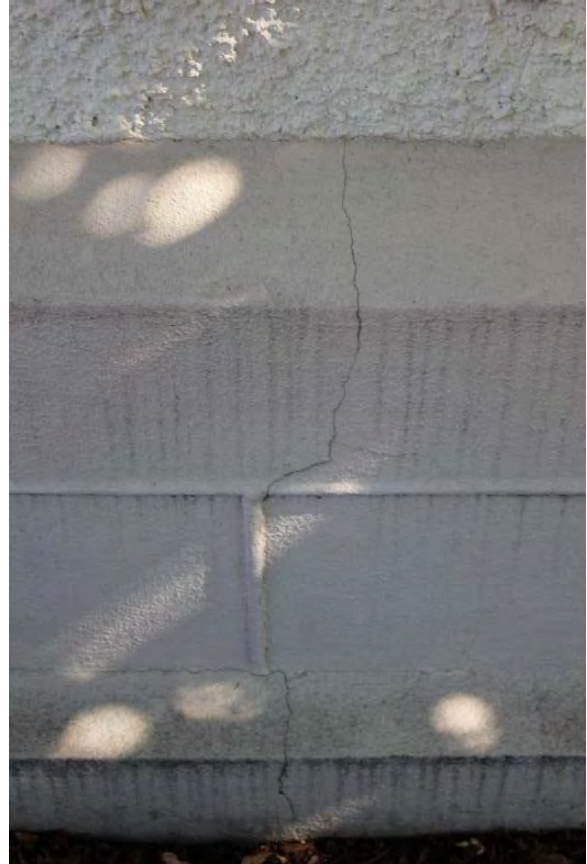
Figure 3.7, Historic Renwick Courthouse, west elevation, detail view of foundation. Note the extruded mortar joints and the vertical crack.

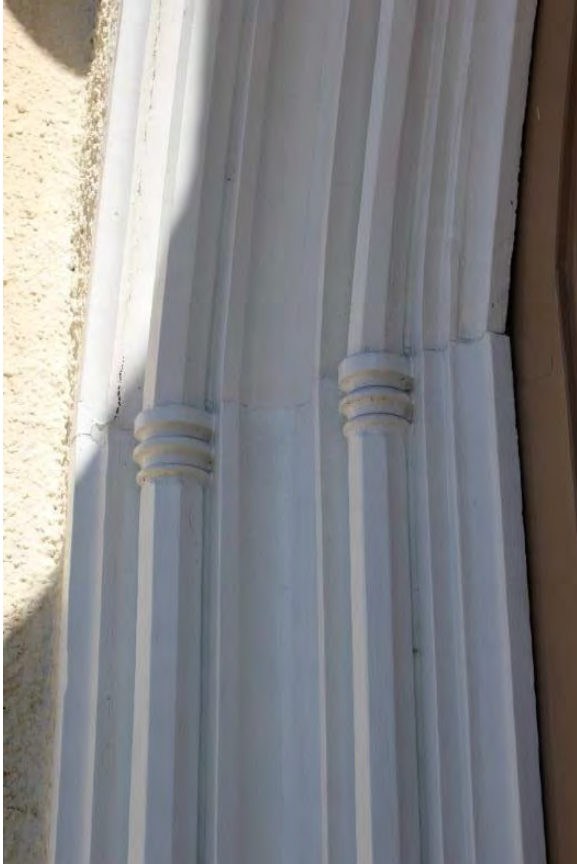
Figure 3.11, Historic Renwick Courthouse, west elevation, detail view of molded wood surround at entry double doors.

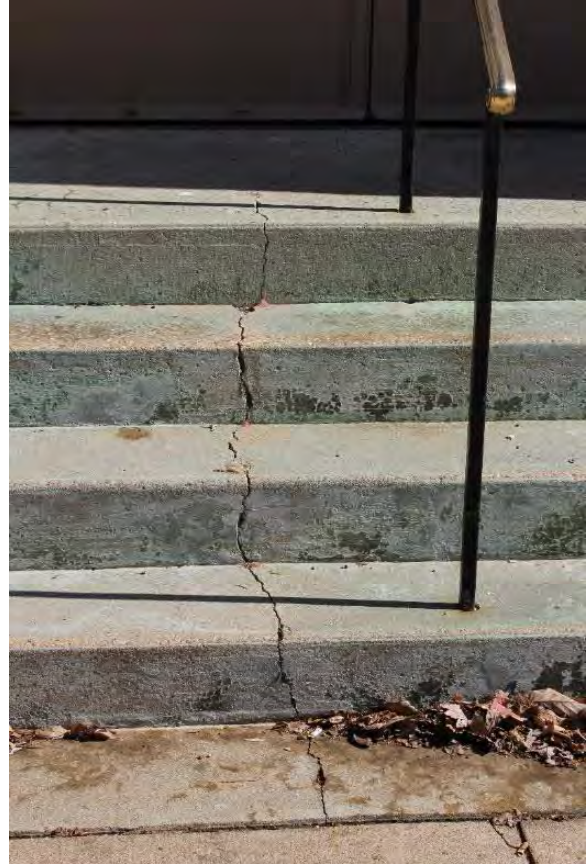
Figure 3.12, Historic Renwick Courthouse, west elevation, view of a crack at the front concrete steps.

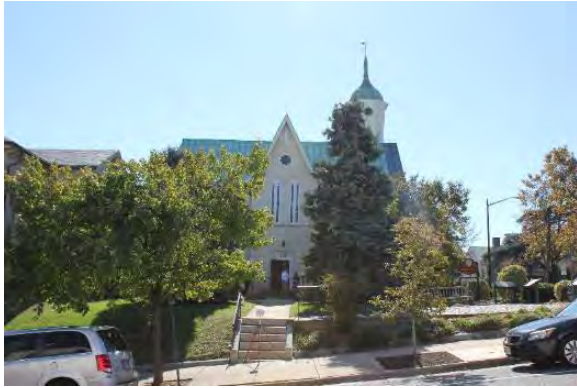
Figure 3.13, Historic Renwick Courthouse, north elevation, general view looking south.

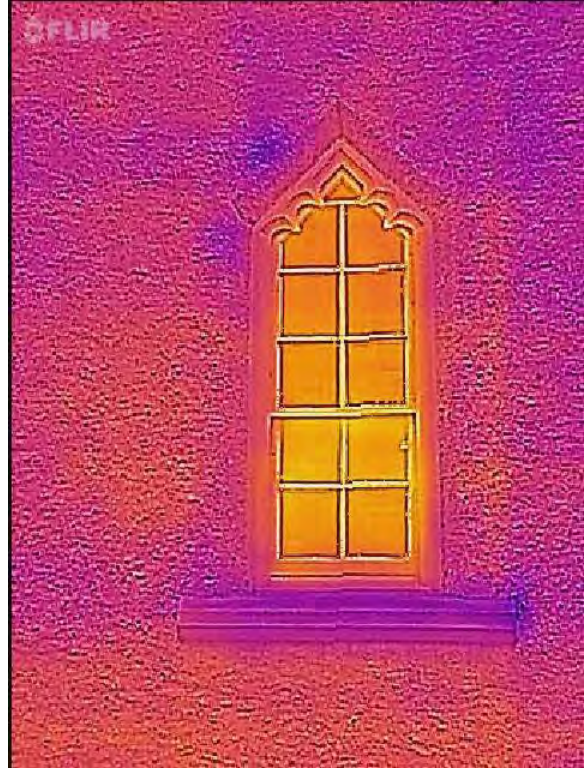
Figure 3.16A, Historic Renwick Courthouse, infrared detail of window. Note the cooler hue on the window sill and upper left near cracking in the stucco. This may be due to water sitting on these surfaces and soaking in through the cracks.

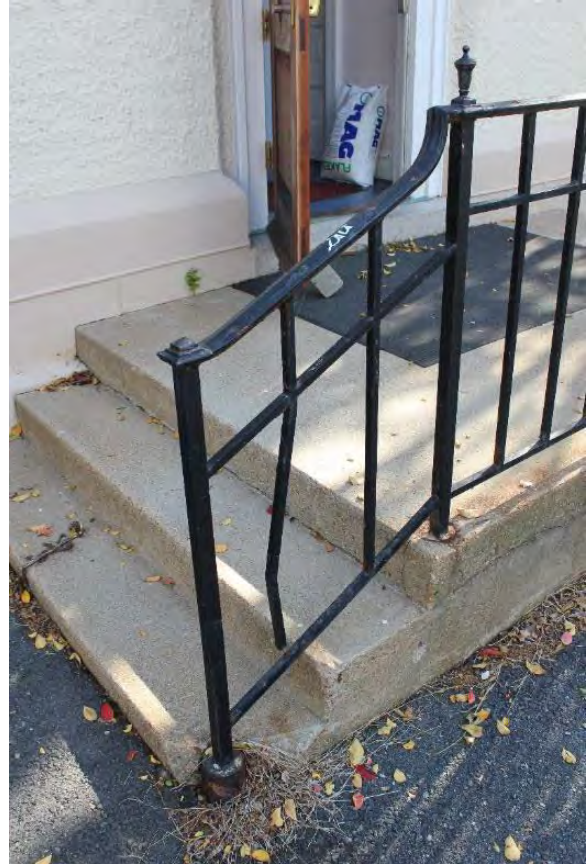
Figure 3.21, Historic Renwick Courthouse, north elevation, view of concrete steps; note the rust and the bent baluster.

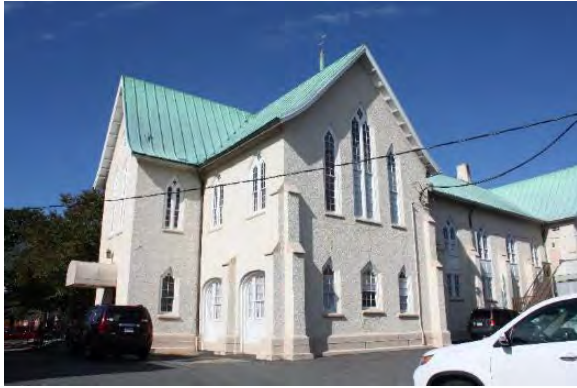
Figure 3.22, Historic Renwick Courthouse, east elevation, general view looking west.

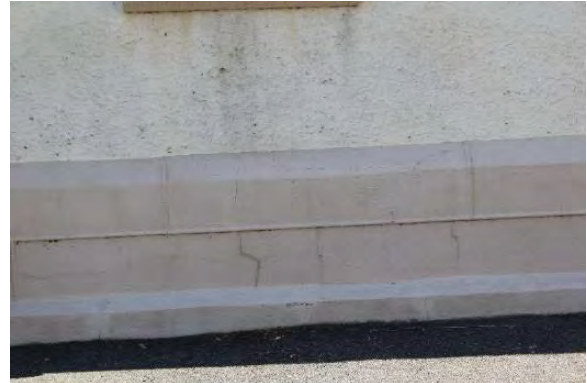
Figure 3.25, Historic Renwick Courthouse, east elevation, detail view of foundation. Note the extruded mortar joints and the vertical crack.

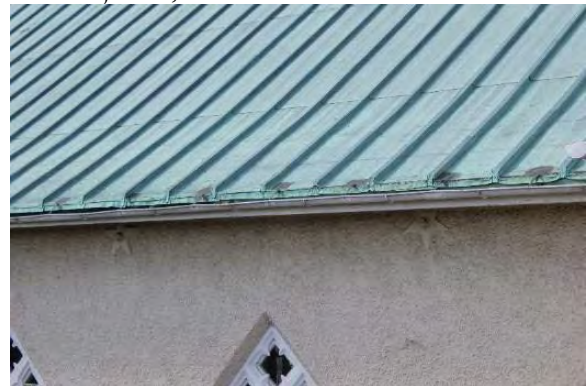
Figure 3.26, Historic Renwick Courthouse, east elevation, detail view of star-shaped tie rods below the cornice.

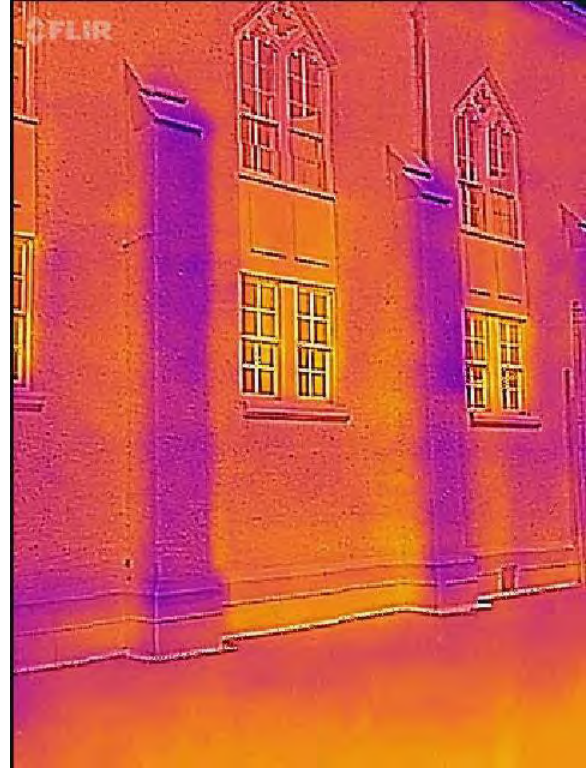
Figure 3.27A, Historic Renwick Courthouse, east elevation, infrared view of butresses. Note how much cooler in color the butresses are. This could be due to moisture sitting on the projecting surfaces.

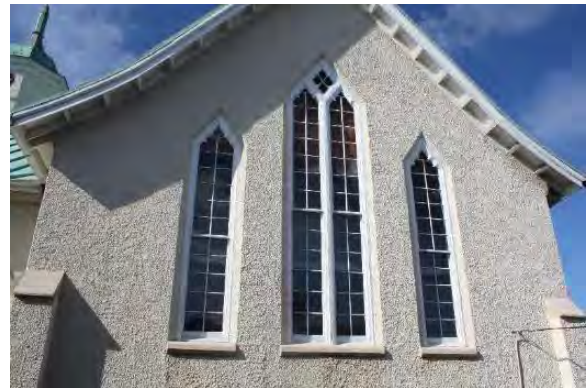
Figure 3.28, Historic Renwick Courthouse, east elevation, view of multistory, Gothic Revival-style wood windows at the upper stories of the south crossing gable.

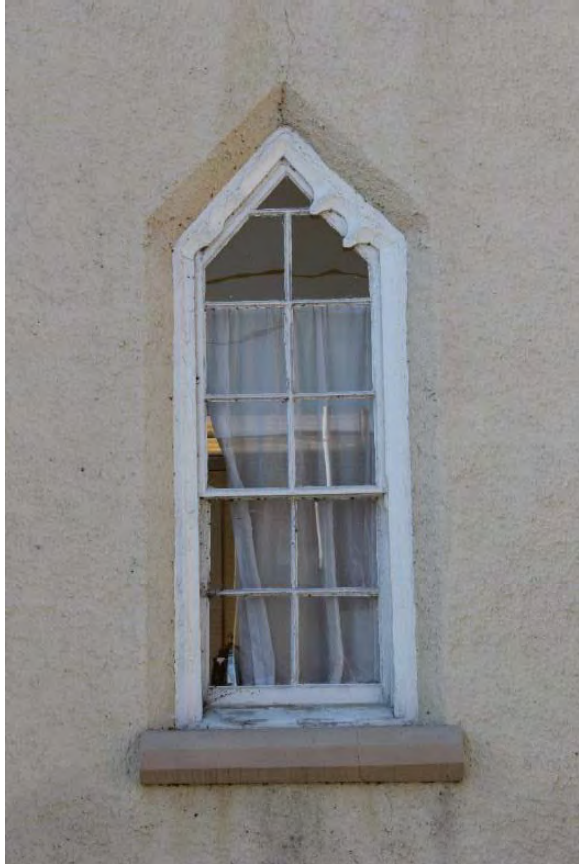
Figure 3.29, Historic Renwick Courthouse, east elevation, view of a typical first-story window; note that this window is missing part of its carved, decorative head, exhibits paint loss, and has a crack at the sill.

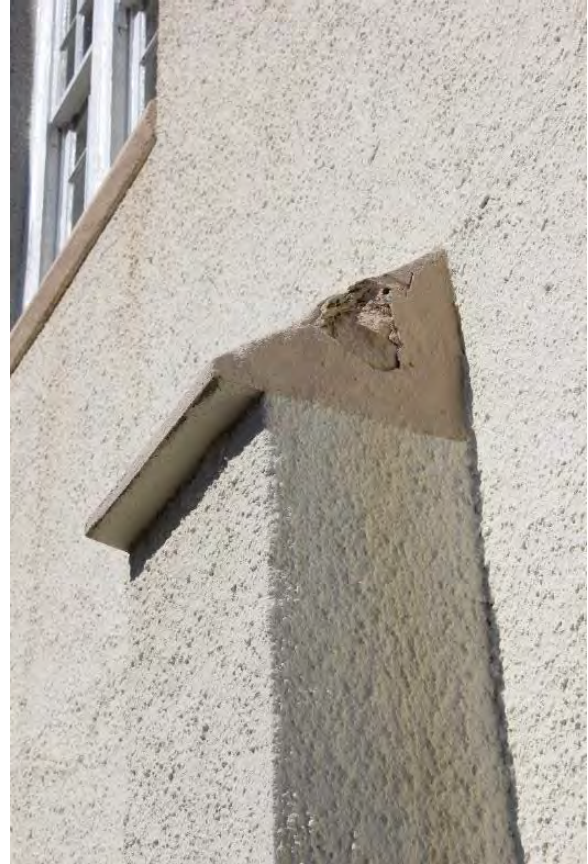
Figure 3.32, Historic Renwick Courthouse, south elevation, detail view of stucco buttress with stone amortizement. Note the damaged amortizement.

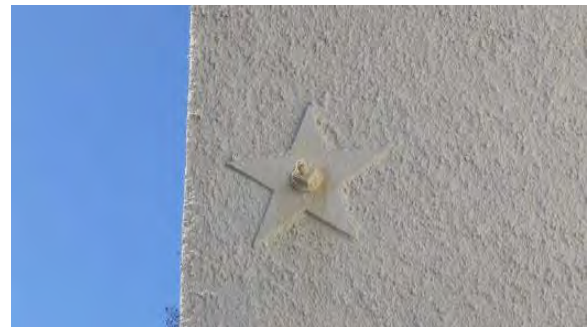
Figure 3.33, Historic Renwick Courthouse, south elevation, detail view of star-shaped tie rod at side wall of projecting gable end.

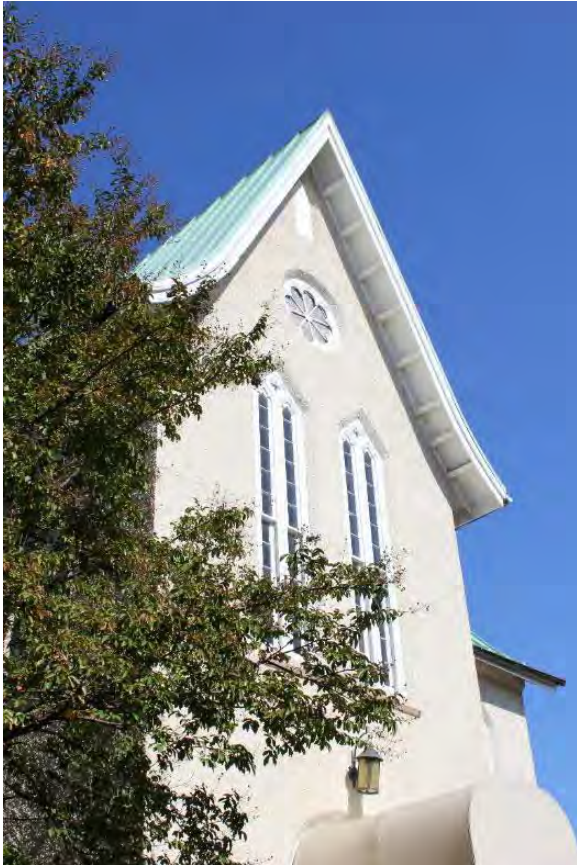
Figure 3.34, Historic Renwick Courthouse, south elevation, view of upper-story windows at projecting gable end.

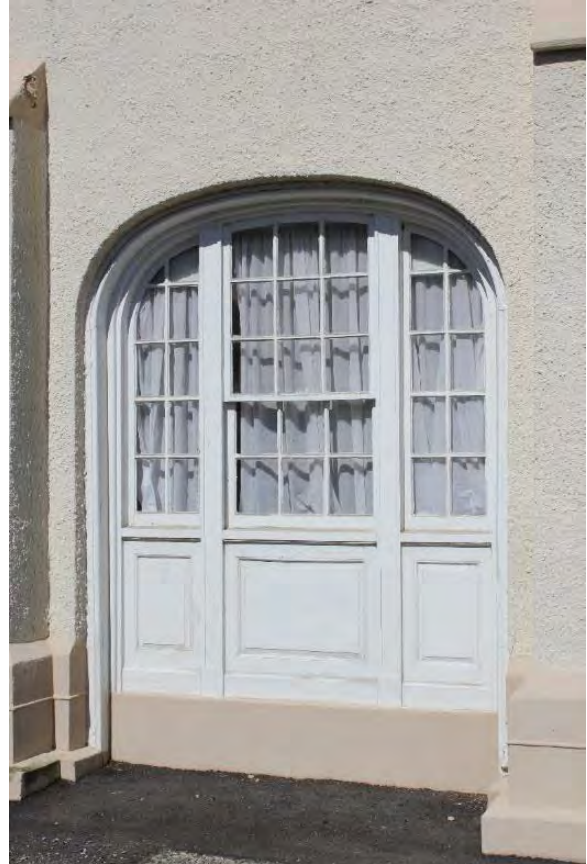
Figure 3.35, Historic Renwick Courthouse, south elevation, view of one of the arched windows, which replaced a former garage door for fire equipment

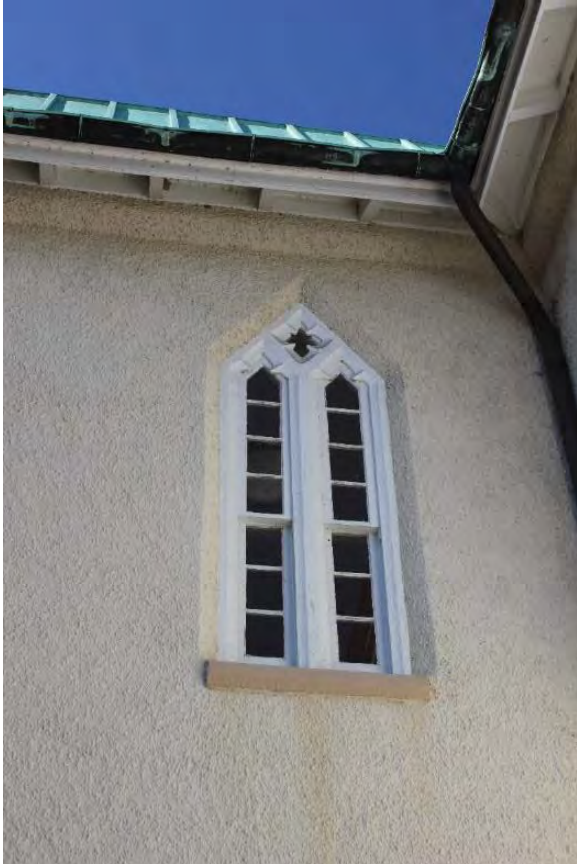
Figure 3.36, Historic Renwick Courthouse, south elevation, view of a second-story window at side wall of projecting gable end.

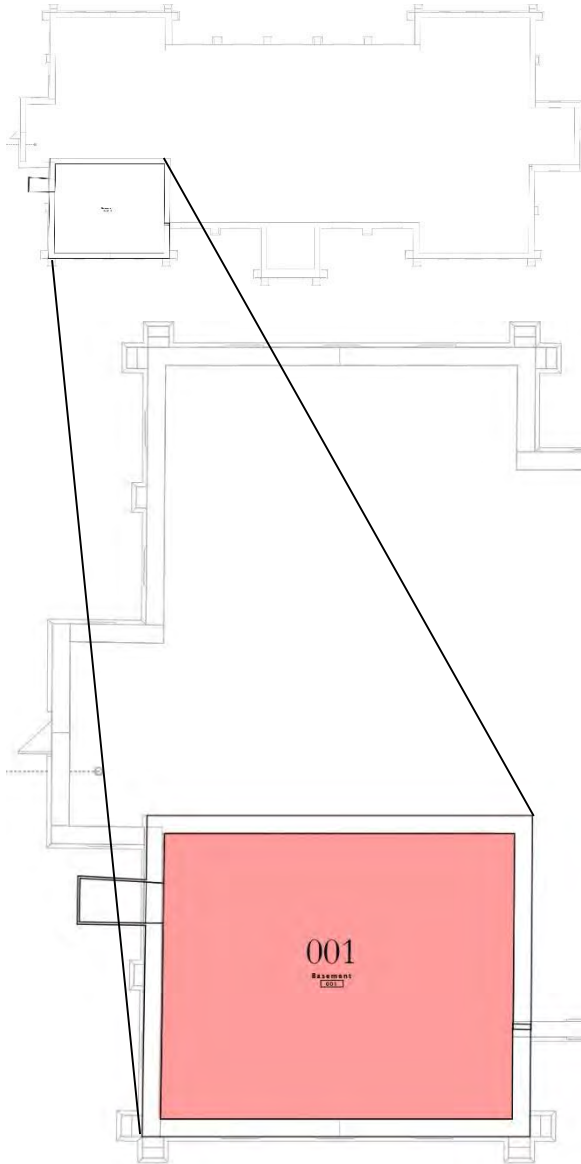
Key Plan 1: Renwick Courthouse Basement Key Plan

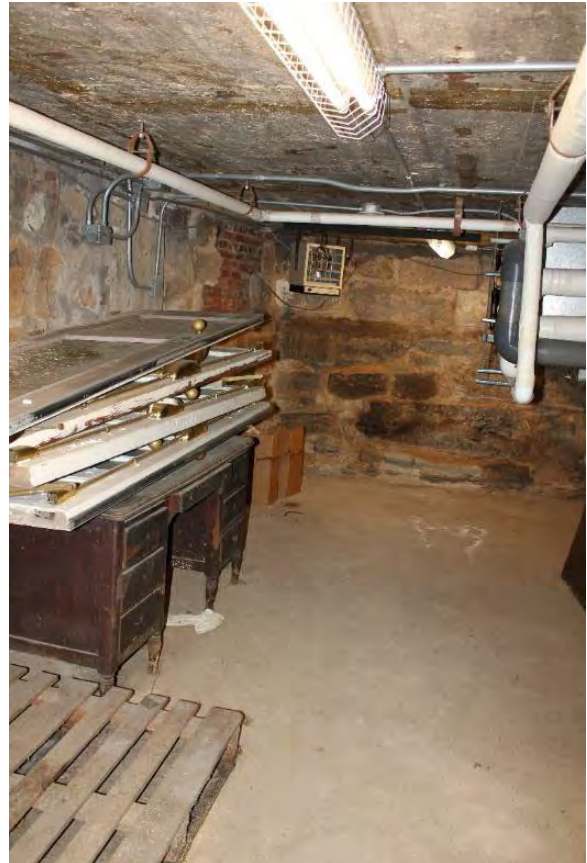
Figure 3.39, Historic Courthouse, Basement, Room 001, general view looking south. Note the deterioration of the concrete at the ceiling.

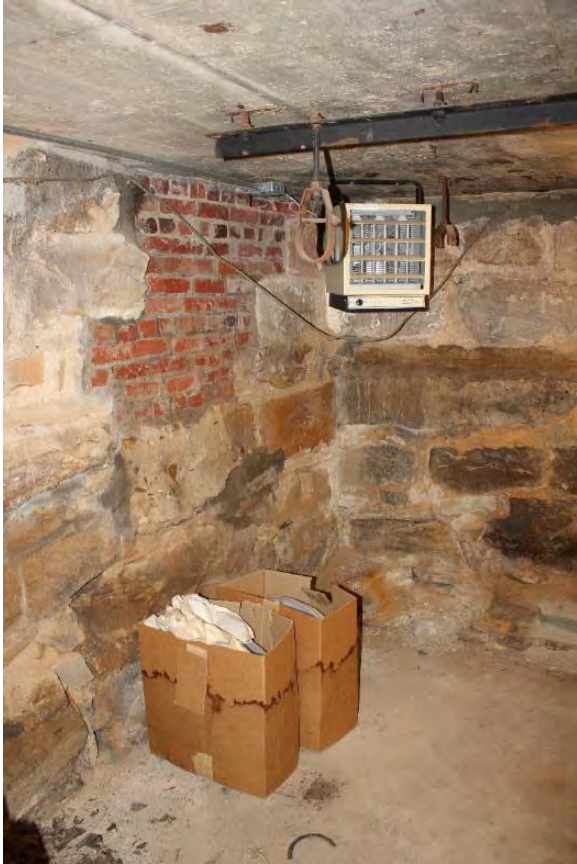
Figure 3.40, Historic Courthouse, Basement, Room 001, view of mixed wall materials including rubble stone and exposed brick.

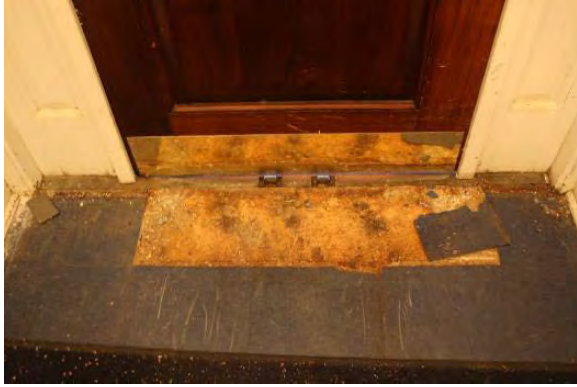
Figure 3.51, Historic Courthouse, First Floor, Room 103, view broken and missing floor tiles.

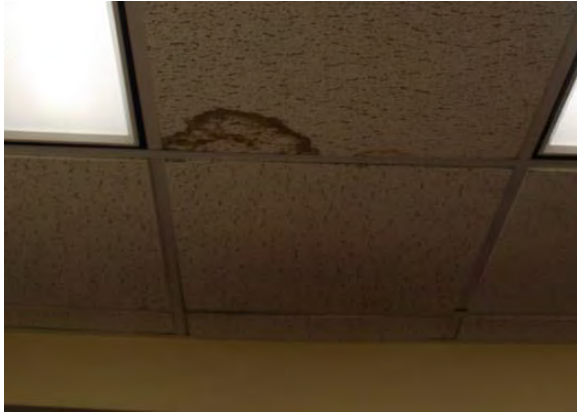
Figure 3.63, Historic Courthouse, First Floor, Room 112, view of moisture staining at the ceiling toward the center of the room.

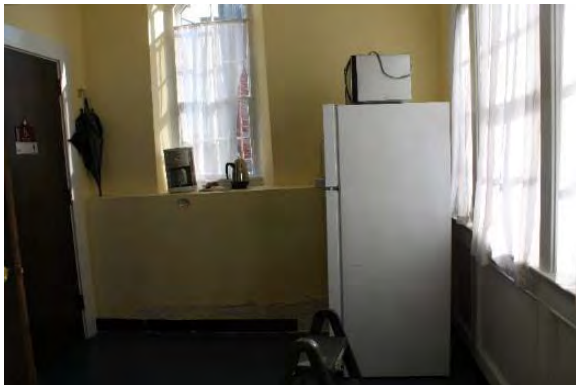
Figure 3.66, Historic Courthouse, First Floor, Room 115, general view looking east. Note the plaster damage toward the base of the wall and missing sections of the vinyl base.

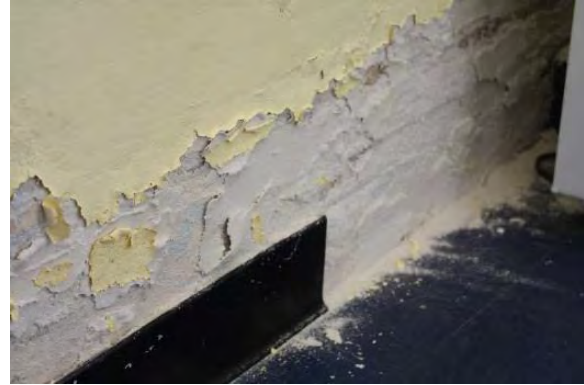
Figure 3.67, Historic Courthouse, First Floor, Room 115, view of damaged plaster and missing base at the east wall.

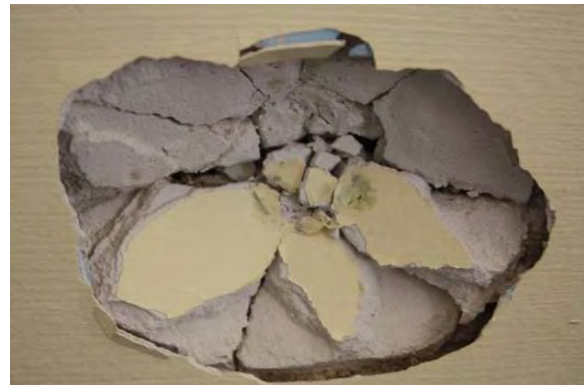
Figure 3.68, Historic Courthouse, First Floor, Room 115, view of hole in east plaster wall.

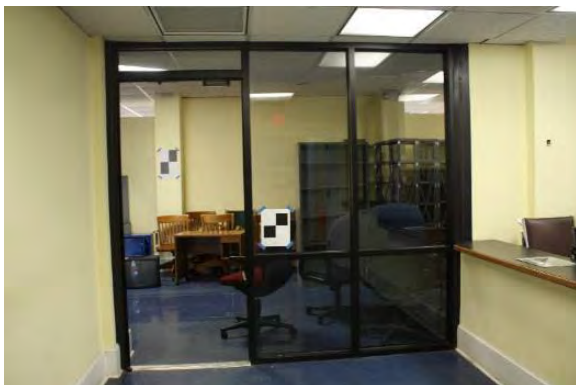
Figure 3.77, Historic Courthouse, First Floor, Room 118, view looking east at the storefront windows; note the missing door at left.

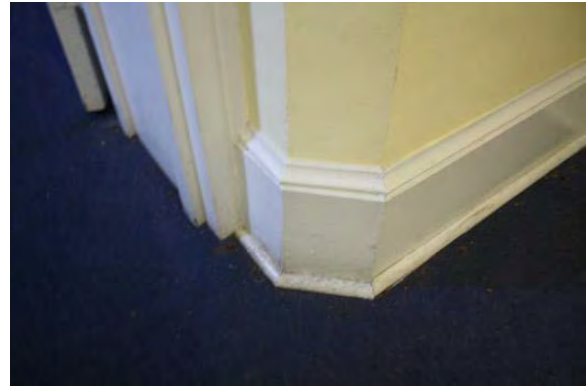
Figure 3.78, Historic Courthouse, First Floor, Room 118, view of typical wood base with shoe mold and top cove mold.
