Historic Structures Report
Renwick Courthouse, Wallace Library, and Old Jail
City of Fredericksburg, Virginia

Created / Last Revised:

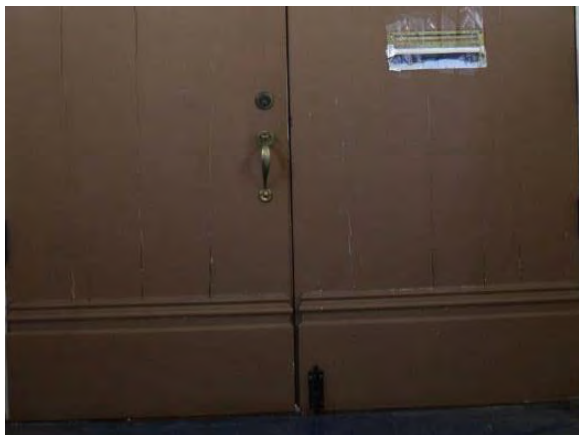
Figure 3.82, Historic Courthouse, First Floor, Room 119, detail view of vertical cracks at base of doors.

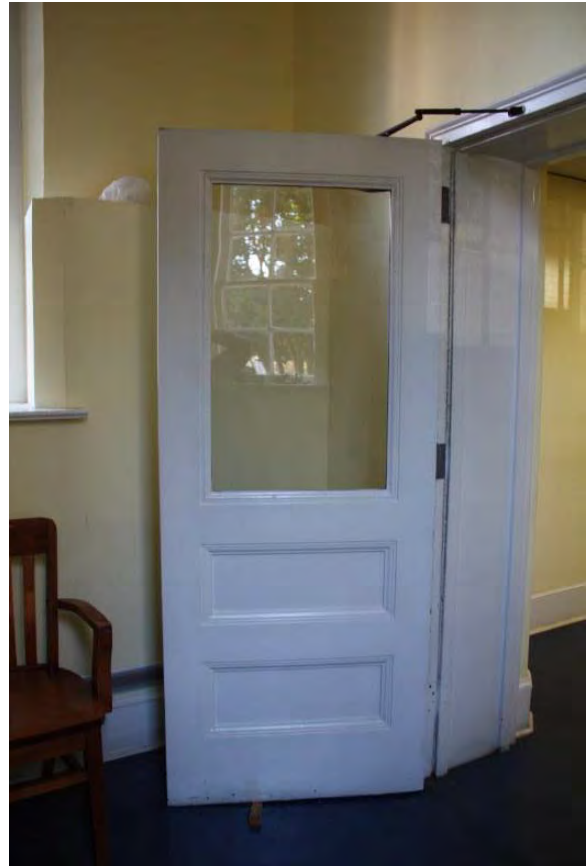
Figure 3.83, Historic Courthouse, First Floor, Room 119, view of one of paneled wood doors at the east wall.

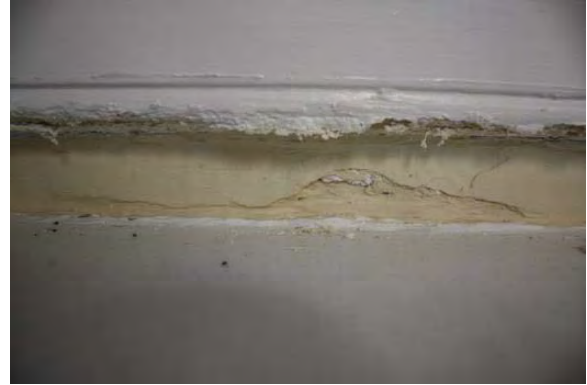
Figure 3.92, Historic Courthouse, First Floor, Room 123, view of plaster damage underneath the apron of the west window of the north wall.

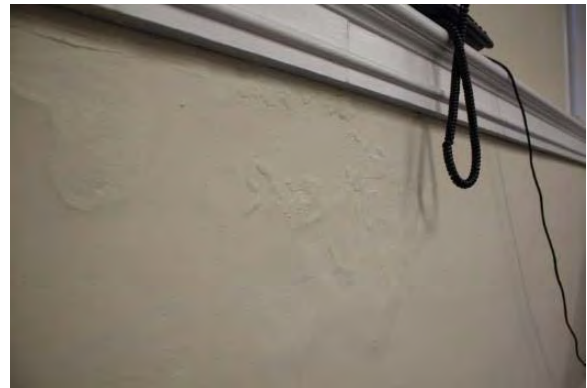
Figure 3.93, Historic Courthouse, First Floor, Room 123, view of plaster damage underneath the west window of the north wall.

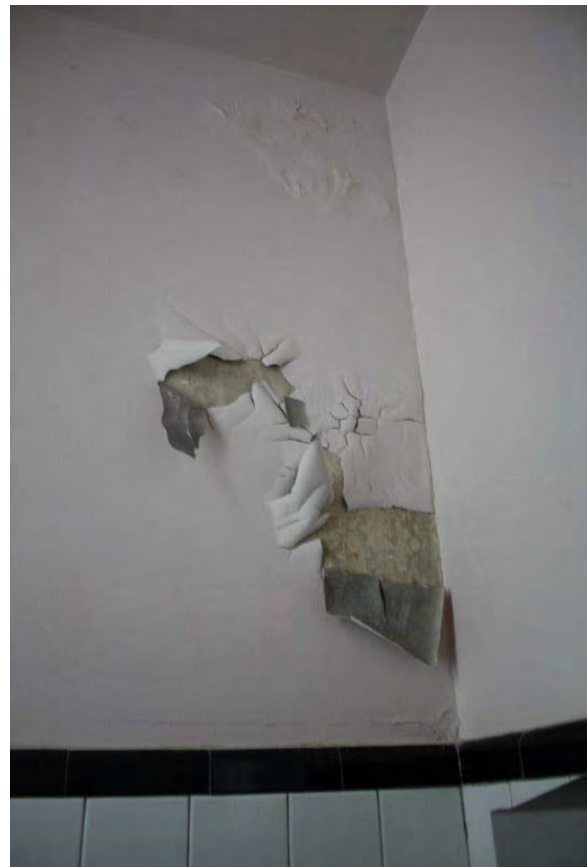
Figure 3.95, Historic Courthouse, First Floor, Room 124, view of damage to the plaster and paint at the north wall near the northeast corner of the room.

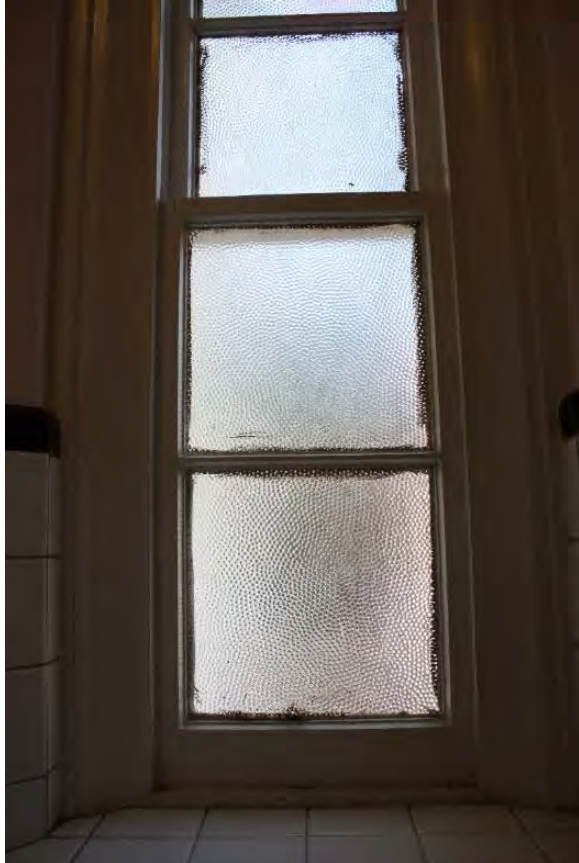
Figure 3.96, Historic Courthouse, First Floor, Room 124, view of the privacy glass at the lower sash of the window.

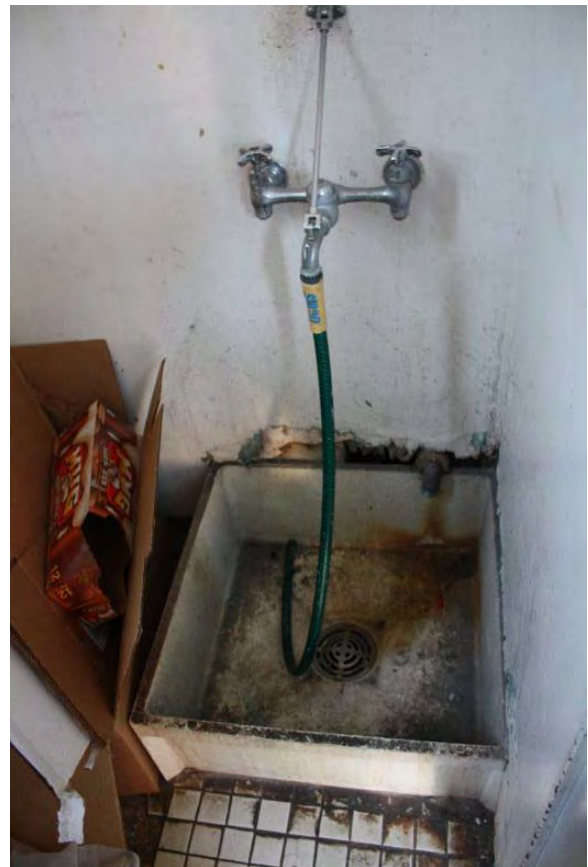
Figure 3.100, Historic Courthouse, First Floor, Room 126, view of mop sink. Note heavy soiling and rusting at sink, heavily soiled floor, and hole at the plaster wall.

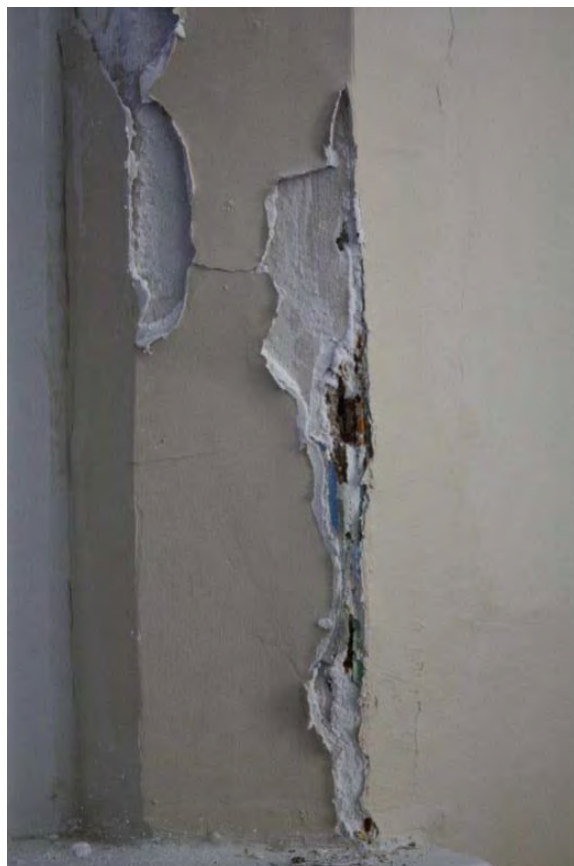
Figure 3.102, Historic Courthouse, First Floor, Room 127, view of plaster damage and efflorescence at the reveal of the easternmost window at the north wall.

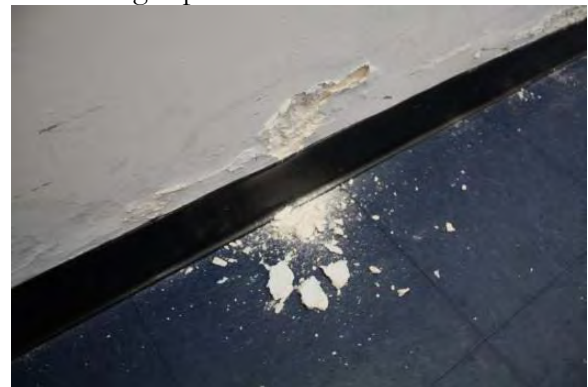
Figure 3.105, Historic Courthouse, First Floor, Room 128, detail view of plaster damage and efflorescence at east wall.

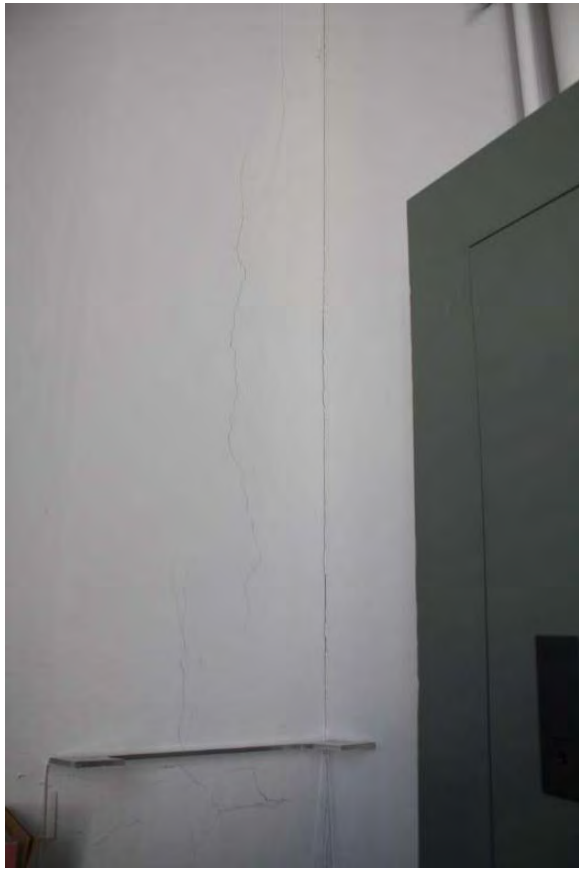
Figure 3.106, Historic Courthouse, First Floor, Room 128, detail view of vertical cracks in plaster near southwest corner of room.

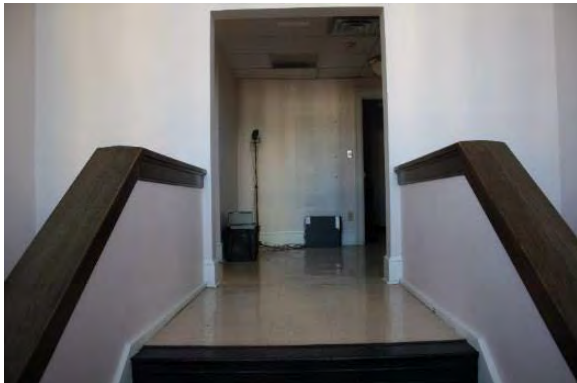
Figure 3.112, Historic Courthouse, Room 132 (Stairway 2), general view from the intermediate landing to the second floor.

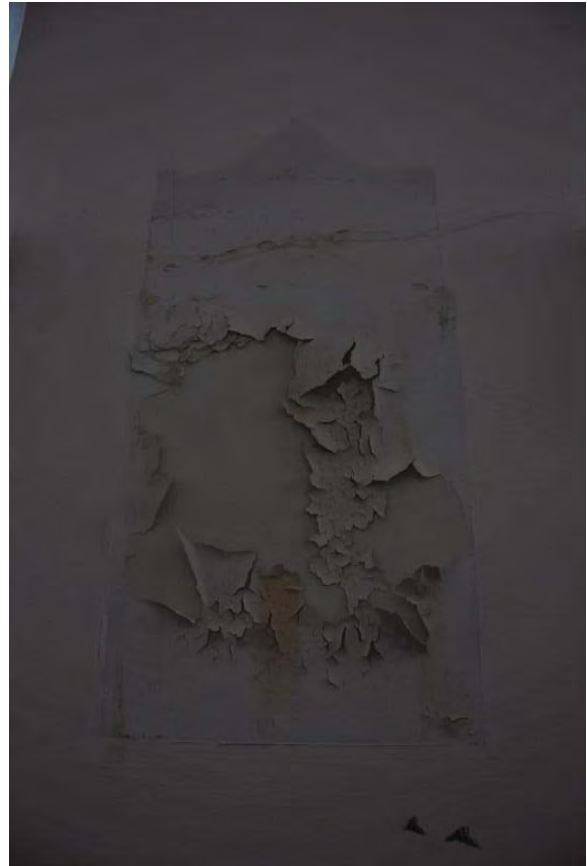
Figure 3.113, Historic Courthouse, First Floor, Room 132 (Stairway 2), view of paint failure due to moisture between the windows at the north wall.

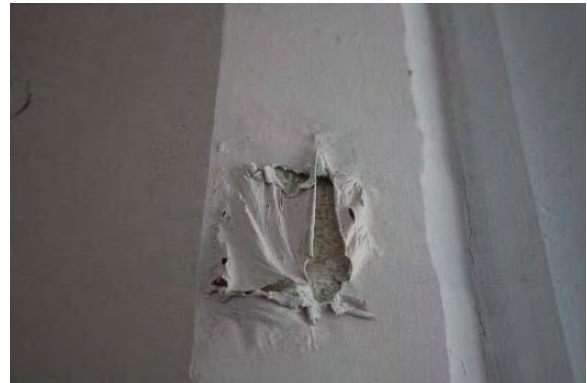
Figure 3.114, Historic Courthouse, First Floor, Room 132 (Stairway 2), view of paint failure due to moisture at the reveal of the window at the east wall.

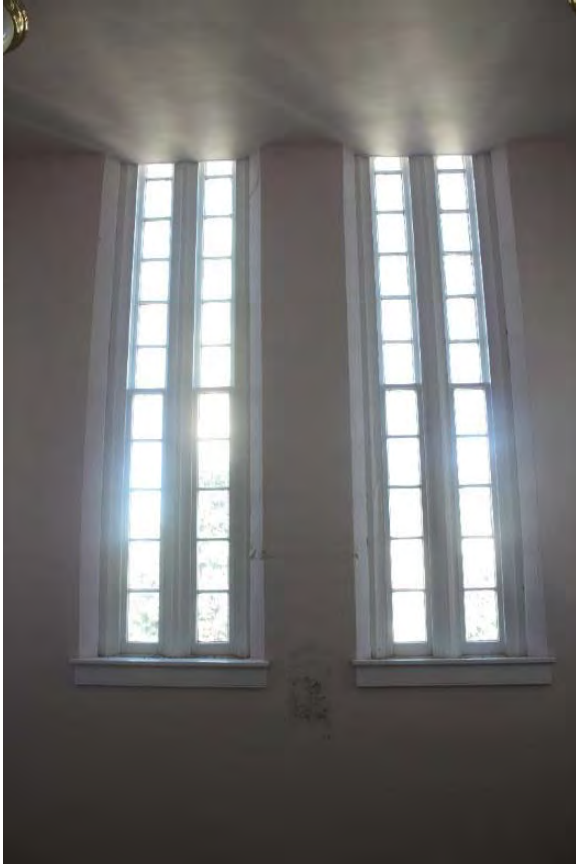
Figure 3.115, Historic Courthouse, First Floor, Room 132 (Stairway 2), view of windows at north wall of stair landing. Note the truncated heads of the windows.

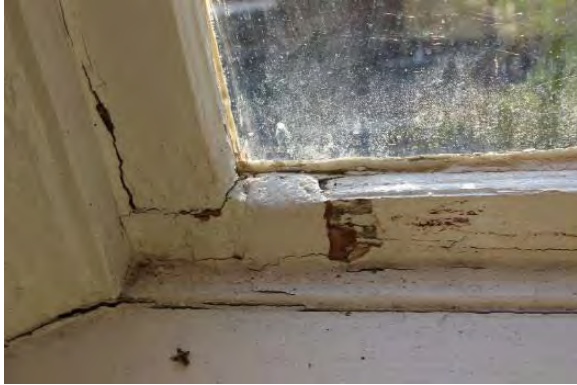
Figure 3.125, Historic Courthouse, Second Floor, Room 202, view of wood deterioration and cracking at a window frame.

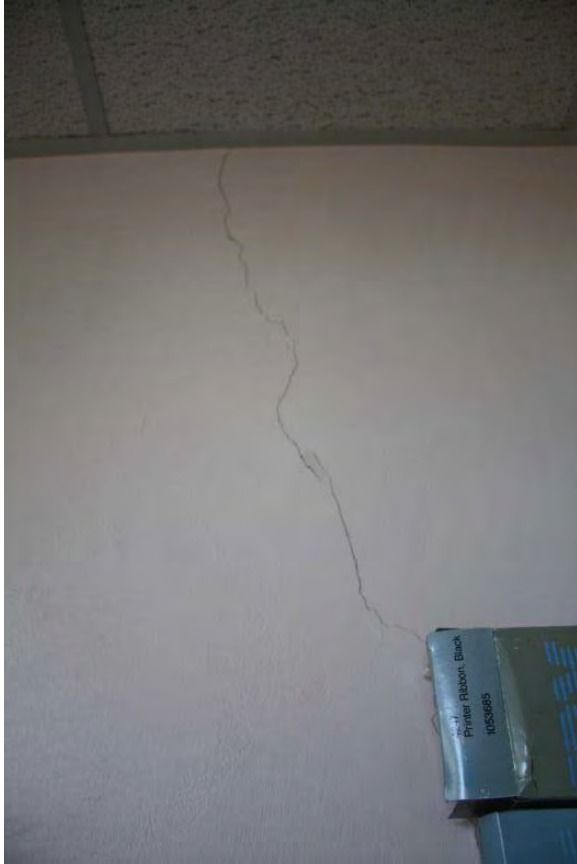
Figure 3.127, Historic Courthouse, Second Floor, Room 203, detail view of crack at the north wall.

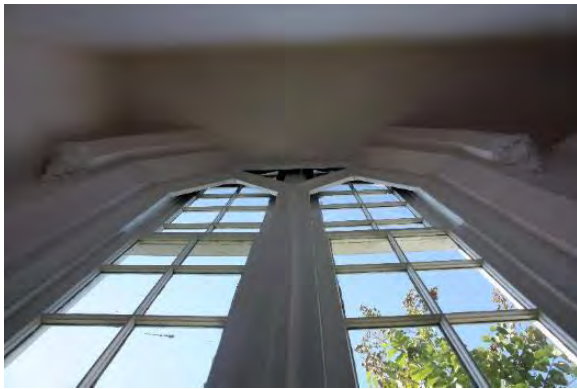
Figure 3.128, Historic Courthouse, Second Floor, Room 203, view of southernmost window at west wall. Note that this is a multistory window truncated by the second-floor ceiling.

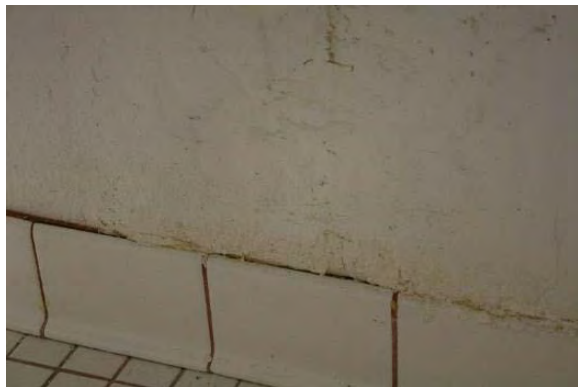
Figure 3.131, Historic Courthouse, Second Floor, Room 204, view of damage to south wall under urinal.

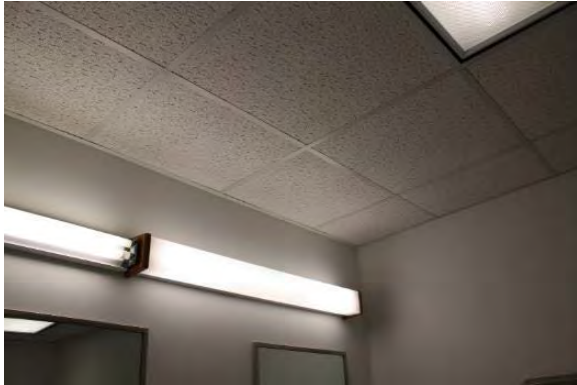
Figure 3.134, Historic Courthouse, Second Floor, Room 206, view of ceiling and lights above sink at the west wall; note the missing light cover at left.

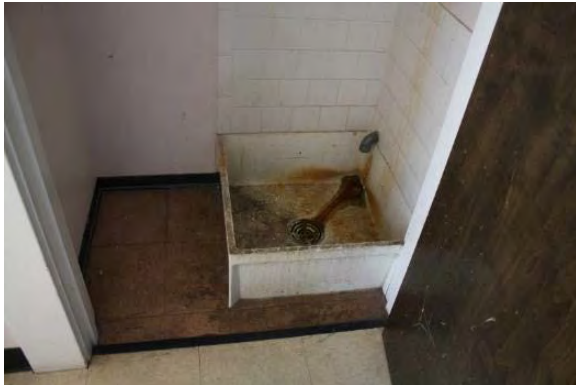
Figure 3.136, Historic Courthouse, Second Floor, Room 207, view of mop sink. Note heavy soiling and rust at both sink and tile and soiled floor.

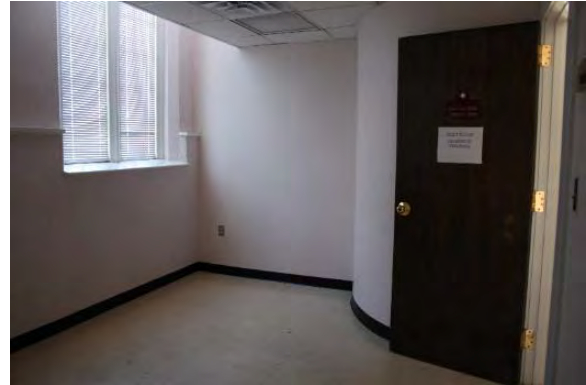
Figure 3.137, Historic Courthouse, Second Floor, Room 208, general view looking south.

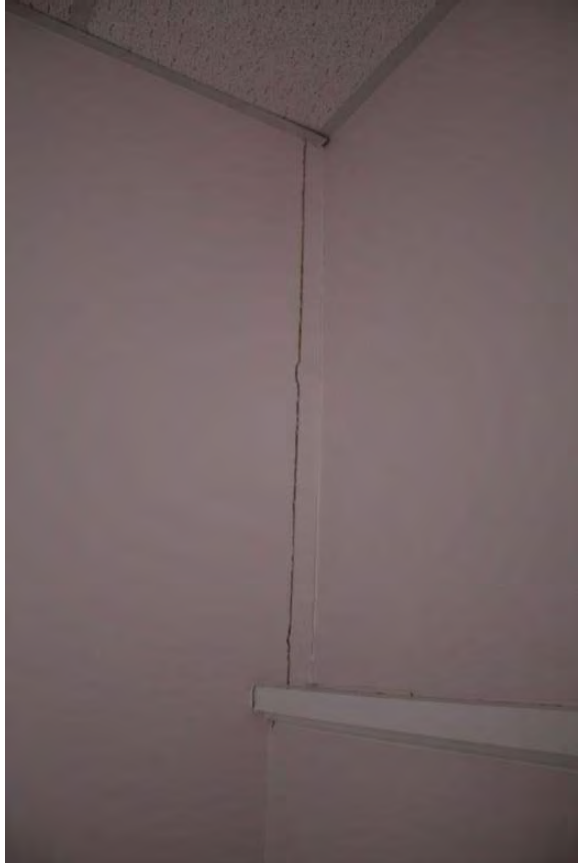
Figure 3.138, Historic Courthouse, Second Floor, Room 208, view of crack at northwest corner of the room.

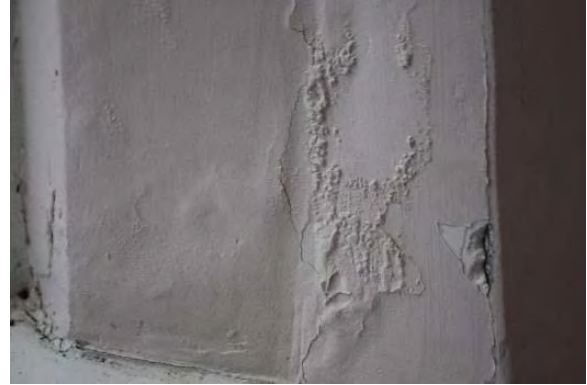
Figure 3.139, Historic Courthouse, Second Floor, Room 208, view of plaster damage at one of the window reveals.

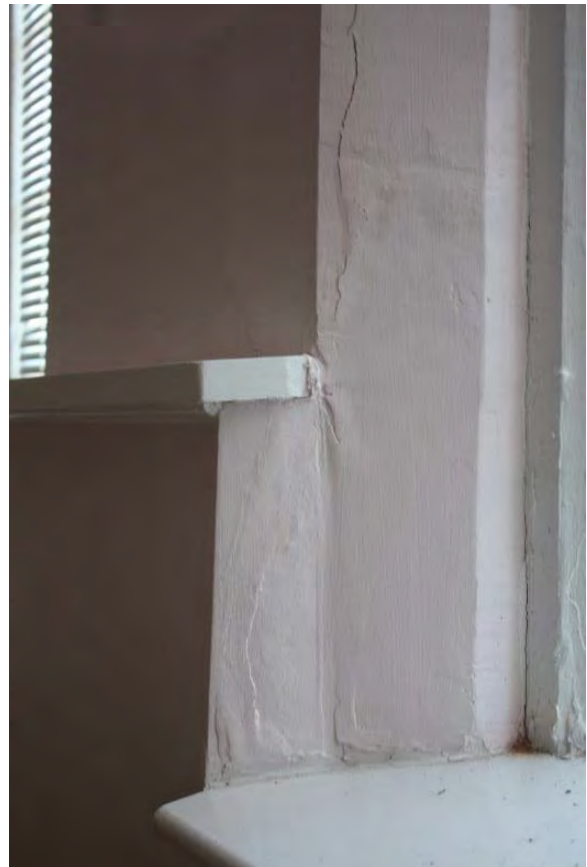
Figure 3.140, Historic Courthouse, Second Floor, Room 208, view of plaster damage at one of the window reveals.

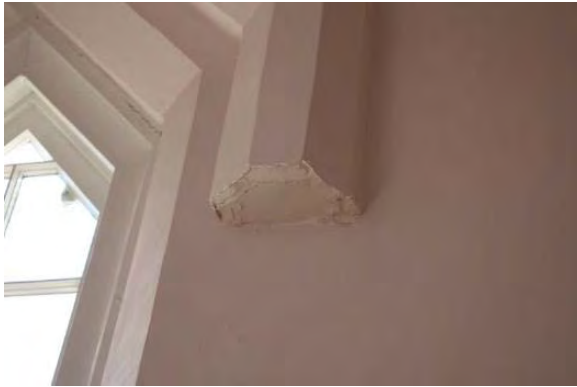
Figure 3.144, Historic Courthouse, Second Floor, Room 211, view of missing pendant at window hood mold.

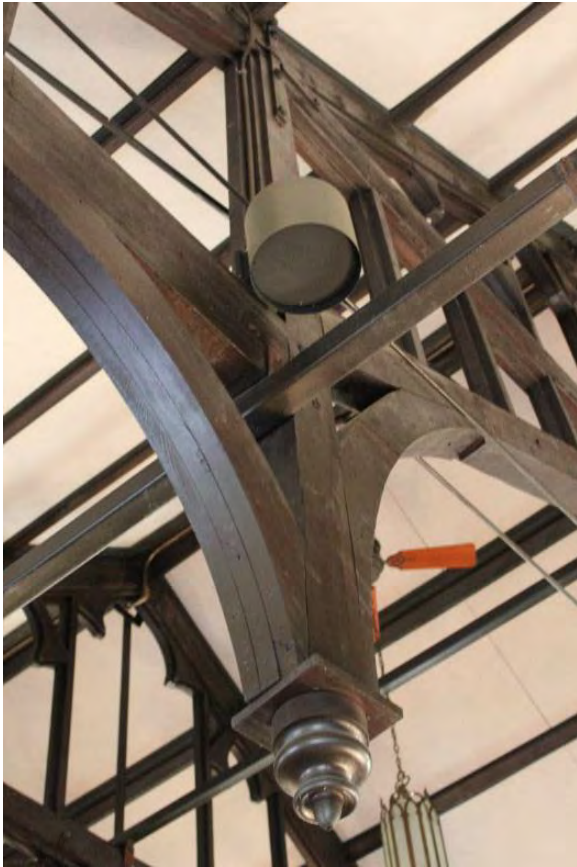
Figure 3.149, Historic Courthouse, Second Floor, Room 212, view of a pendant descending from one of the trusses.

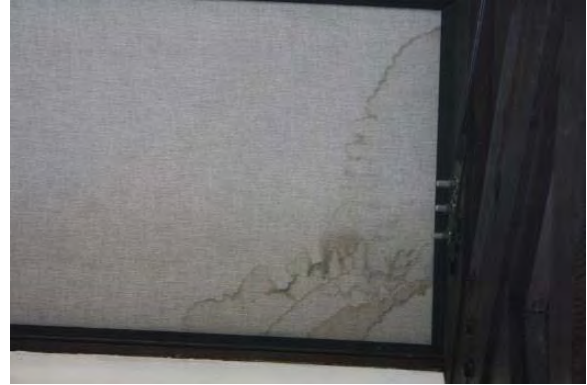
Figure 3.150, Historic Courthouse, Second Floor, Room 212, view of moisture staining at the acoustic paneling.

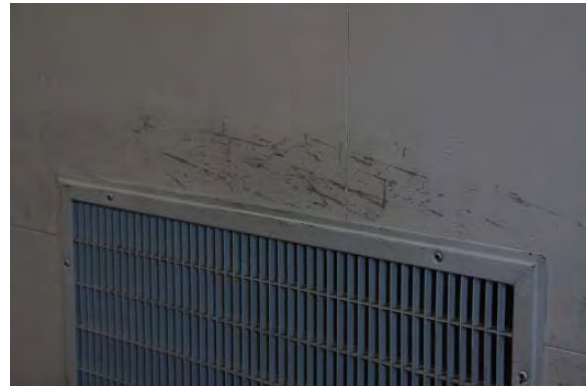
Figure 3.151, Historic Courthouse, Second Floor, Room 212, view of scratches above a vent at the north wall.

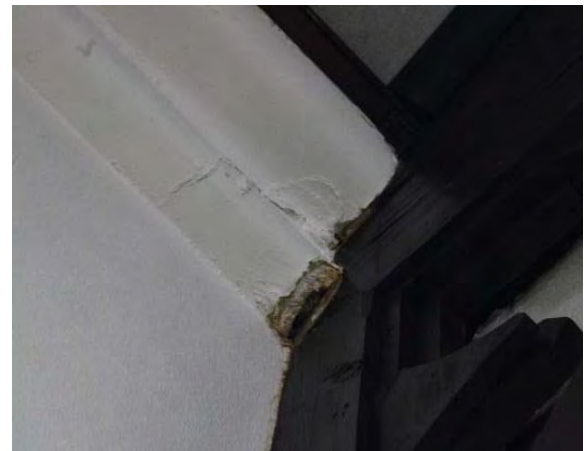
Figure 3.152, Historic Courthouse, Second Floor, Room 212, view of cracks at the crown molding in the southeast corner of the room.

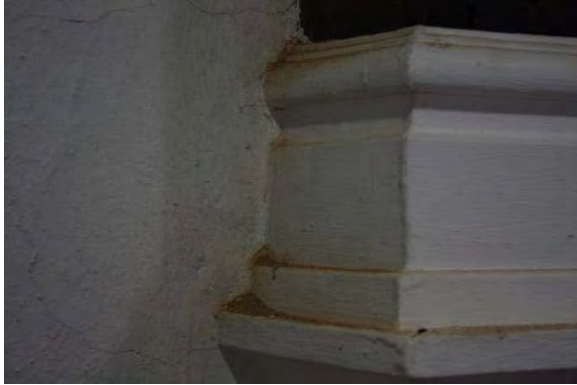
Figure 3.153, Historic Courthouse, Second Floor, Room 212, view of dust from masonry wall adjacent to a pendant post in the northwest corner of the room; this is evidence of efflorescence.

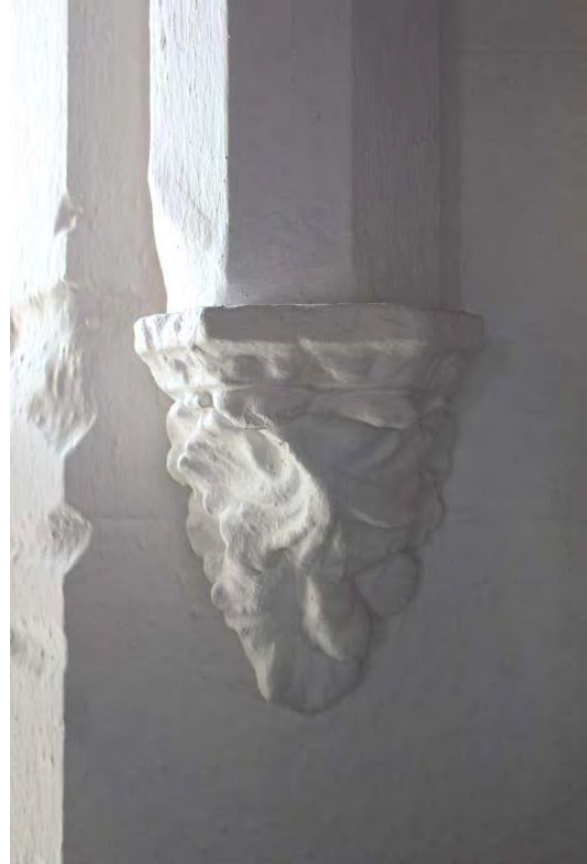
Figure 3.155, Historic Courthouse, Second Floor, Room 212, view of a decorative pendant at a plaster hood mold above a window.

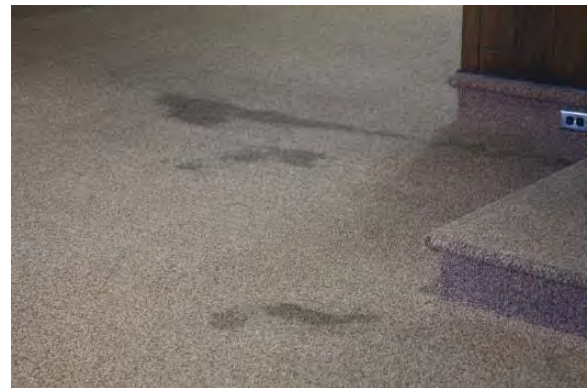
Figure 3.156, Historic Courthouse, Second Floor, Room 212, view of stains at the carpet adjacent to the judge's bench.

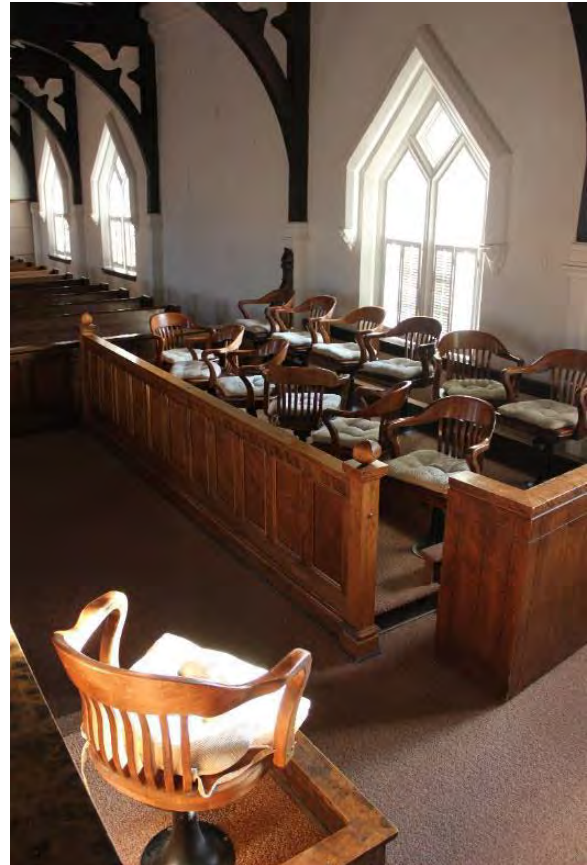
Figure 3.158, Historic Courthouse, Second Floor, Room 212, view of the jury box.

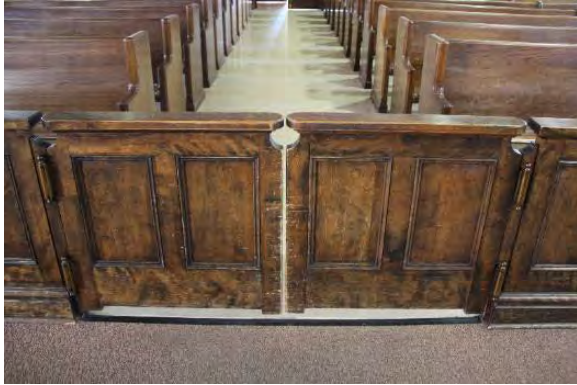
Figure 3.159, Historic Courthouse, Second Floor, Room 212, view of the swinging doors at the bar. Note the heavy wear and scratching where the doors meet.

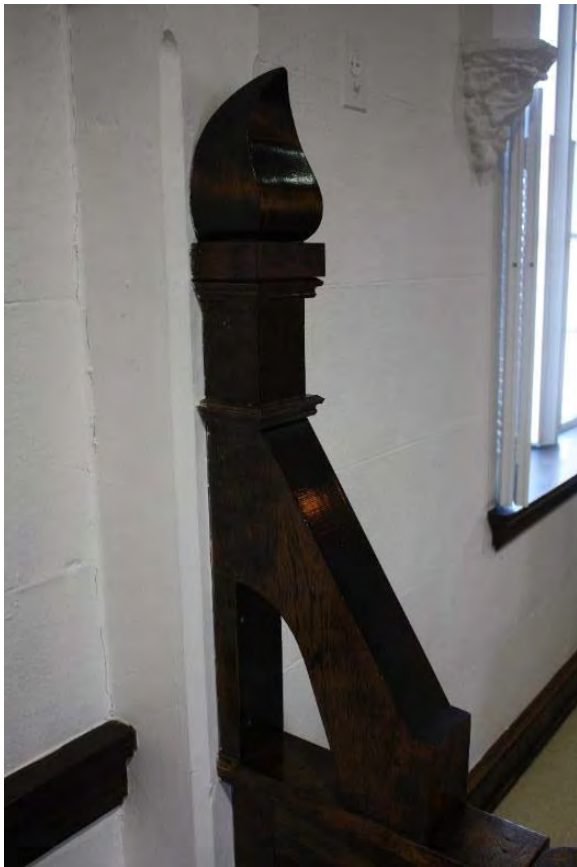
Figure 3.160, Historic Courthouse, Second Floor, Room 212, view of one of the decorative wood brackets at one end of the bar.

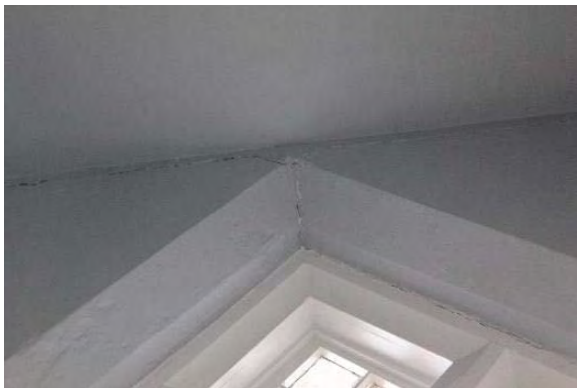
Figure 3.167, Historic Courthouse, Second Floor, Room 216, view of crack at head of window at north wall.

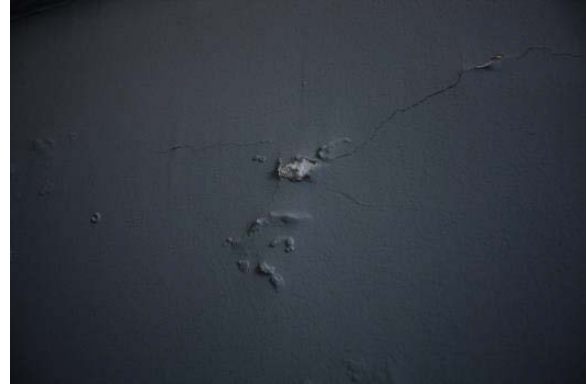
Figure 3.168, Historic Courthouse, Second Floor, Room 216, view of efflorescence below center window at west wall.

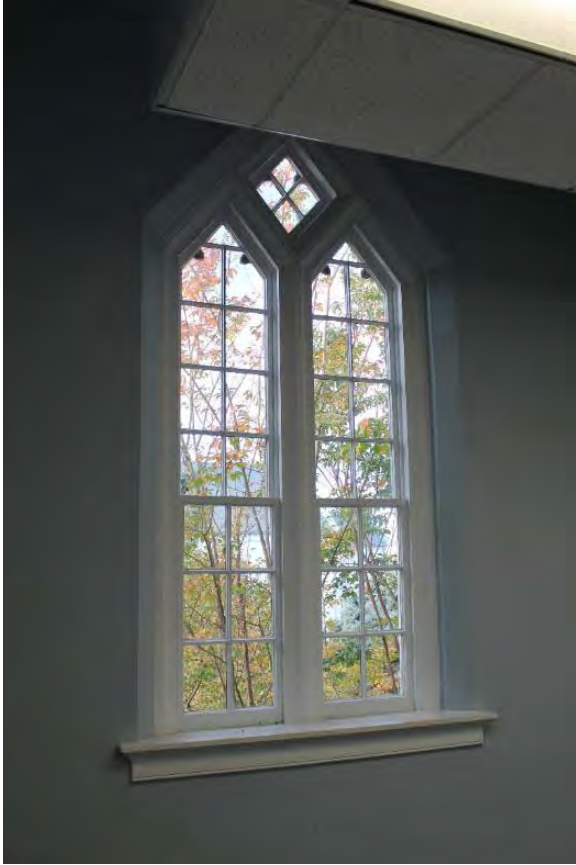
Figure 3.169, Historic Courthouse, Second Floor, Room 216, view of window at north wall.

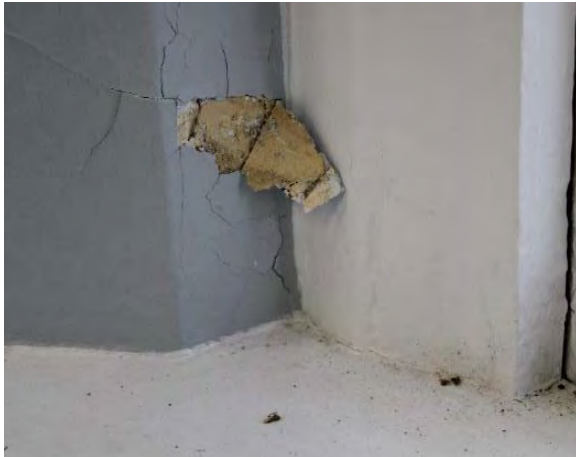
Figure 3.170, Historic Courthouse, Second Floor, Room 216, view of plaster damage due to efflorescence at the northernmost window of the west wall.

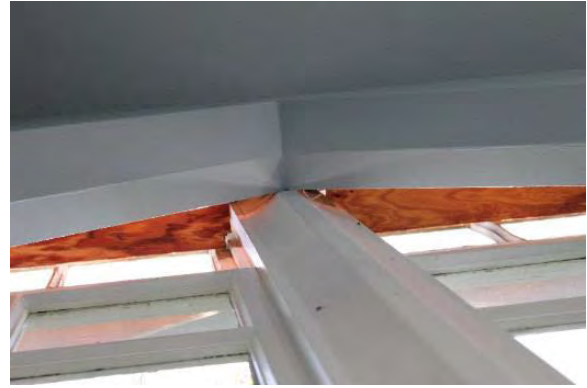
Figure 3.171, Historic Courthouse, Second Floor, Room 216, view of plywood between window and opening at head of center window at west wall.

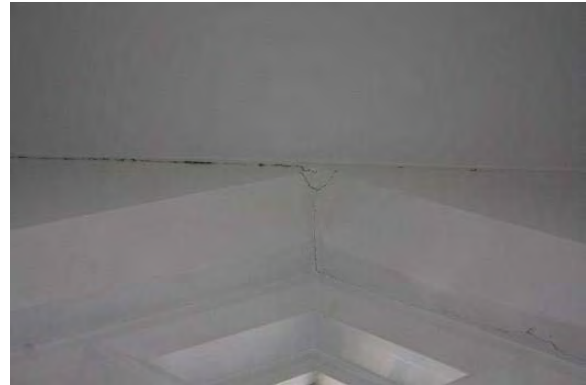
Figure 3.174, Historic Courthouse, Second Floor, Room 217, view of crack in plaster at head of window.

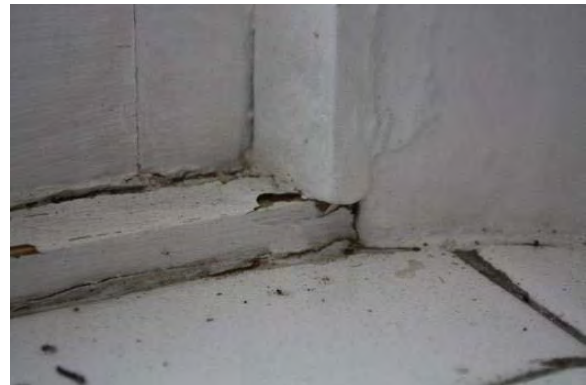
Figure 3.175, Historic Courthouse, Second Floor, Room 217, view of paint loss and damage at the wood window frame.

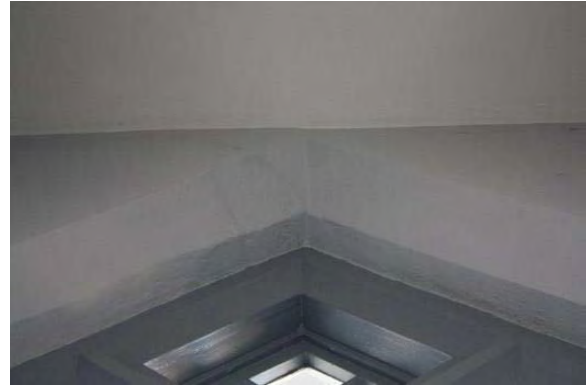
Figure 3.179, Historic Courthouse, Second Floor, Room 219, view of water damage at head of window.

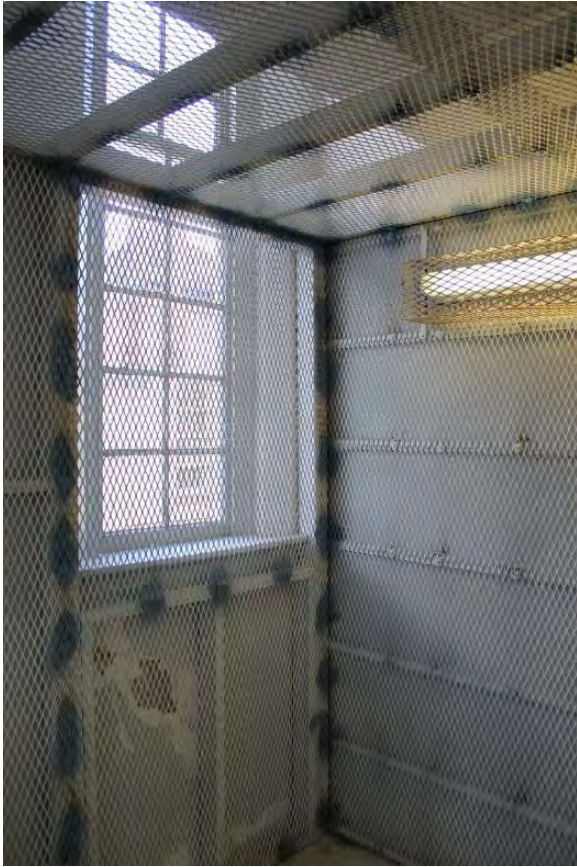
Figure 3.181, Historic Courthouse, Second Floor, Room 221, general view looking southeast. Note the area of plaster damage under the window.

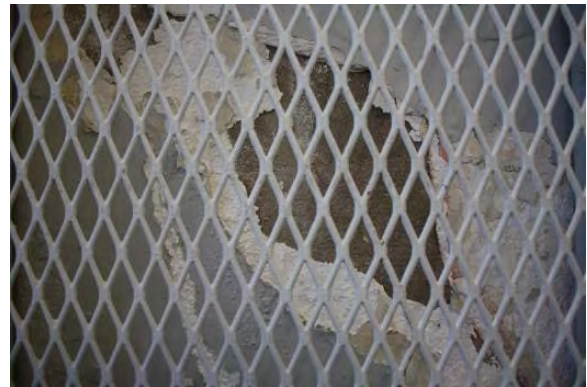
Figure 3.183, Historic Courthouse, Second Floor, Room 221, view of plaster damage due to efflorescence underneath the east window.

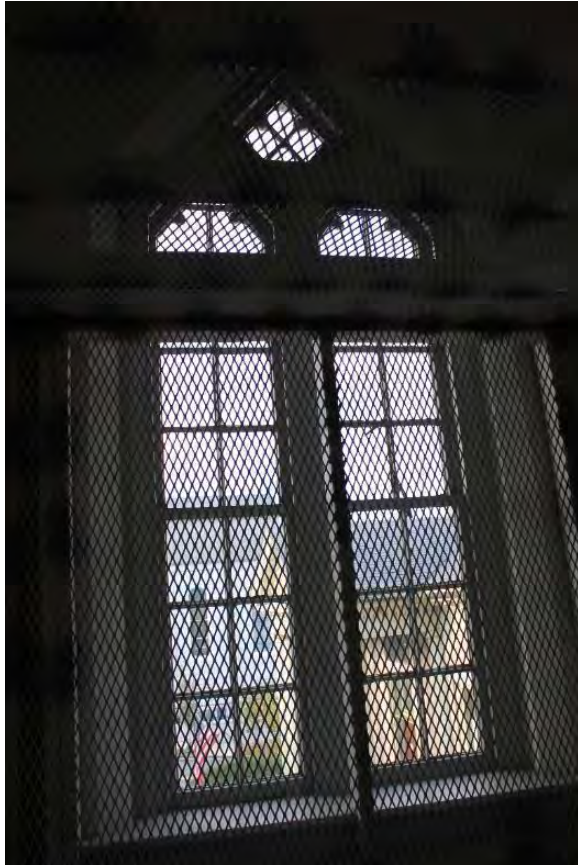
Figure 3.184, Historic Courthouse, Second Floor, Room 221, view of the north window.

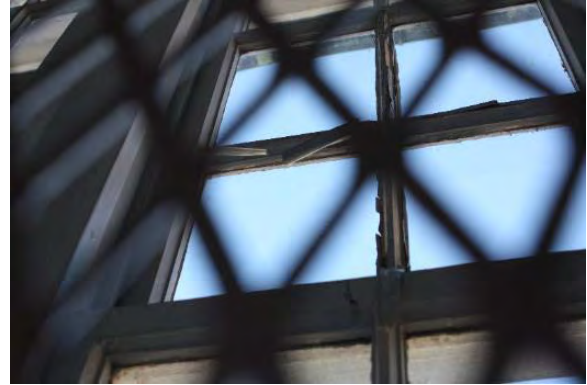
Figure 3.185, Historic Courthouse, Second Floor, Room 221, view of paint failure at the muntins of the north window.

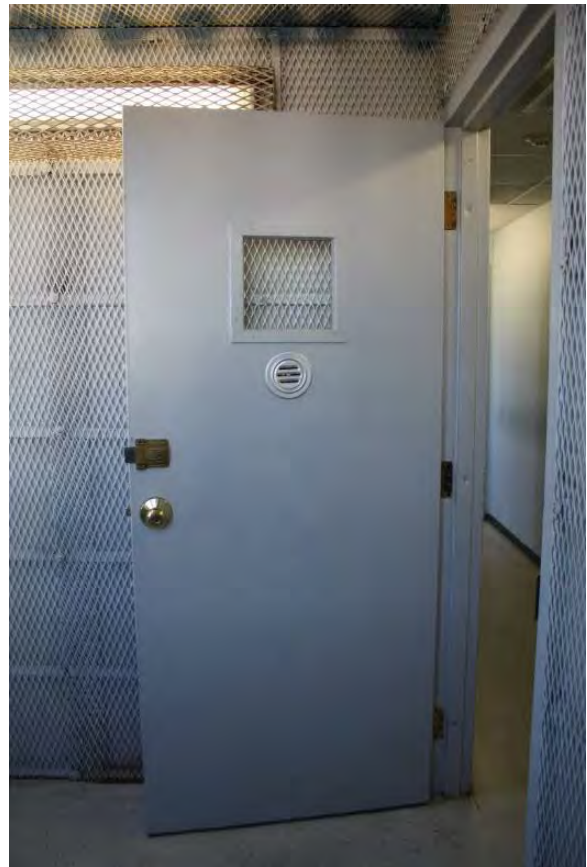
Figure 3.186, Historic Courthouse, Second Floor, Room 221, view of the metal door with speak hole.

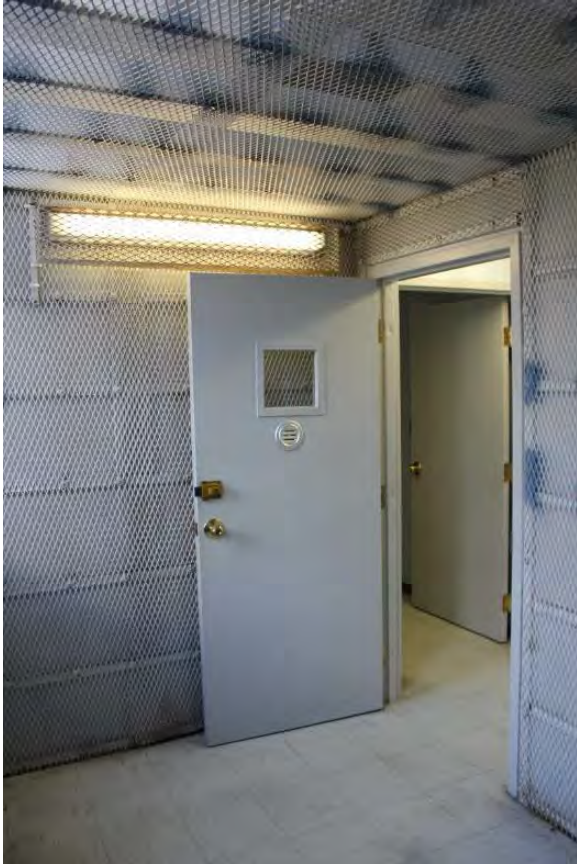
Figure 3.188, Historic Courthouse, Second Floor, Room 222, general view looking southwest.

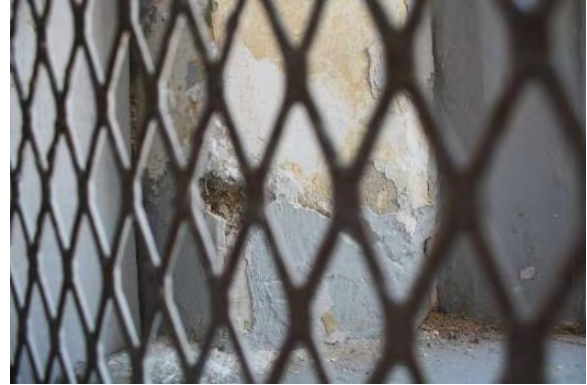
Figure 3.190, Historic Courthouse, Second Floor, Room 222, view of efflorescence and paint failure at a window reveal.

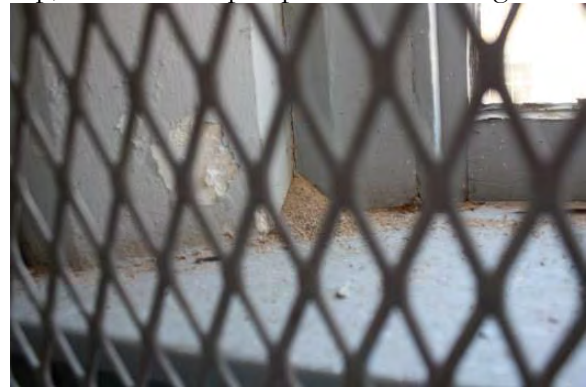
Figure 3.191, Historic Courthouse, Second Floor, Room 222, view of efflorescence and paint failure at a window reveal.

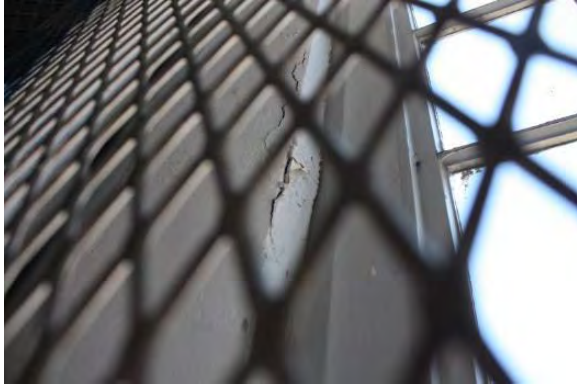
Figure 3.192, Historic Courthouse, Second Floor, Room 222, view of a crack at the reveal of the north window.

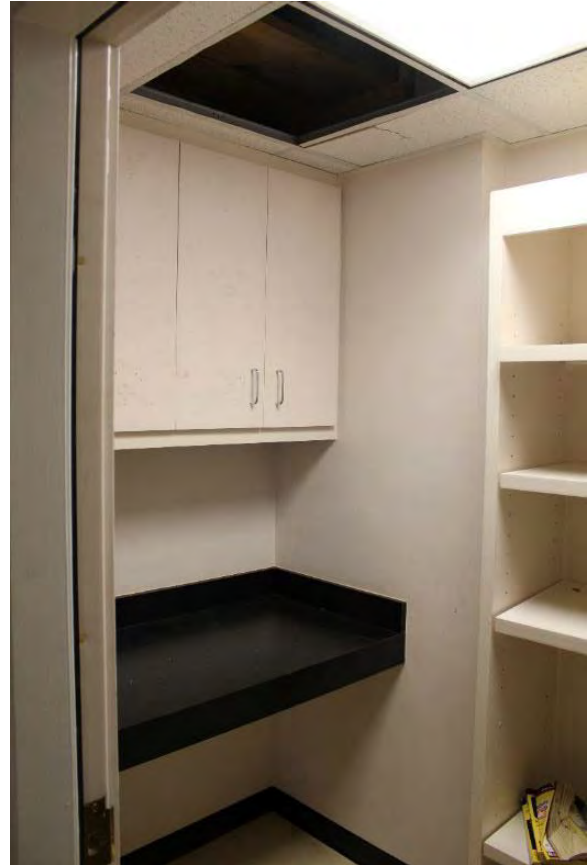
Figure 3.196, Historic Courthouse, Second Floor, Room 226, general view. Note the missing ceiling tile and adjacent cracked tile.

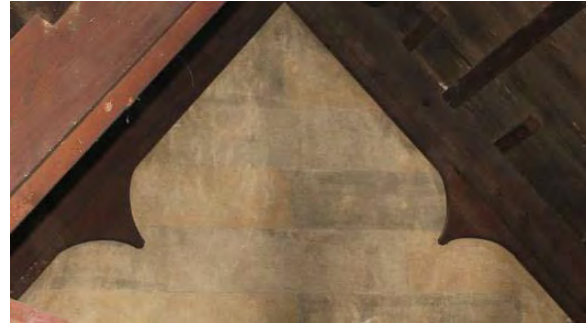
Figure 3.199, Historic Courthouse, South Attic, Room 301, detail view of stucco wall with ashlar scoring and simulated stone finish.

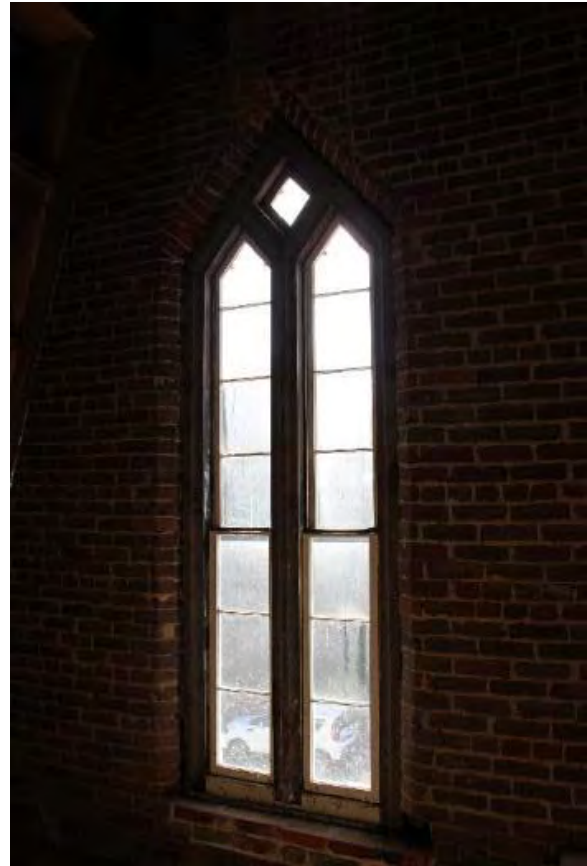
Figure 3.202, Historic Courthouse, Bell Tower, Room 302, view of a second-story window.

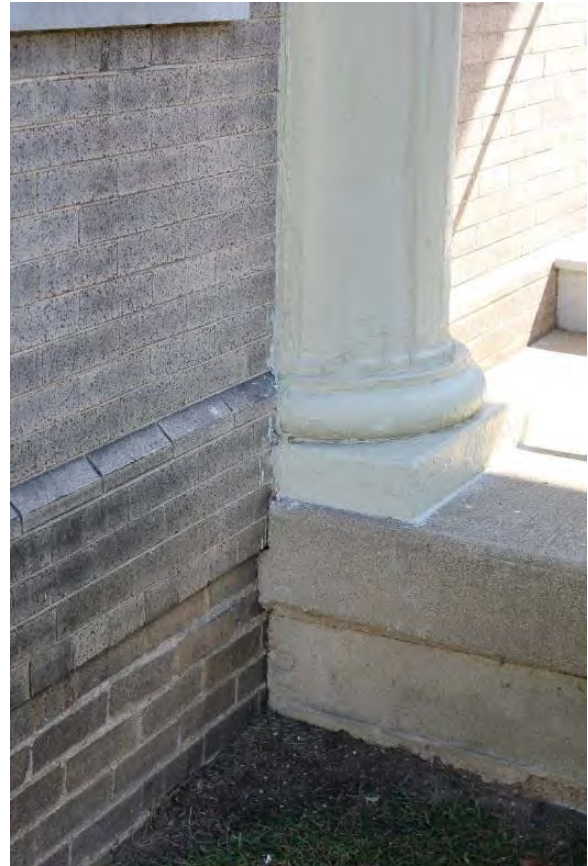
Figure 3.214, Wallace Library, West elevation, detail of foundation.

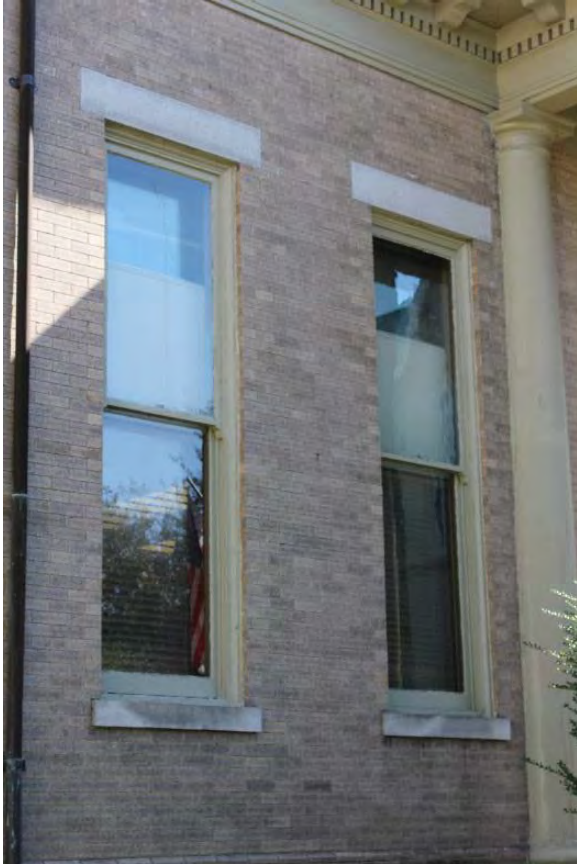
Figure 3.215, Wallace Library, West elevation, detail of windows. Note the second floor structure visible through the windows. Note the staining on the stone sills.

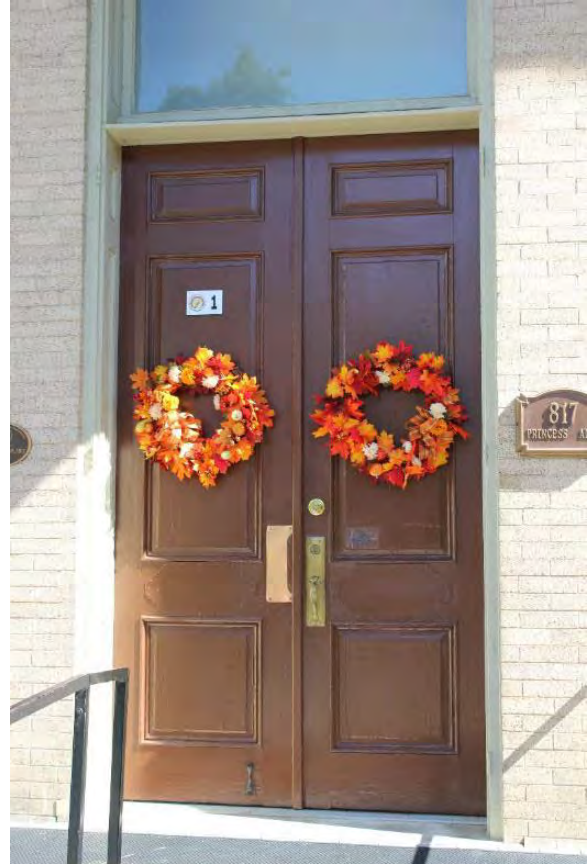
Figure 3.216, Wallace Library, West elevation, detail of double entry door.

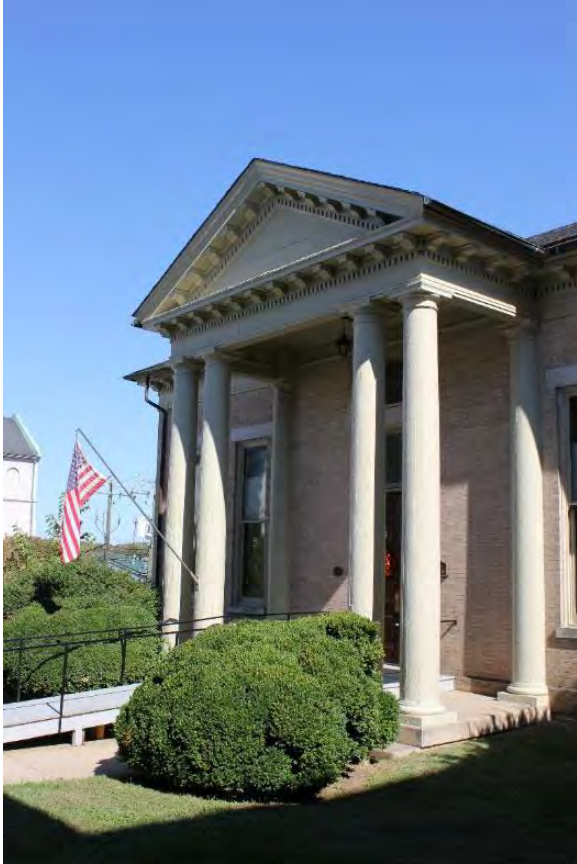
Figure 3.217, Wallace Library, West elevation, detail of porch, view northeast.

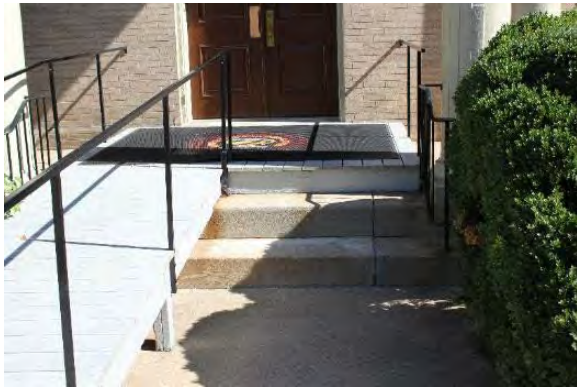
Figure 3.218, Wallace Library, West elevation, detail of ramp and platform overlay of historic porch.

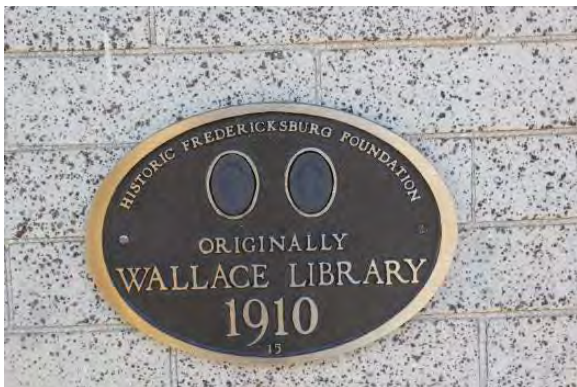
Figure 3.221, Wallace Library, West elevation, detail of Historic Fredericksburg Foundation plaque.
