Historic Structures Report
Renwick Courthouse, Wallace Library, and Old Jail
City of Fredericksburg, Virginia

Created / Last Revised:

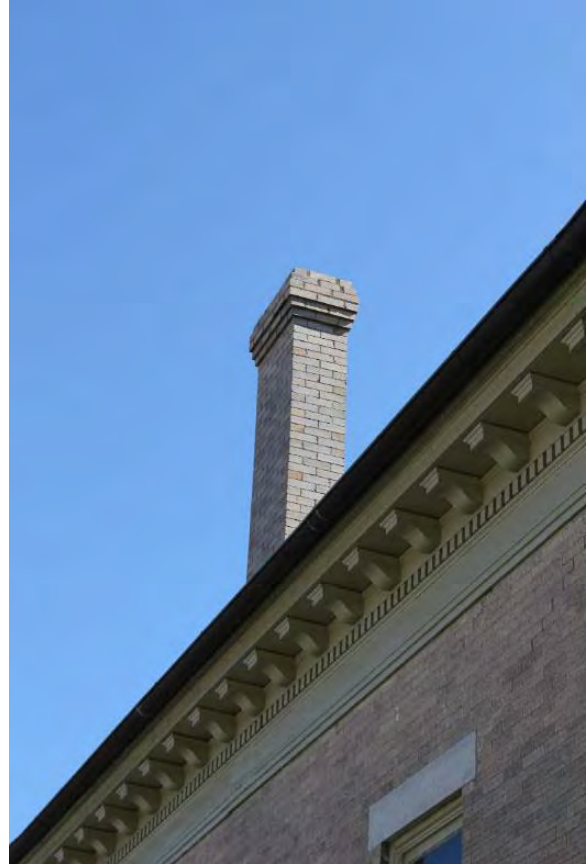
Figure 3.223, Wallace Library, North elevation, detail of chimney.

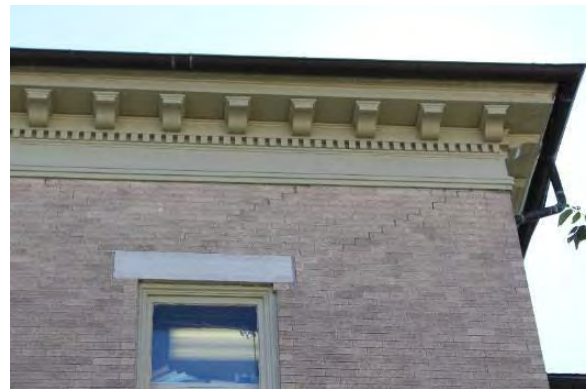
Figure 3.224, Wallace Library, North elevation, detail of cornice. Note the stepped cracks above the window.

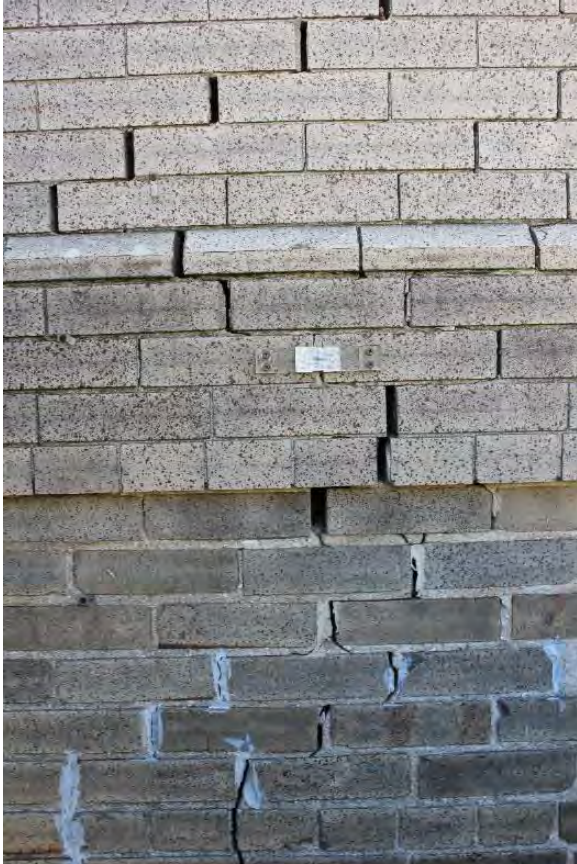
Figure 3.225, Wallace Library, North elevation, detail crack and shifting damage.

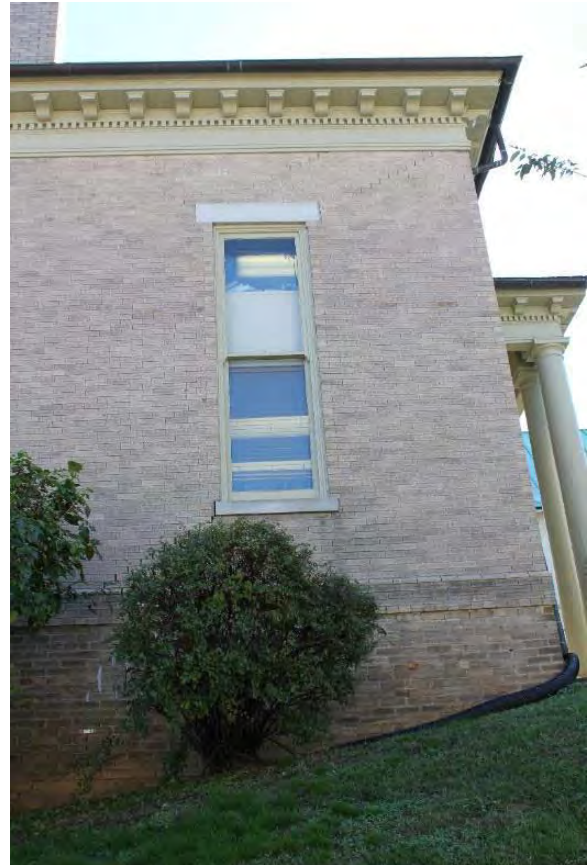
Figure 3.226, Wallace Library, North elevation, detail of window.

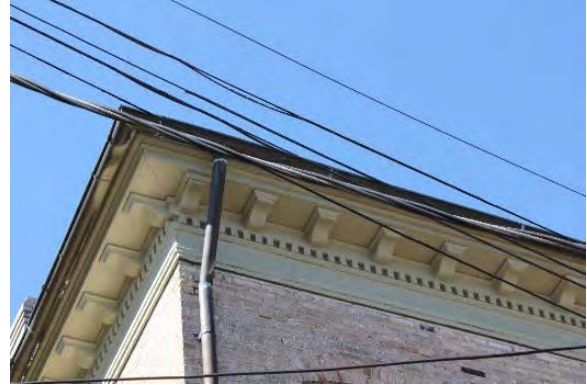
Figure 3.229, Wallace Library, East elevation, cornice detail.

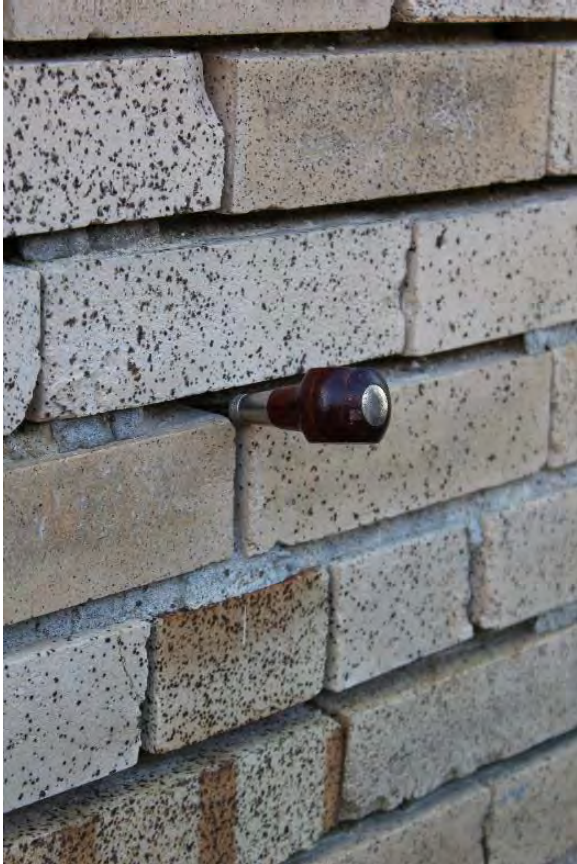
Figure 3.230, Wallace Library, East elevation, detail of brick wall. Note missing mortar.

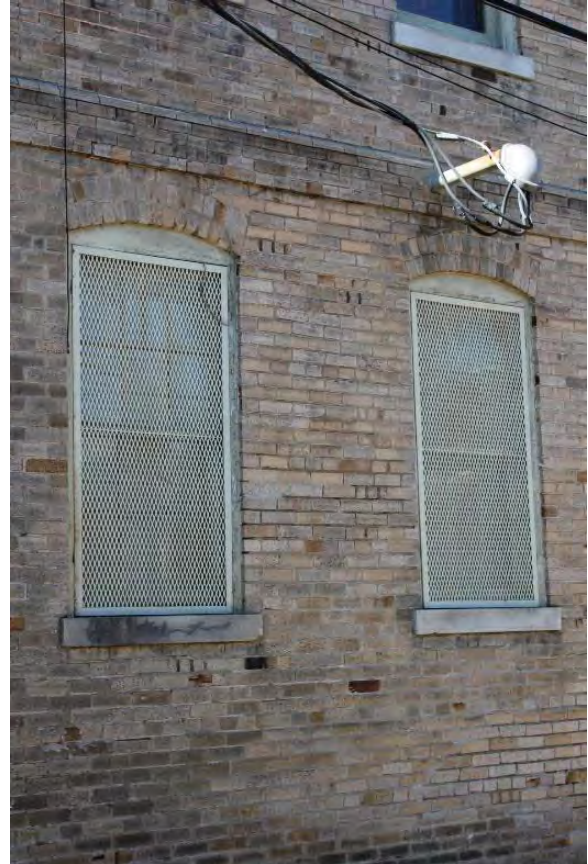
Figure 3.231, Wallace Library, East elevation, detail of basement windows.

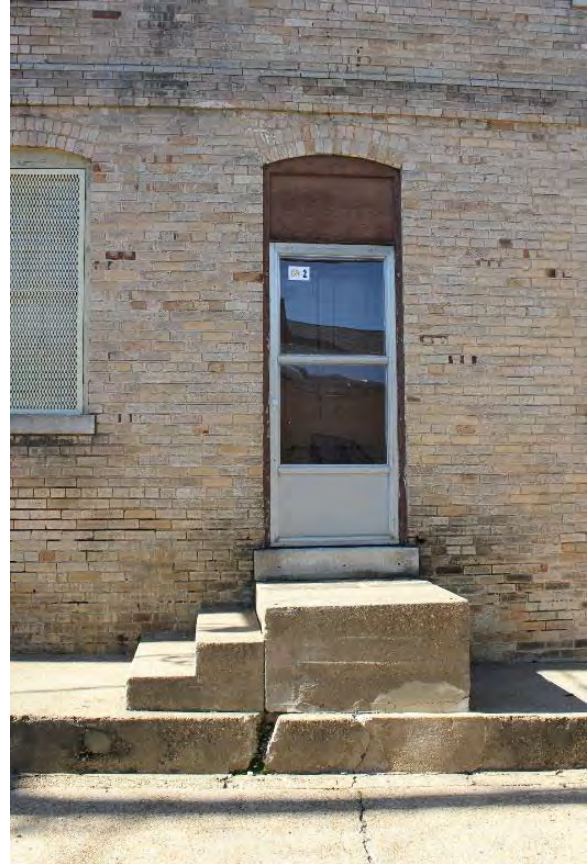
Figure 3.233, Wallace Library, East elevation, basement door and concrete stoop detail.

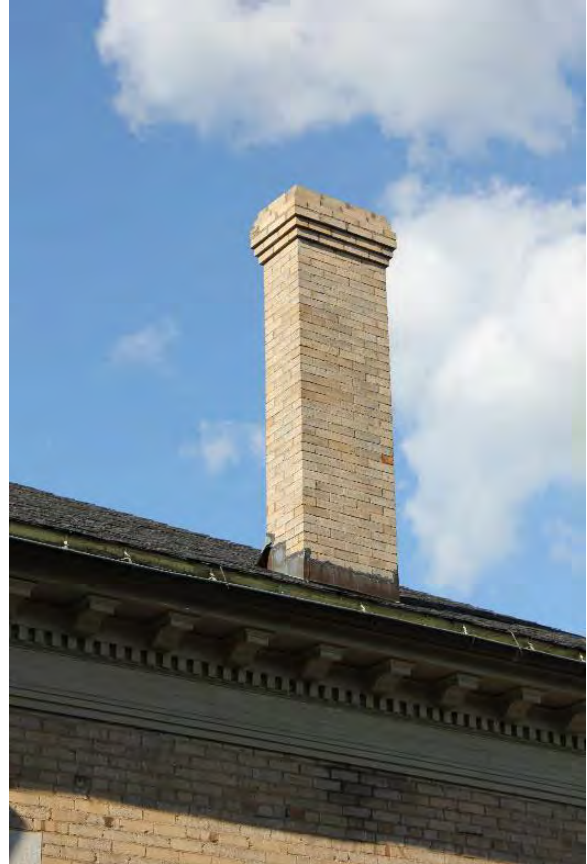
Figure 3.238, Wallace Library, South elevation, detail of chimney.

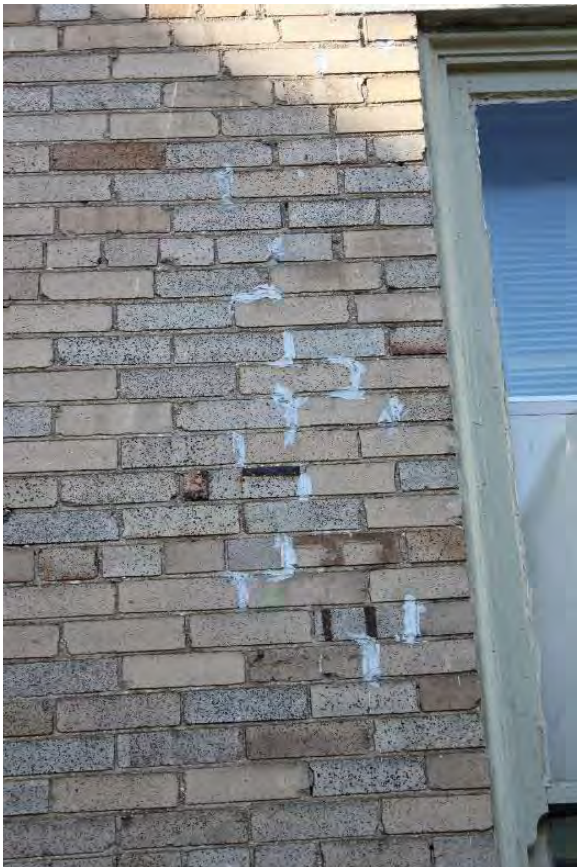
Figure 3.241, Wallace Library, South elevation, wall detail.

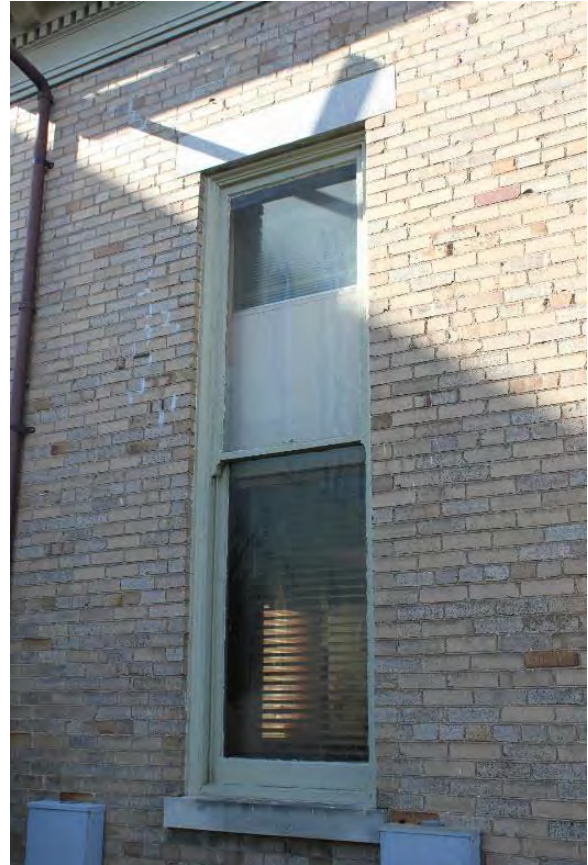
Figure 3.242, Wallace Library, South elevation, detail of window.

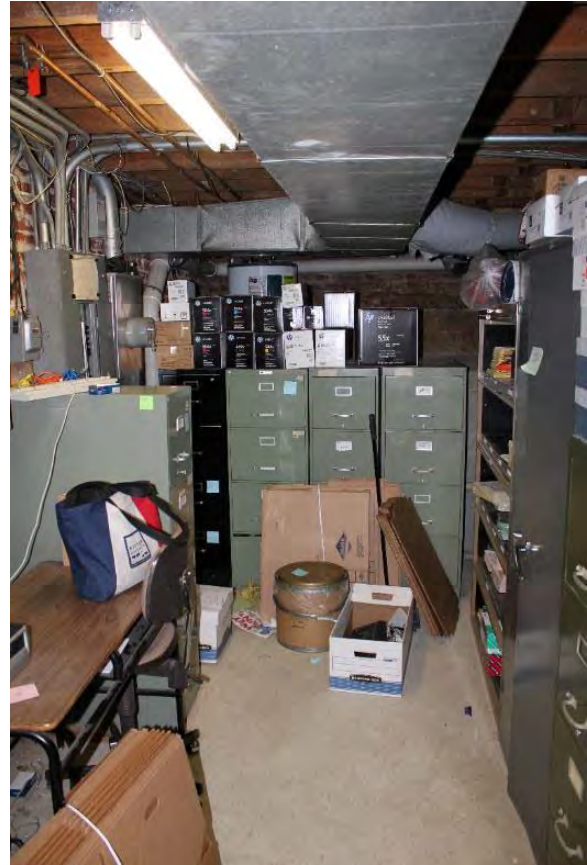
Figure 3.244, Old Wallace Library, Basement, Room 001, general view looking south.

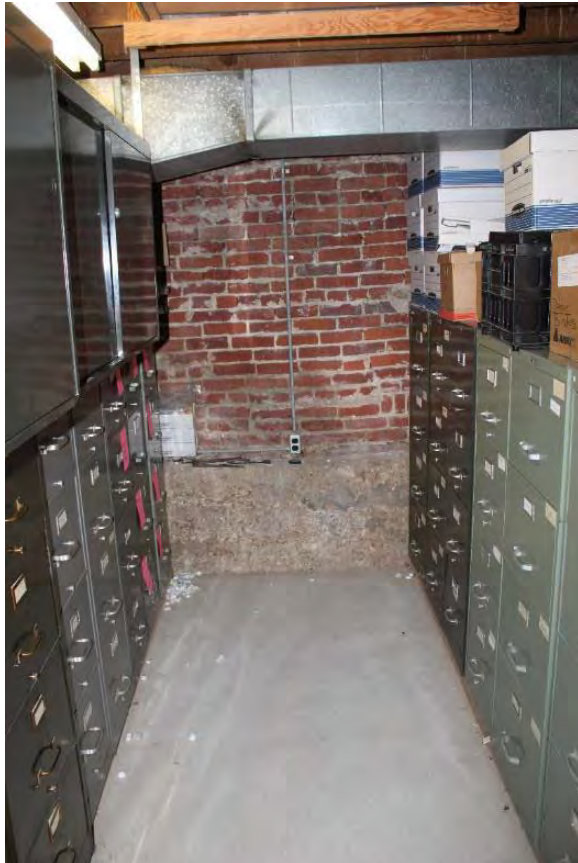
Figure 3.245, Old Wallace Library, Basement, Room 001, general view looking north. Note the transition of wall material from concrete at the base to brick above.

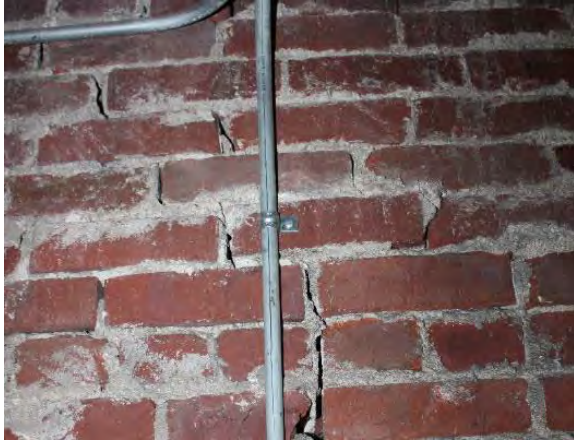
Figure 3.248, Old Wallace Library, Basement, Room 001, view of a step crack at the north wall.

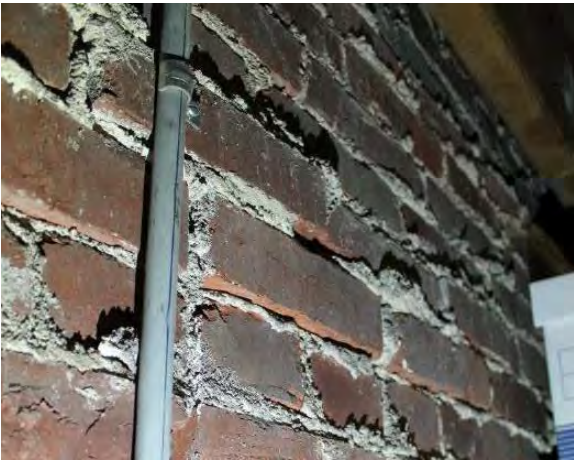
Figure 3.249, Old Wallace Library, Basement, Room 001, view of uneven mortar at the north wall.

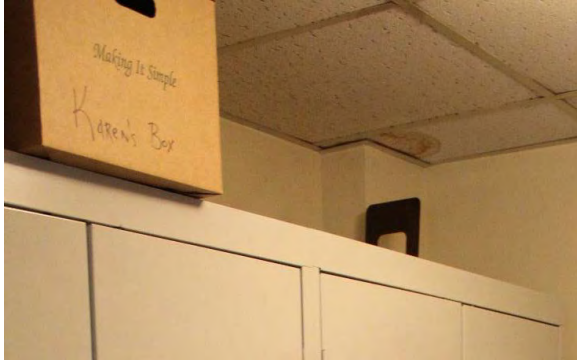
Figure 3.309, Old Wallace Library, Second Floor, Room 207, view of moisture staining at a ceiling tile.

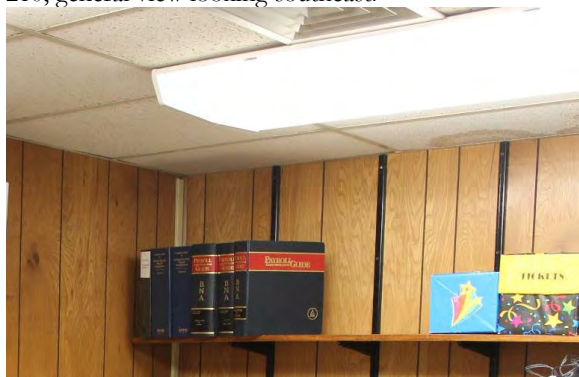
Figure 3.315, Old Wallace Library, Second Floor, Room 210, view of moisture staining at a ceiling tile.

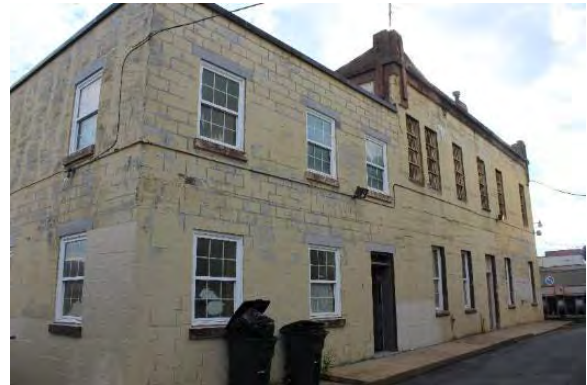
Figure 3.316, Old Jail, west elevation, general view looking southeast.

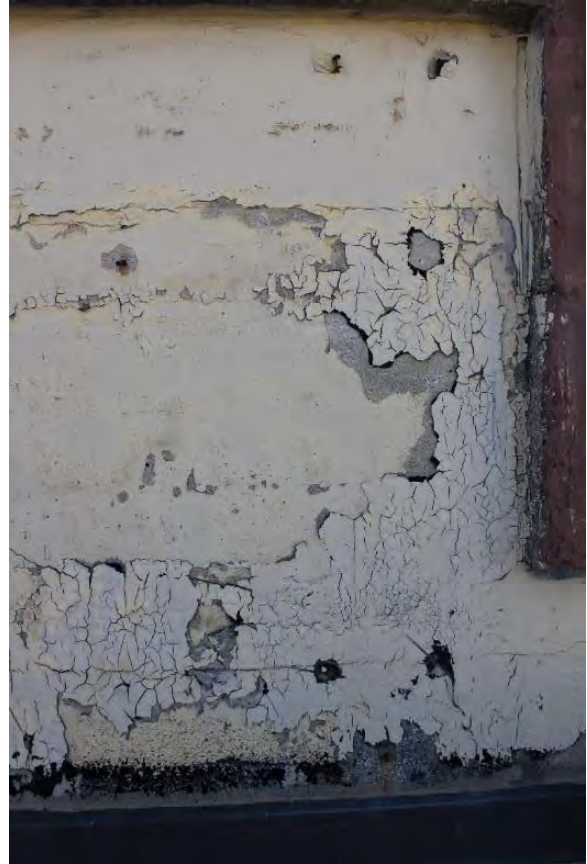
Figure 3.319, Old Jail, roof, view of paint deterioration at transition between low and high roof.

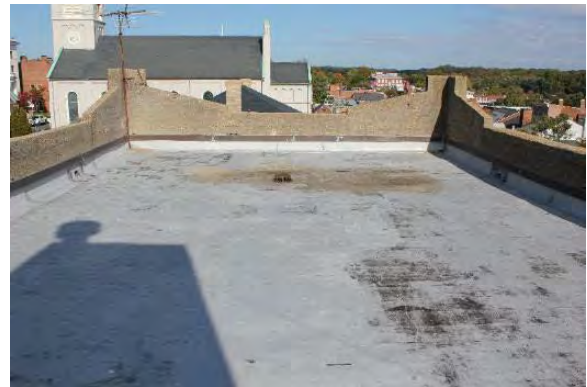
Figure 3.320, Old Jail, roof, view of higher flat membrane roof looking south. Note the parapets.

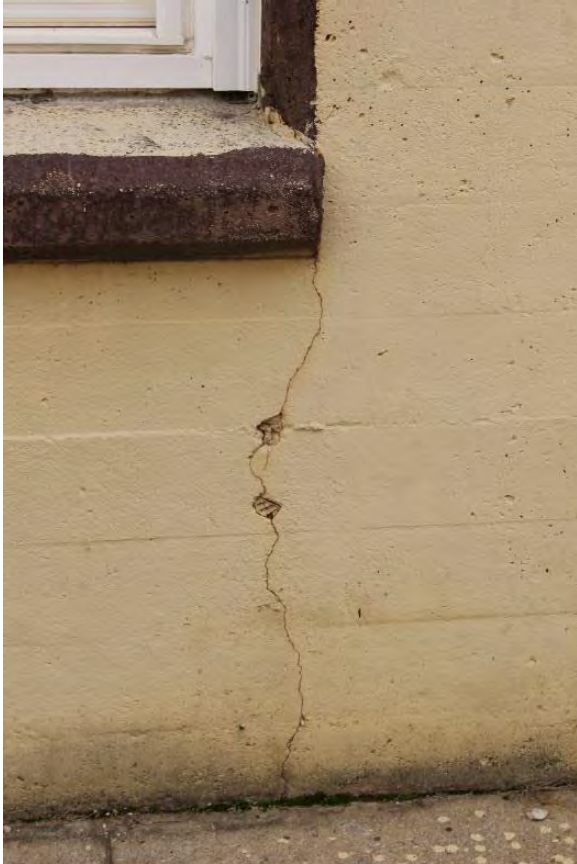
Figure 3.324, Old Jail, west elevation, view of a crack underneath the first-story window south of the northernmost door.

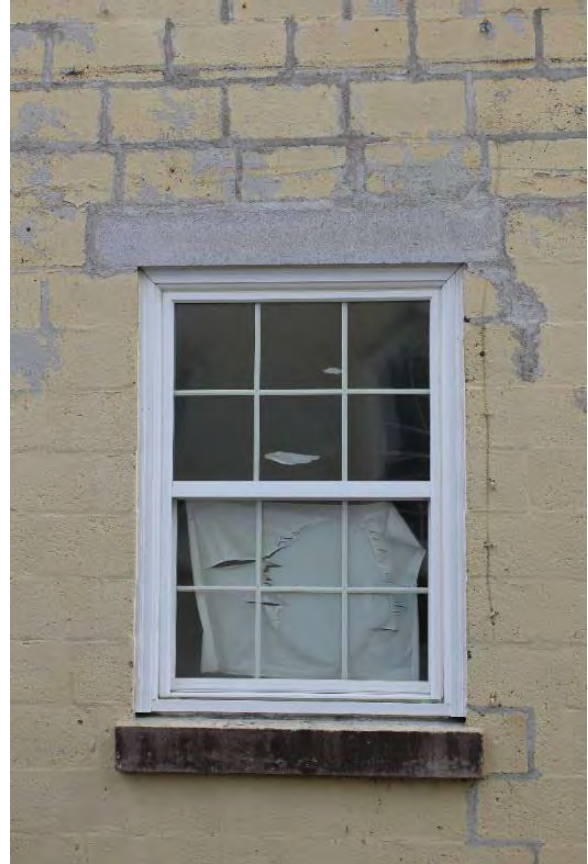
Figure 3.325, Old Jail, west elevation, view of a typical vinyl replacement window at the low-roofed north section.

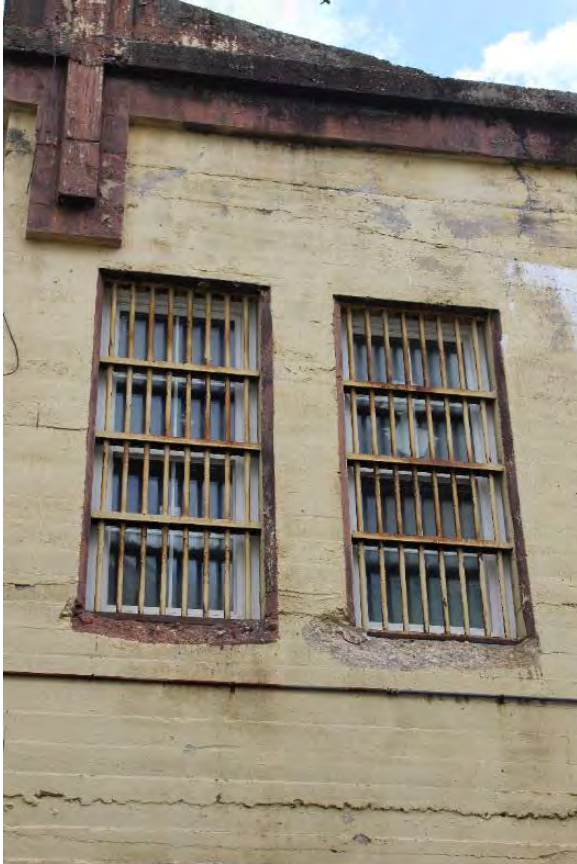
Figure 3.326, Old Jail, west elevation, view of typical second-story windows at the high-roofed south section. Note the concrete spalling where the sills are missing.

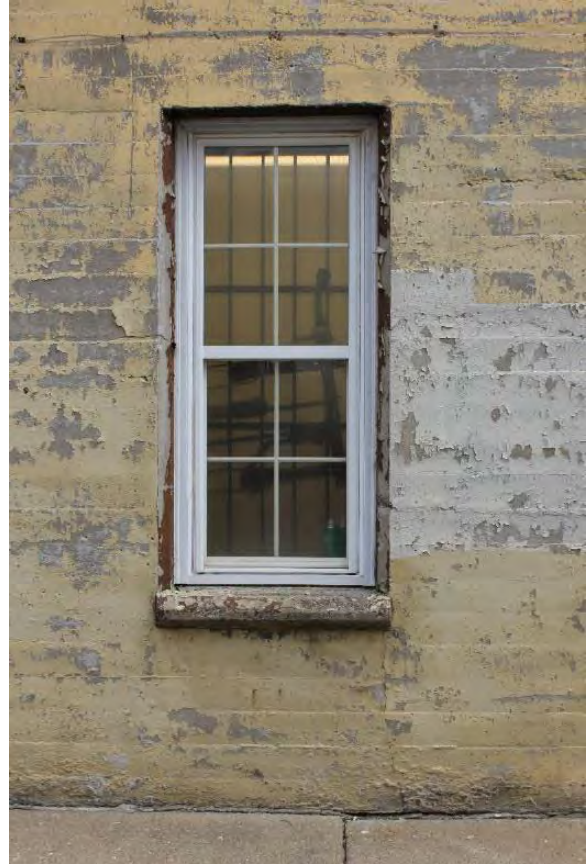
Figure 3.327, Old Jail, west elevation, view of a typical vinyl replacement first-story window at the high-roofed south section.

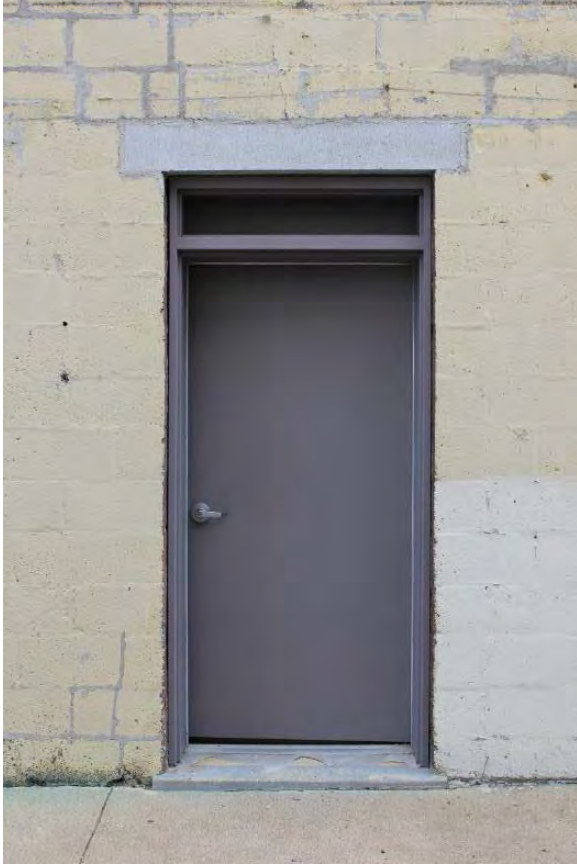
Figure 3.328, Old Jail, west elevation, view of north door.

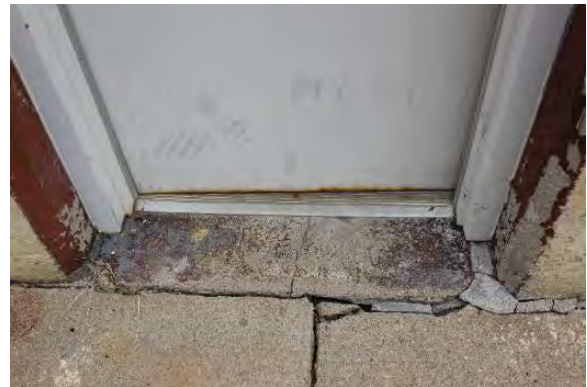
Figure 3.330, Old Jail, west elevation, view of cracked concrete at threshold of south door.

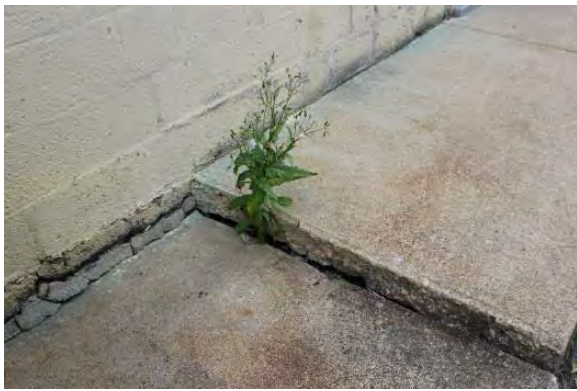
Figure 3.331, Old Jail, west elevation, view of uneven concrete walk.

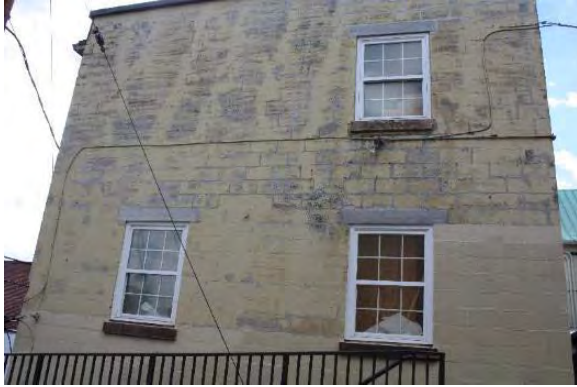
Figure 3.332, Old Jail, north elevation, general view looking south. Note the large areas of paint loss at the wall.

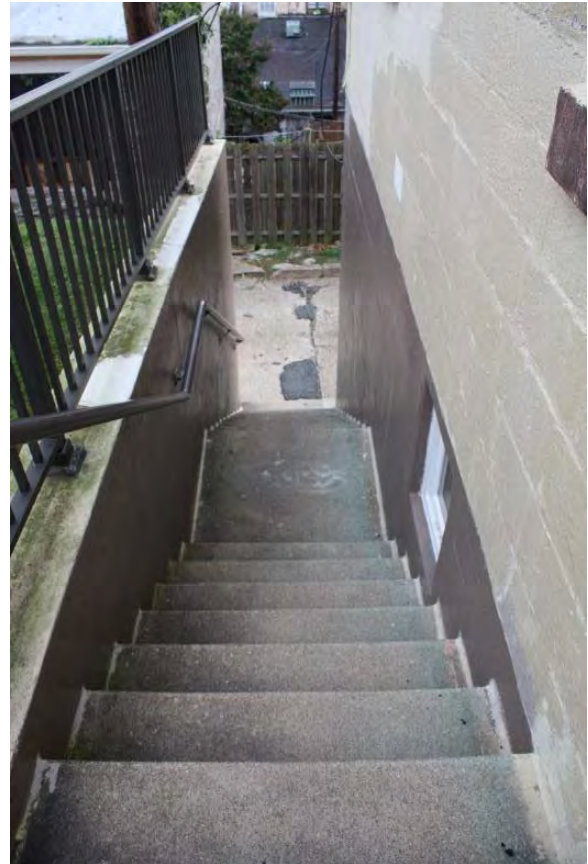
Figure 3.334, Old Jail, north elevation, view of stairwell to basement level.

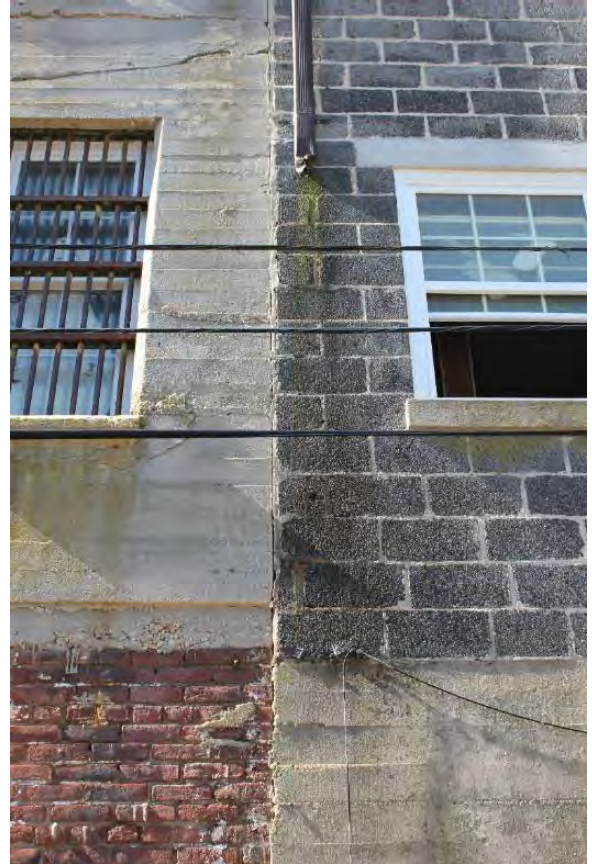
Figure 3.338, Old Jail, east elevation, view of intersection of high- and low-roofed sections at the north end of the building. Note the mix of building materials and the damaged, truncated downspout.

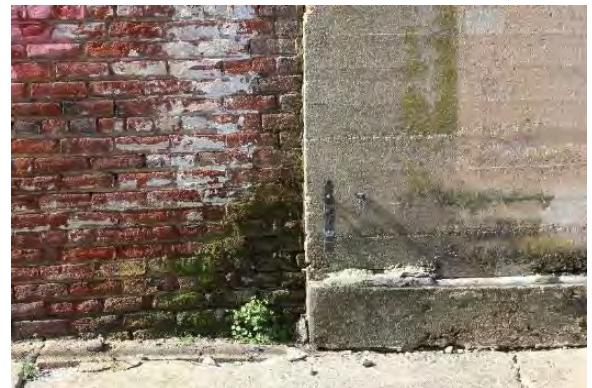
Figure 3.339, Old Jail, east elevation, view of basement at intersection of high- and low-roofed sections at the north end of the building. Note the large area of biological growth.

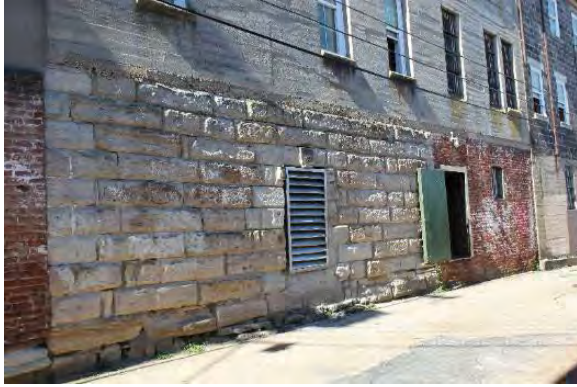
Figure 3.340, Old Jail, east elevation, view of mix of rustic masonry and brick at the basement level at two-story center section.

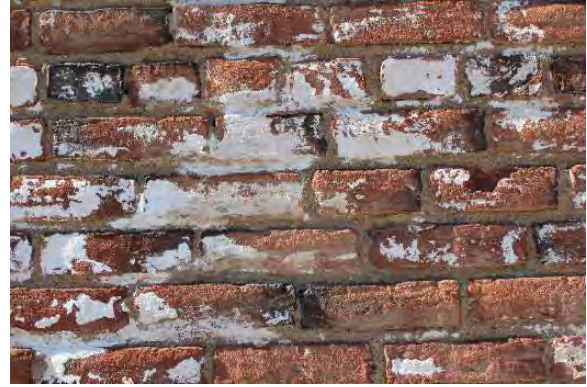
Figure 3.342, Old Jail, east elevation, detail view of brick at basement level of center section; note the efflorescence.

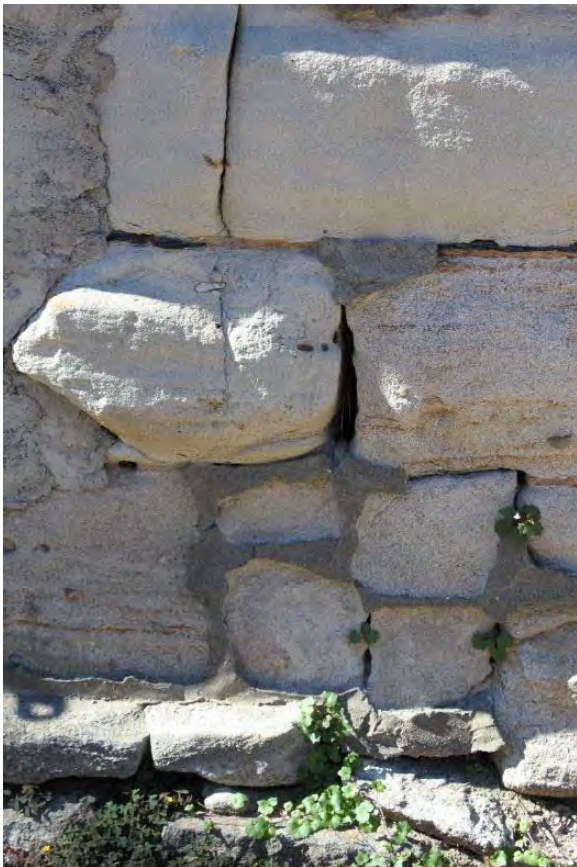
Figure 3.341, Old Jail, east elevation, detail view of rustic masonry at basement level; note the large areas of mortar loss.

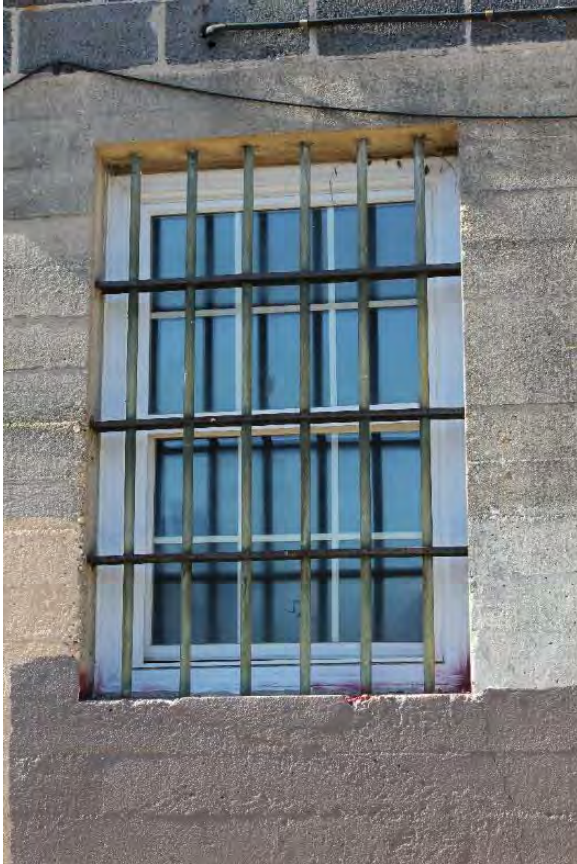
Figure 3.343, Old Jail, east elevation, view of one of the vinyl replacement windows at the basement level of the main, high-roofed section.

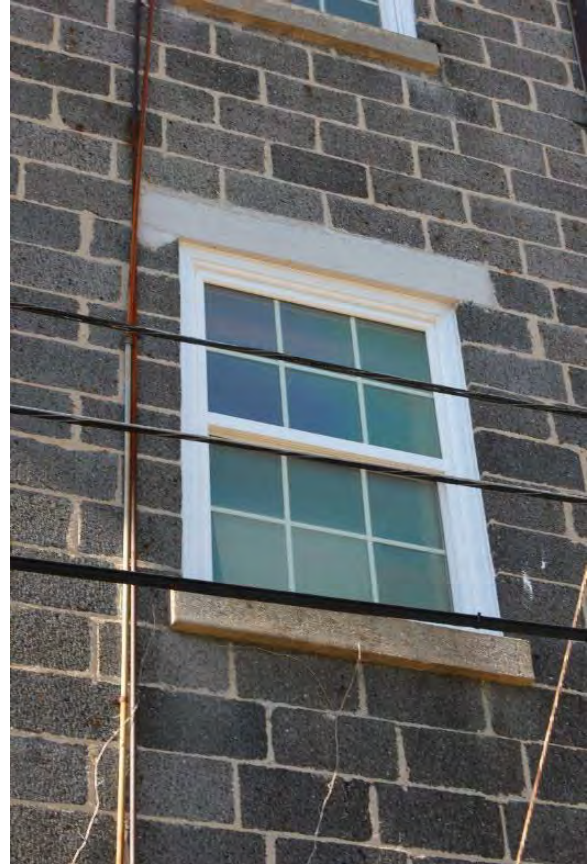
Figure 3.344, Old Jail, east elevation, view of one of the vinyl replacement windows at the second story of the north, low-roofed section.

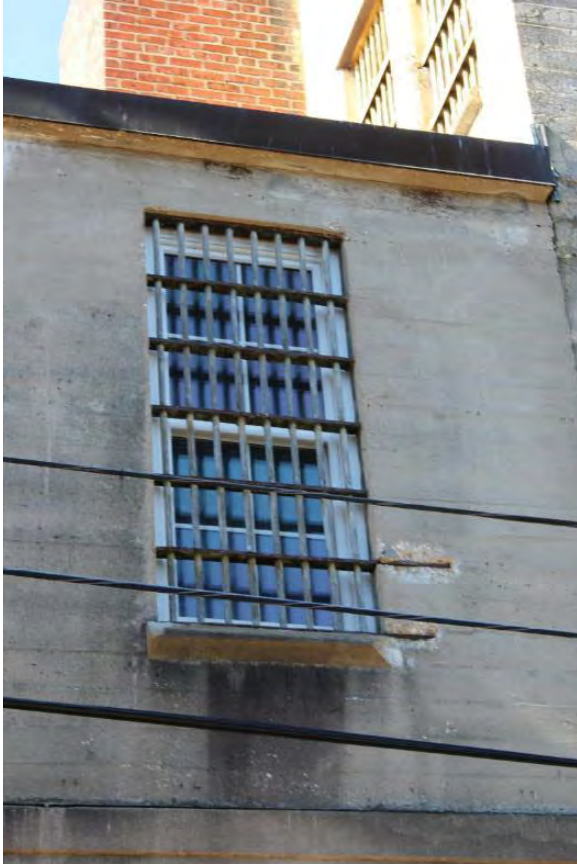
Figure 3.345, Old Jail, east elevation, view of a first-story window at the one-story south wing.

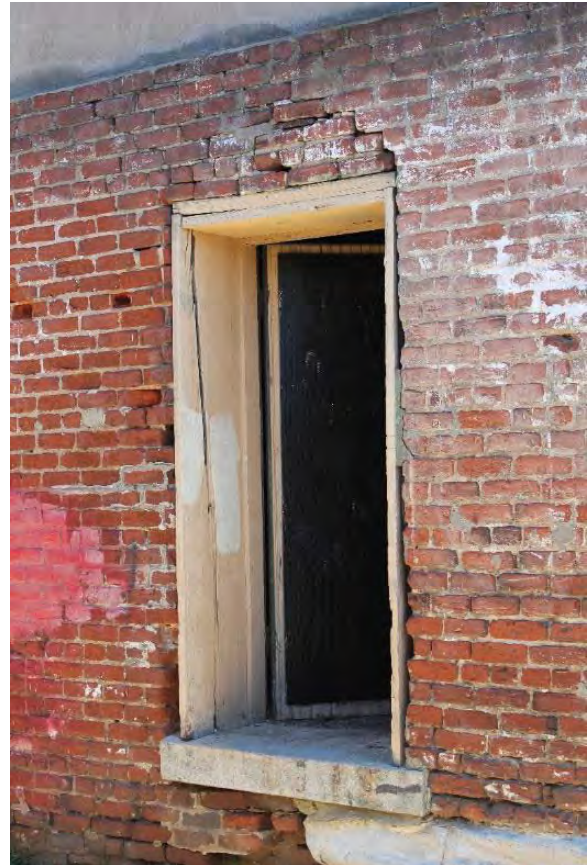
Figure 3.346, Old Jail, east elevation, view of south door at one-story wing. Note the large vertical crack in the door frame, the lack of steps to access the door, and step cracks at the brick wall above the door.

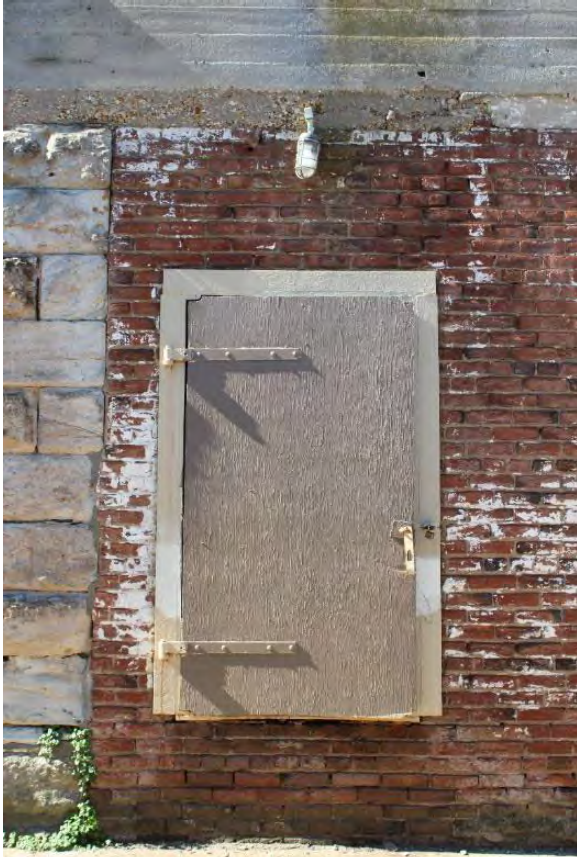
Figure 3.347, Old Jail, east elevation, view of north door at the high-roofed section. Note the lack of steps to access the door.

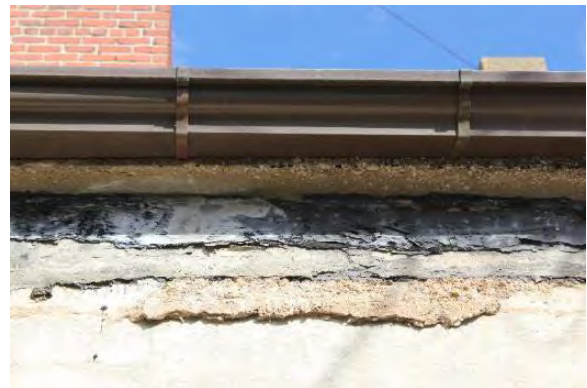
Figure 3.352, Old Jail, south elevation, view of spalling just below the cornice.

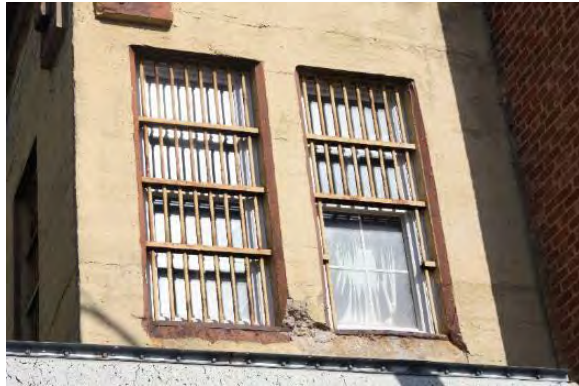
Figure 3.353, Old Jail, south elevation, view of second-story windows west of the chimney. Note the missing sills at both windows and removed bars at the east window. The concrete is spalling where the sills were formerly located.

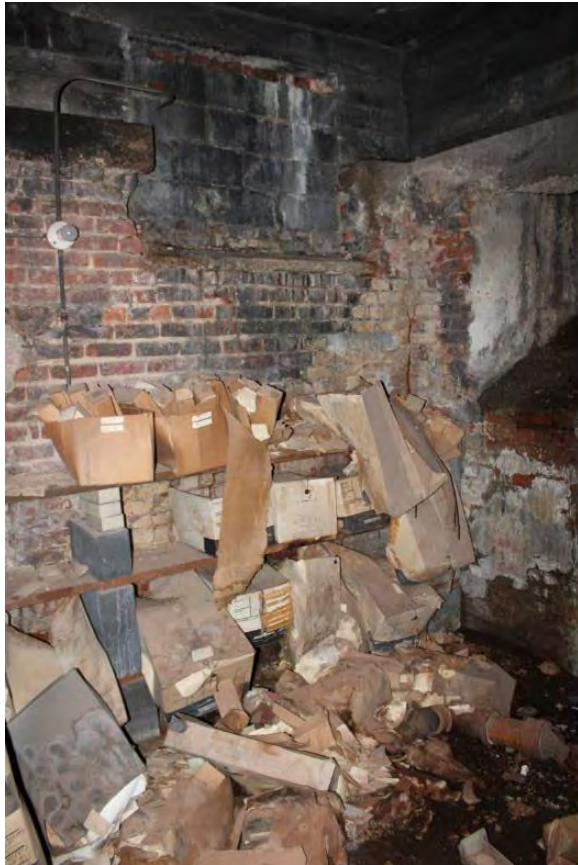
Figure 3.354, Old Jail, Basement, Room 001, general view looking southwest. Note the many moisture-deteriorated cardboard boxes and papers stored in the room and moisture staining under the infilled window.

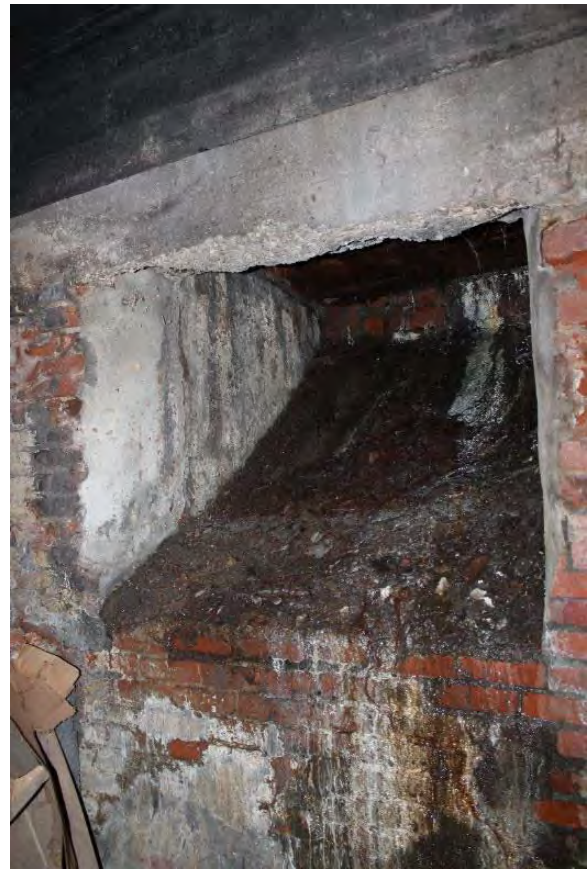
Figure 3.357, Old Jail, Basement, Room 001, view of the coal chute at the west wall. Note that the chute is heavily soiled and there is moisture staining at the wall below.

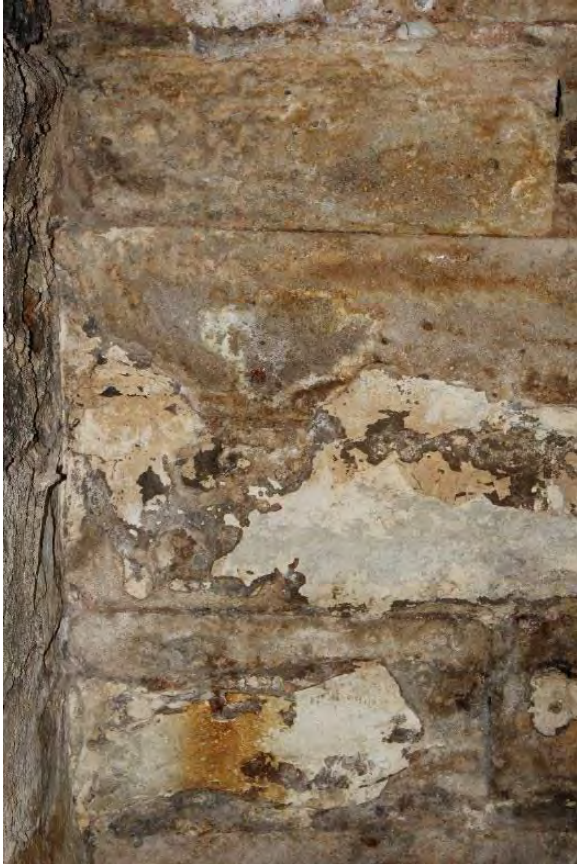
Figure 3.361, Old Jail, Basement, Room 002, detail view of efflorescence and moisture staining at stone walls.

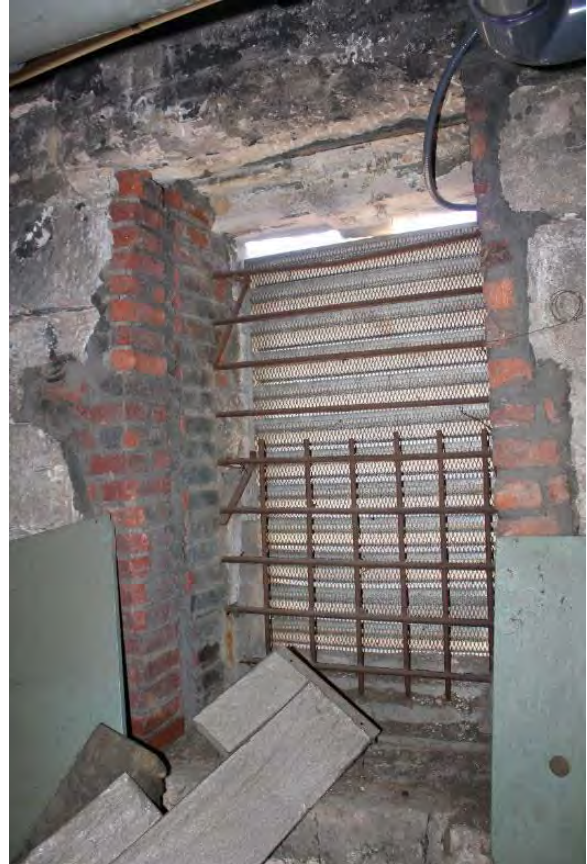
Figure 3.362, Old Jail, Basement, Room 003, view of a mechanical grille and metal bars at the east wall; note that the bars are rusted.

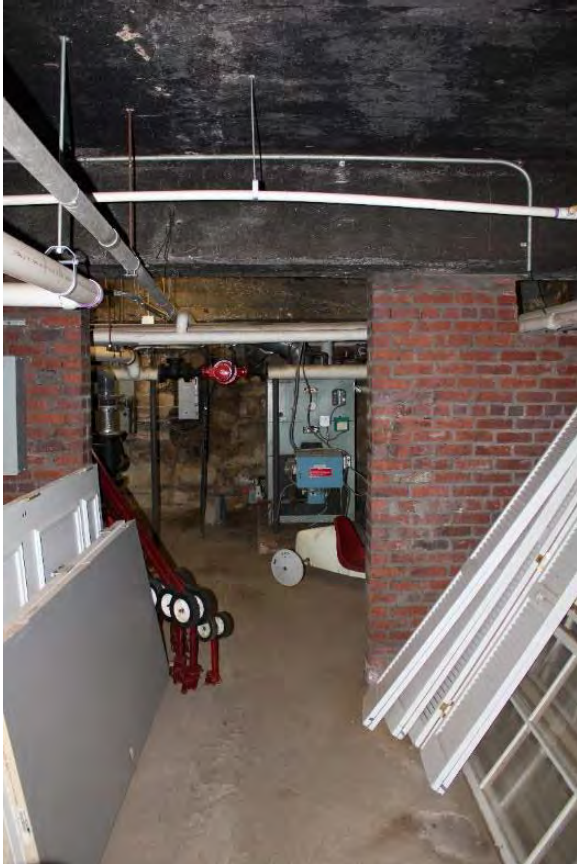
Figure 3.364, Old Jail, Basement, Room 003, general view looking south.

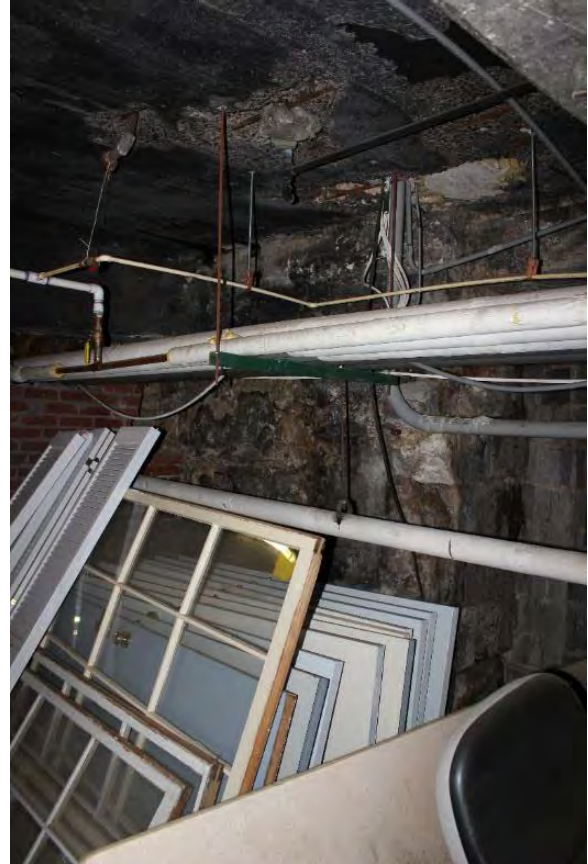
Figure 3.365, Old Jail, Basement, Room 003, general view looking southwest. Note the area of concrete block wall, which exhibits efflorescence and moisture staining.

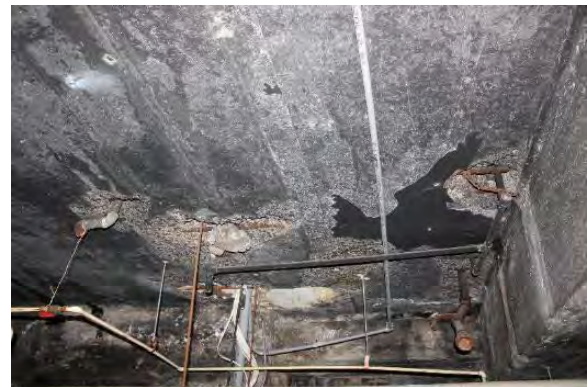
Figure 3.366, Old Jail, Basement, Room 003, view of the poured-in-place concrete ceiling. Note the areas of loss, patching, and exposed, rusted rebar and rusted pipes.

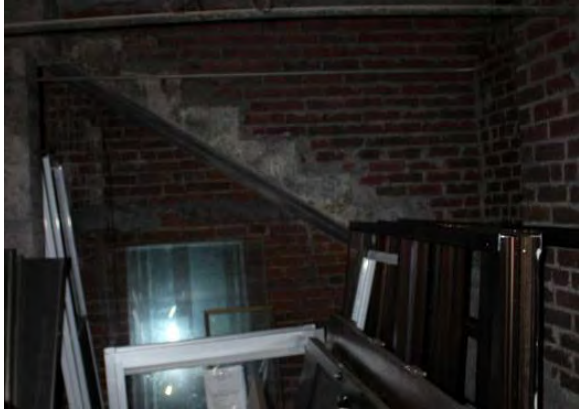
Figure 3.367, Old Jail, Basement, Room 003, view of the north, inner brick wall. Note the ghost of a former staircase.

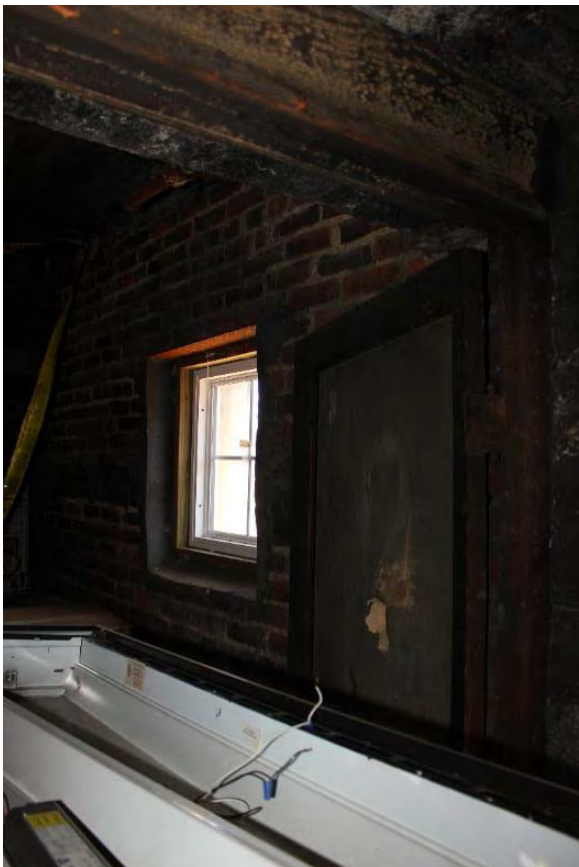
Figure 3.368, Old Jail, Basement, Room 003, view of the four-light, square, vinyl replacement window at the east wall and the adjacent interior door. Note the area of loss at the door.

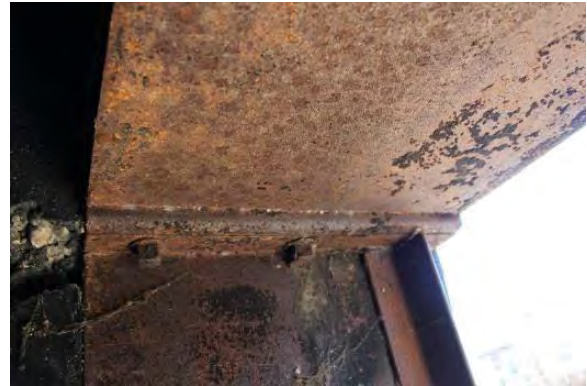
Figure 3.369, Old Jail, Basement, Room 003, view of the rusted frame of the exterior door at the east wall.

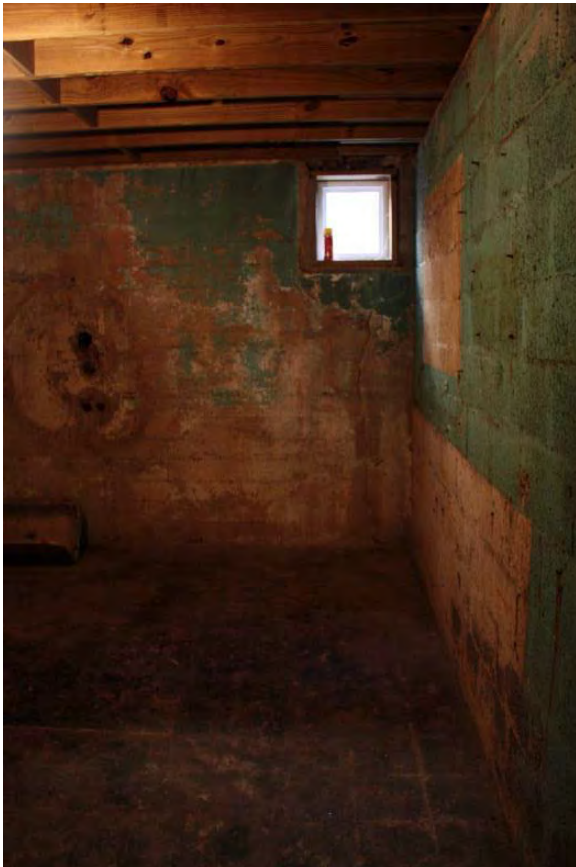
Figure 3.377, Old Jail, Basement, Room 005, general view looking north. Note the single square, vinyl replacement window and holes at the north wall; the large areas of paint loss at each wall; and the heavily soiled floor.

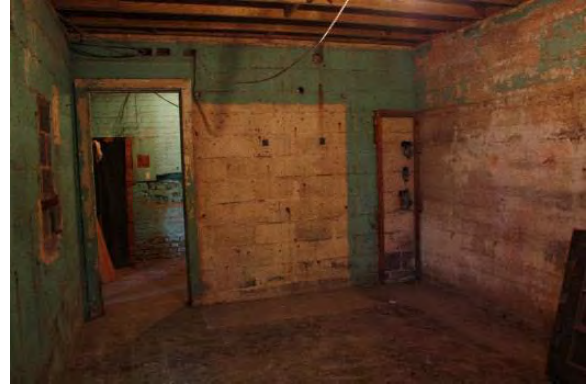
Figure 3.378, Old Jail, Basement, Room 005, general view looking south.
