Historic Structures Report
Renwick Courthouse, Wallace Library, and Old Jail
City of Fredericksburg, Virginia

Created / Last Revised:

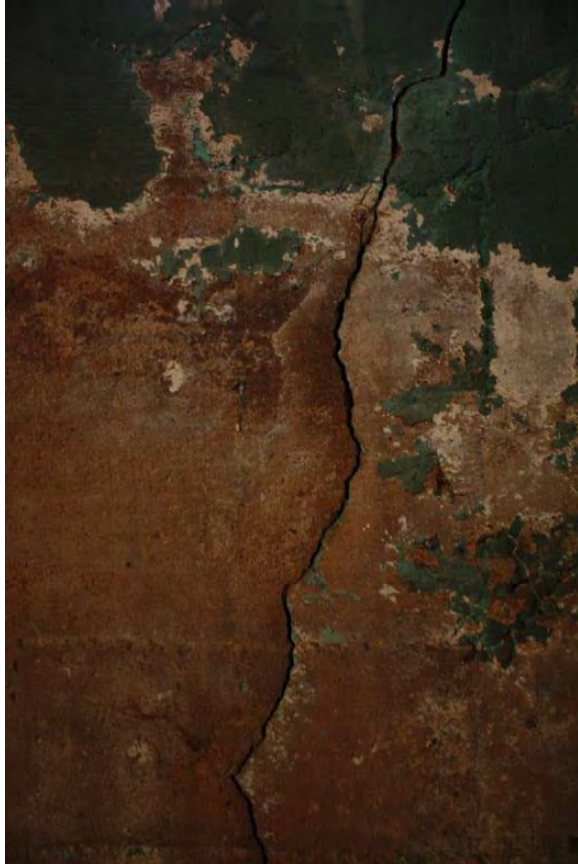
Figure 3.380, Old Jail, Basement, Room 005, detail view of a vertical crack underneath the window at the north wall.

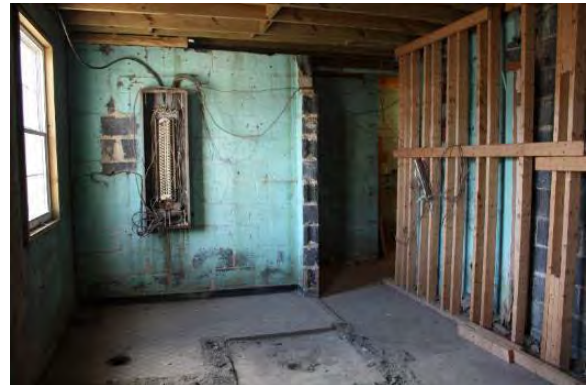
Figure 3.382, Old Jail, Basement, Room 006, general view looking south. Note the electrical panel with exposed wires; moisture staining of the south wall; general paint loss at each wall; and the unfinished wall framing at the west wall.

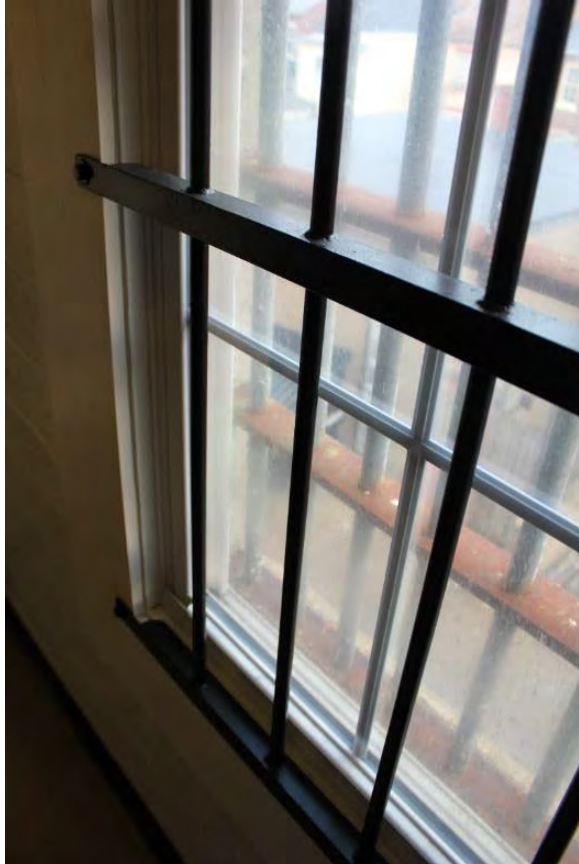
Figure 3.388, Old Jail, First Floor, Room 101, detail view of one of the vinyl replacement windows at the east wall.

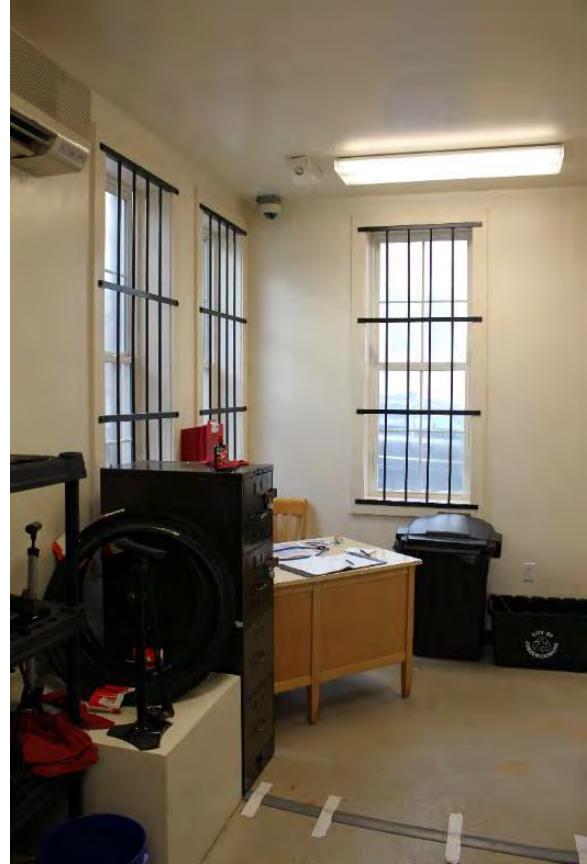
Figure 3.390, Old Jail, First Floor, Room 102, view looking southwest at three typical, four-over-four vinyl replacement windows with interior bars.

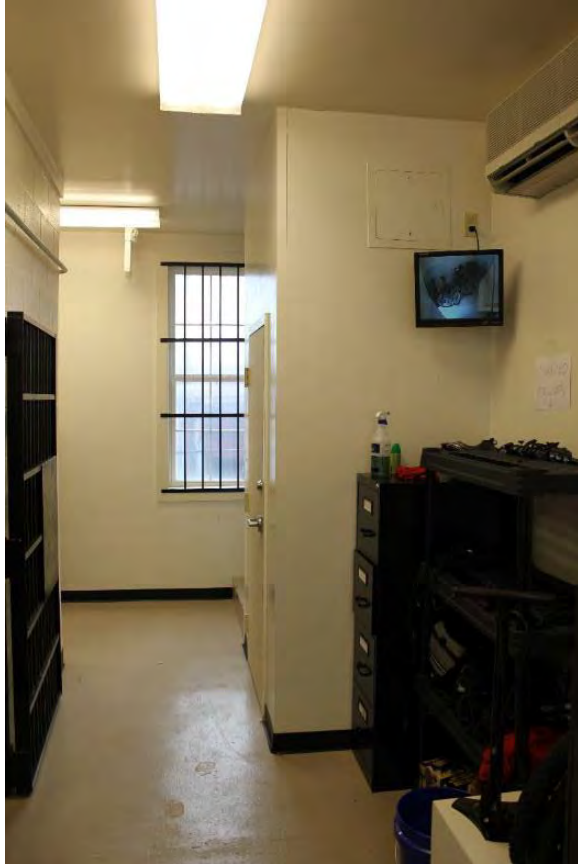
Figure 3.391, Old Jail, First Floor, Room 102, view looking east.

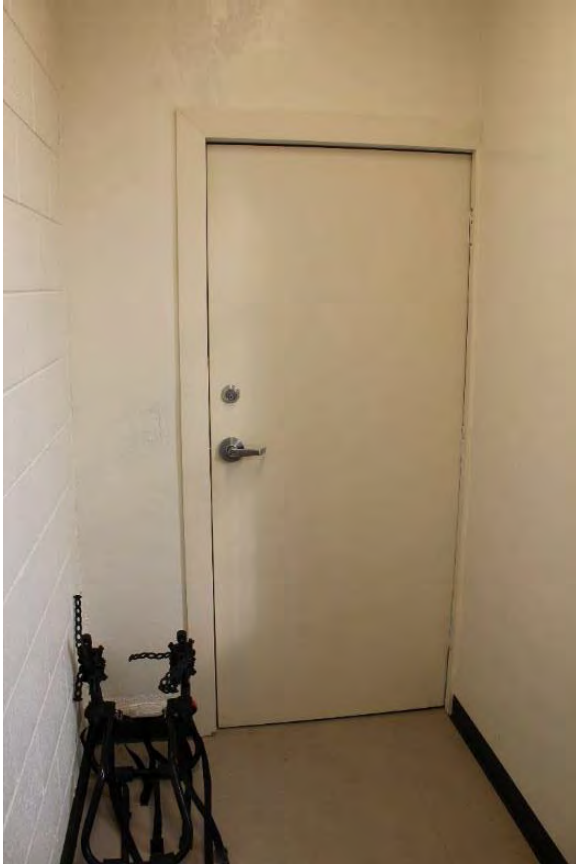
Figure 3.393, Old Jail, First Floor, Room 102, view of a typical metal door at the north end of the east hall.

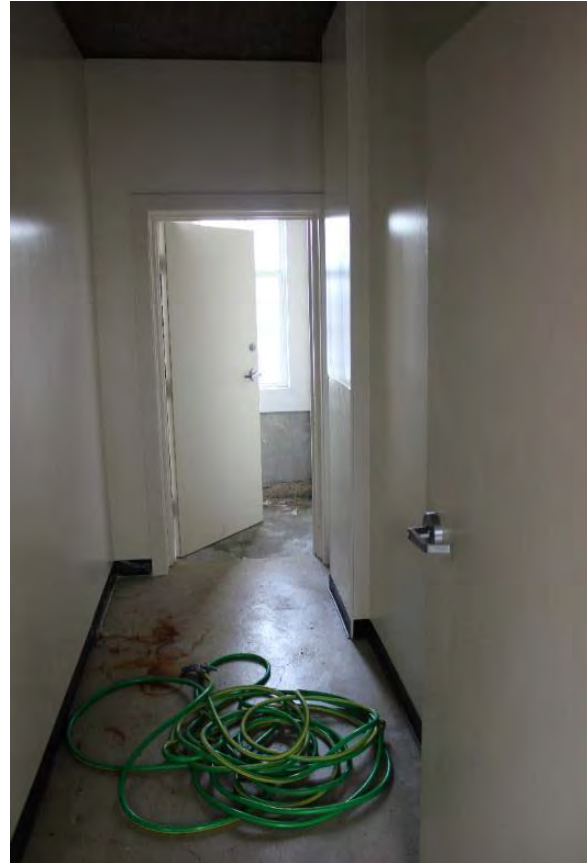
Figure 3.398, Old Jail, First Floor, Room 104, general view looking east. Note the rust stains at the floor.

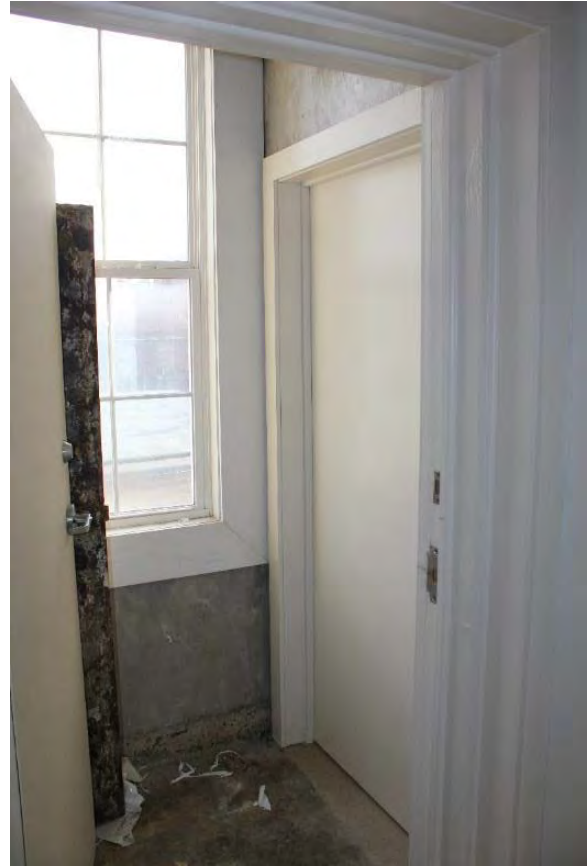
Figure 3.400, Old Jail, First Floor, Room 104, view of east vestibule.

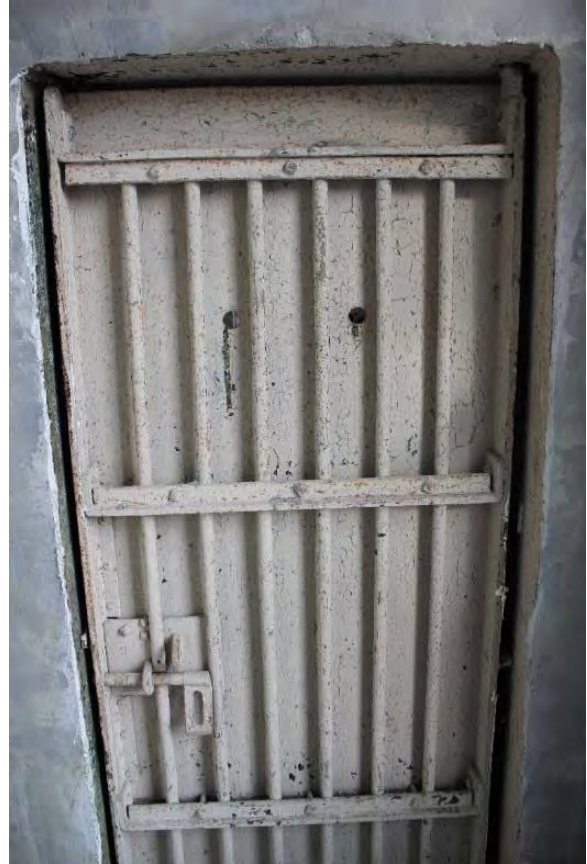
Figure 3.402, Old Jail, First Floor, Room 104, view of the jail cell door at the north wall of the east vestibule. Note the paint crazing and rusting throughout.

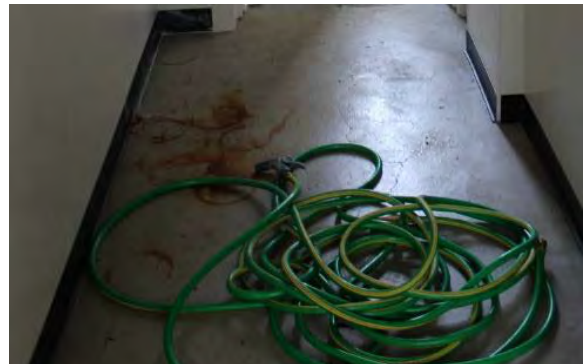
Figure 3.403, Old Jail, First Floor, Room 104, detail view of the circular rust stains at the floor in the center hall.

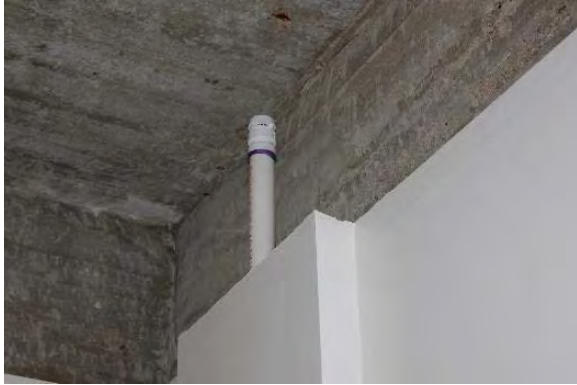
Figure 3.404, Old Jail, First Floor, Room 104, detail view of the vent at the south wall.

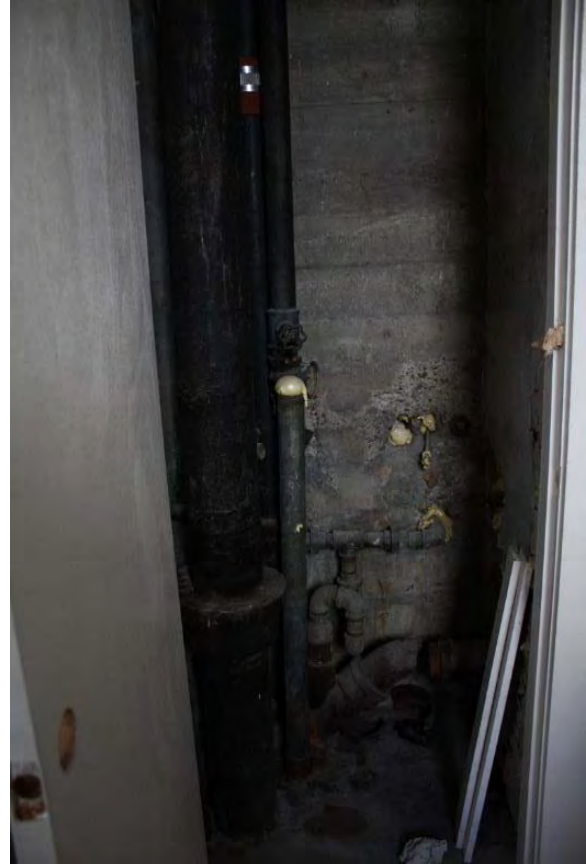
Figure 3.409, Old Jail, First Floor, Room 105, view inside unfinished closet at east wall containing plumbing for the adjacent jail cells. Note the missing knob at the hollow-core door.

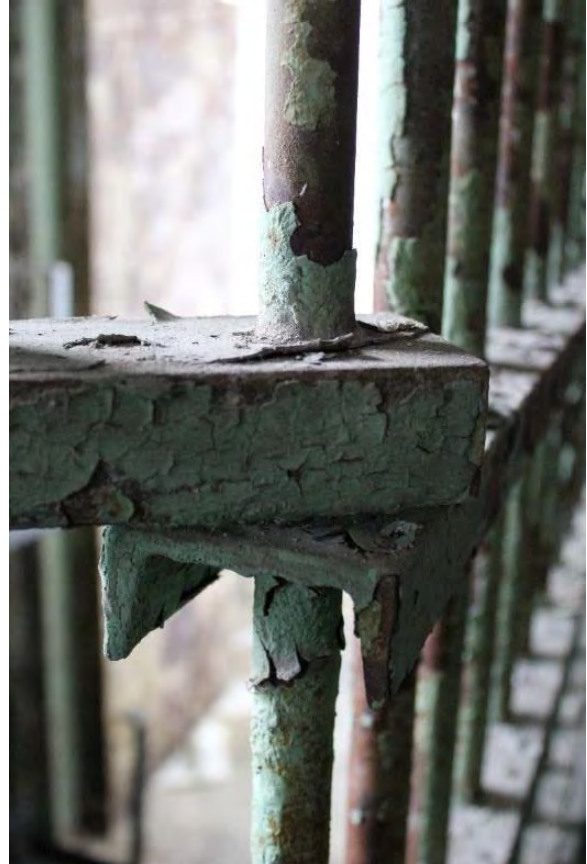
Figure 3.414, Old Jail, First Floor, Room 106, detail view of heavy paint loss and rust at metal bars.

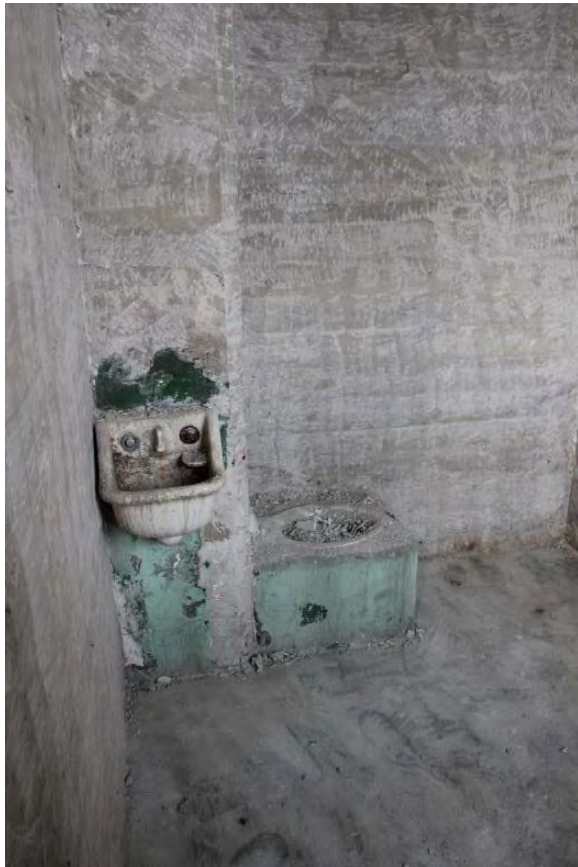
Figure 3.415, Old Jail, First Floor, Room 107, general view looking west.

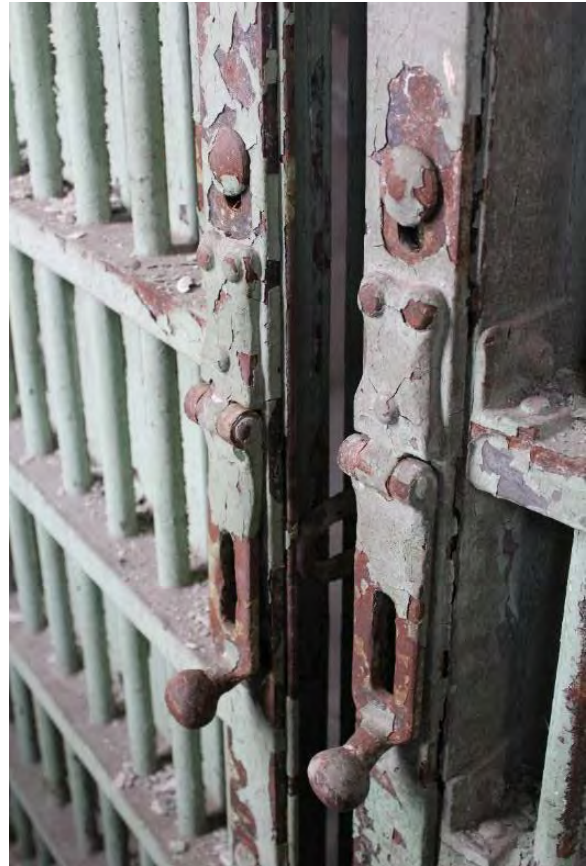
Figure 3.419, Old Jail, First Floor, Room 107, detail view of jail cell doors. Note the heavy paint loss and rust.

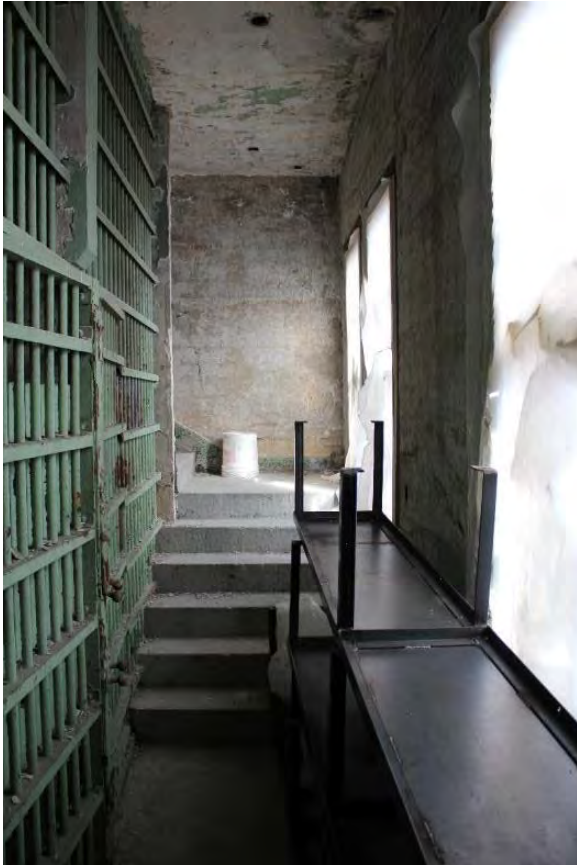
Figure 3.420, Old Jail, First Floor, Room 108, general view looking north.

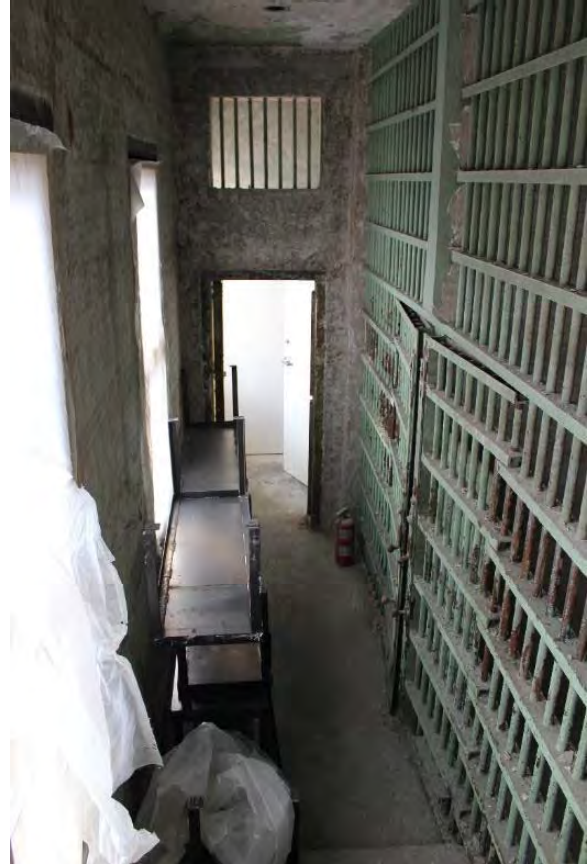
Figure 3.421, Old Jail, First Floor, Room 108, general view looking south.

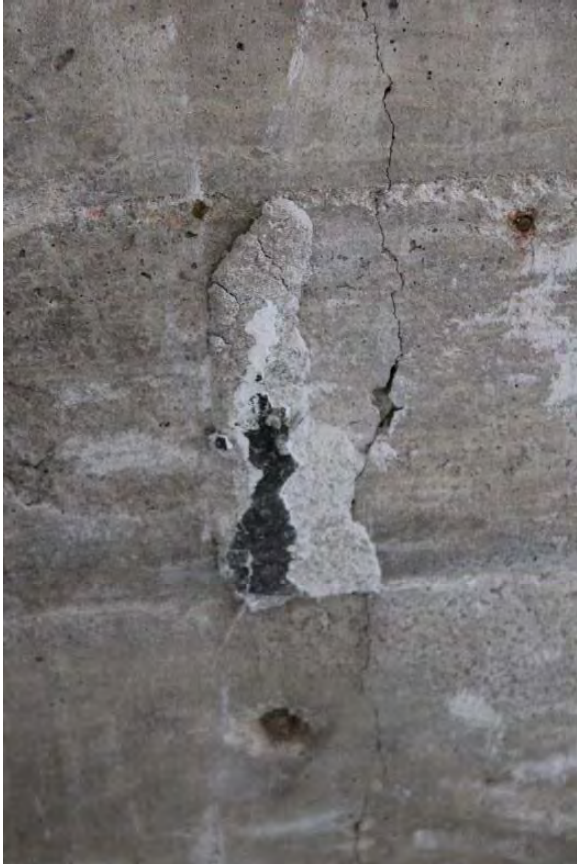
Figure 3.424, Old Jail, First Floor, Room 108, view of a crack in the wall at the stair hall.

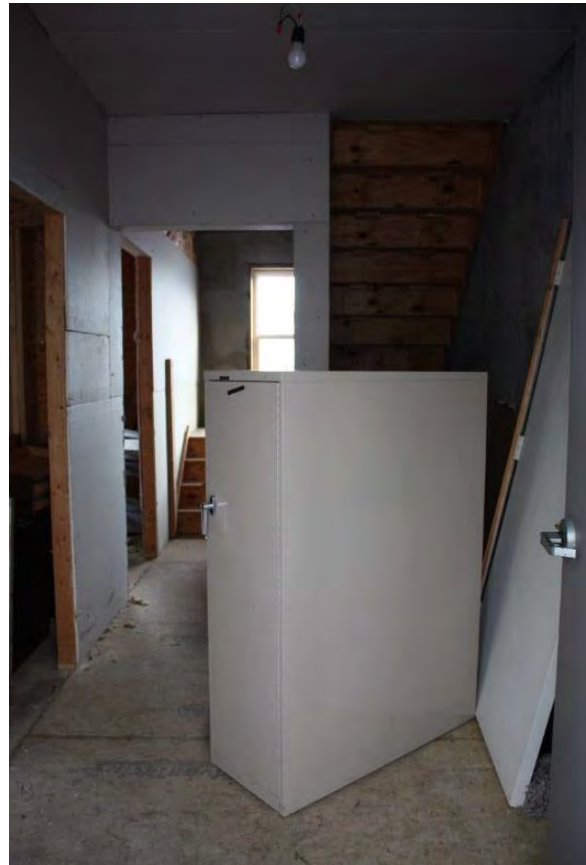
Figure 3.425, Old Jail, First Floor, Room 109, general view looking east. Note the unfinished state of the room.

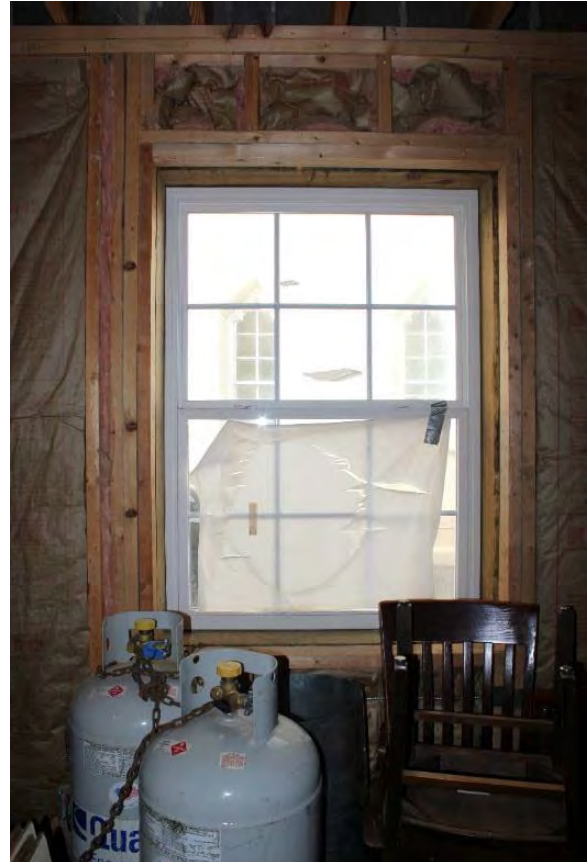
Figure 3.433, Old Jail, First Floor, Room 110, view of a vinyl replacement, six-over-six window at the west wall.

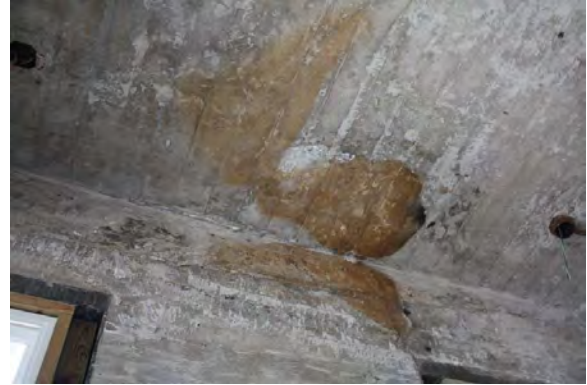
Figure 3.439, Old Jail, Second Floor, Room 201, view of moisture staining at the ceiling.

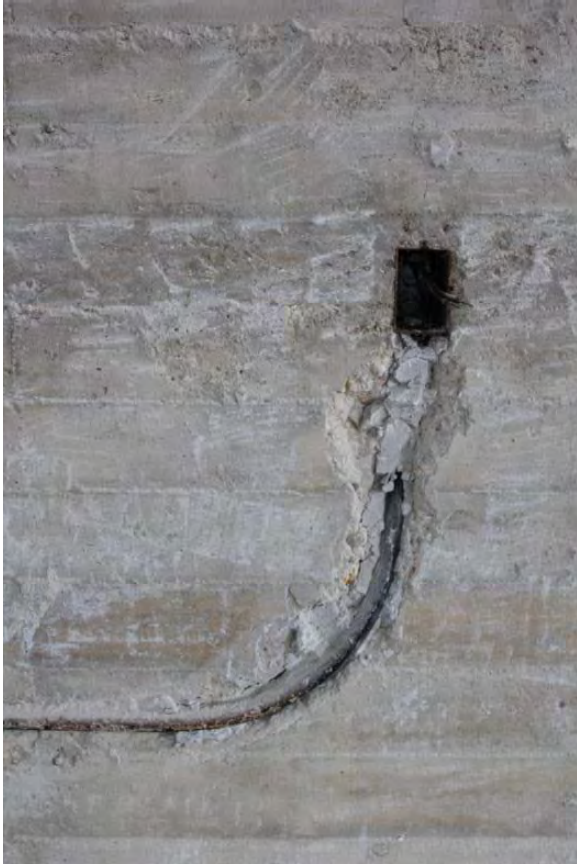
Figure 3.440, Old Jail, Second Floor, Room 201, view of remnants of a former electrical outlet and conduit at the north wall.

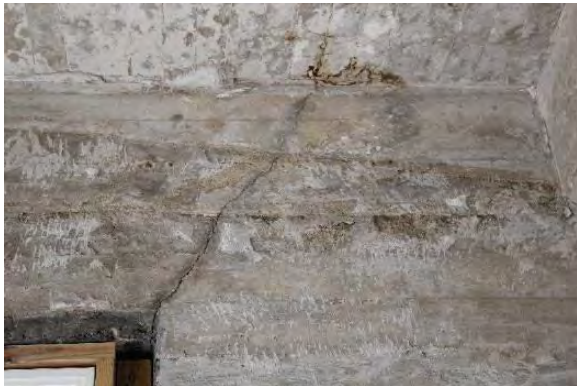
Figure 3.441, Old Jail, Second Floor, Room 201, view of a diagonal crack in the wall at the upper corner of the window.

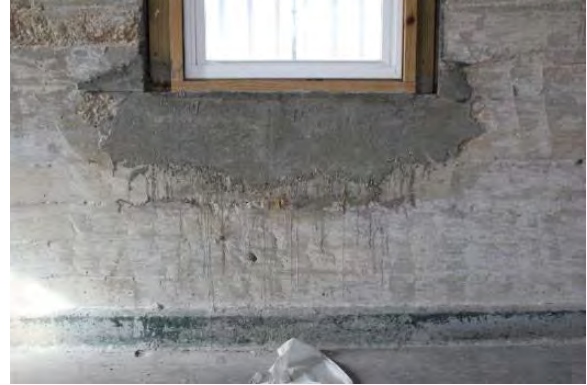
Figure 3.442, Old Jail, Second Floor, Room 201, view of a concrete patch under a window; similar patches are found at other windows.

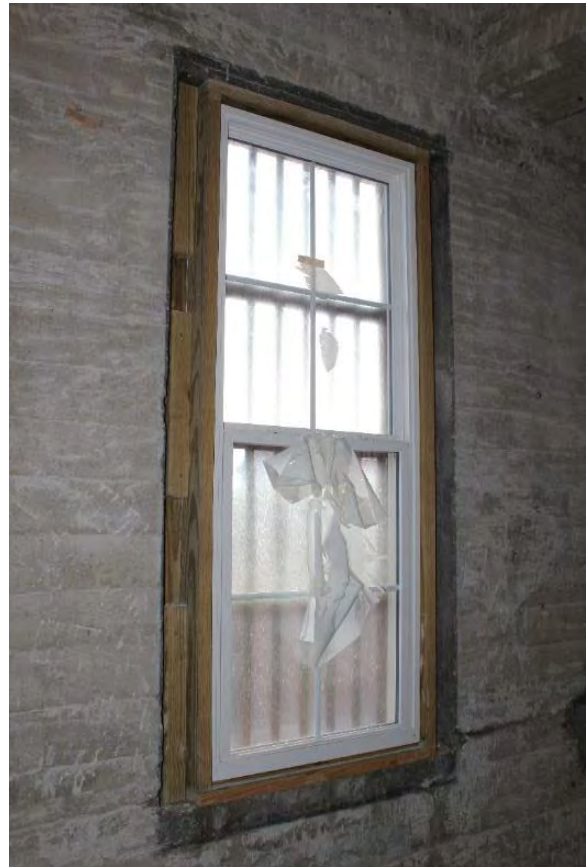
Figure 3.443, Old Jail, Second Floor, Room 201, view of a typical four-over-four vinyl replacement window. Note the remnants of a plastic covering at the sash, a typical condition at other windows.

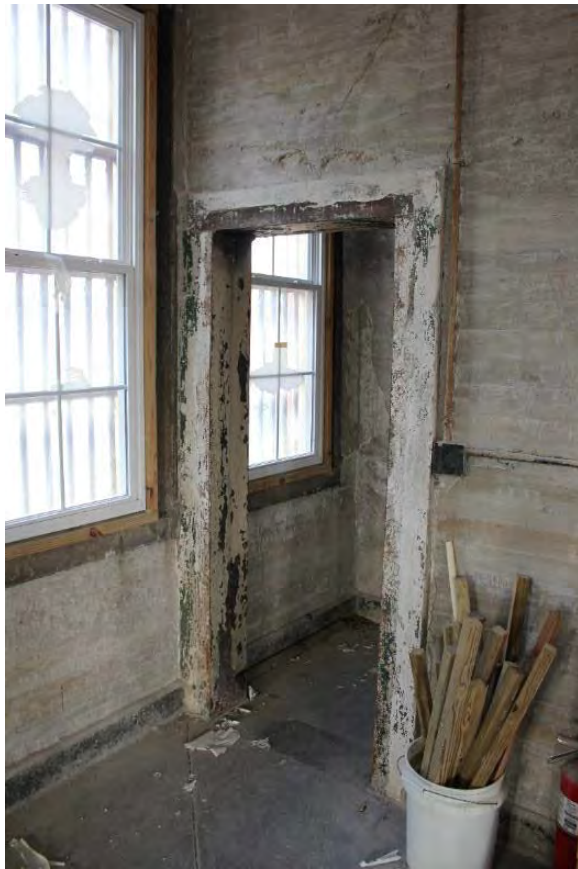
Figure 3.444, Old Jail, Second Floor, Room 201, view of a the doorway to the stairwell at the north wall.

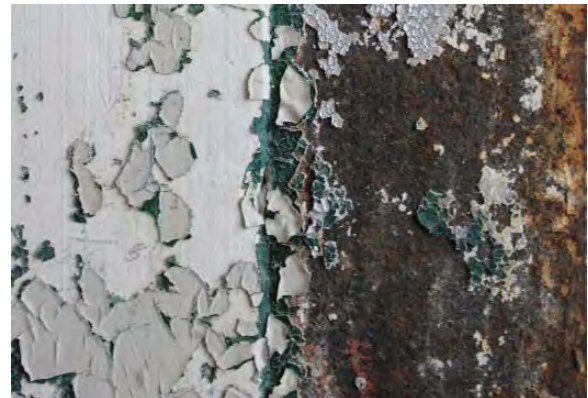
Figure 3.446, Old Jail, Second Floor, Room 201, view of heavy rust and paint loss at the east jail cell door's metal trim, a condition also found at the trim of the west doorway trim.

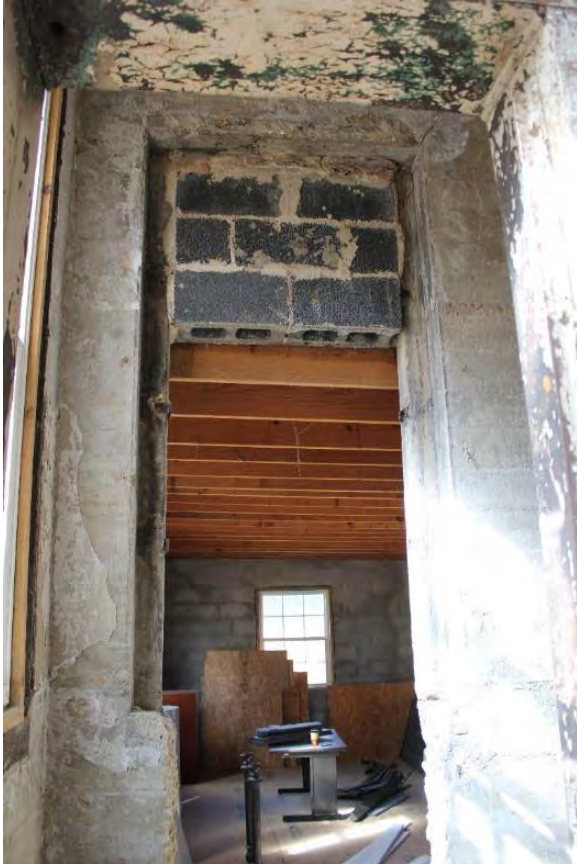
Figure 3.447, Old Jail, Second Floor, Room 201, view of rough-cut opening between Rooms 201 and 202 at the top of the stairs.

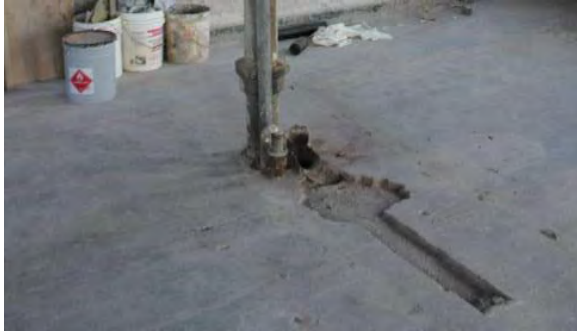
Figure 3.449, Old Jail, Second Floor, Room 201, view of marks from a former sanitary line at the north end of the room.

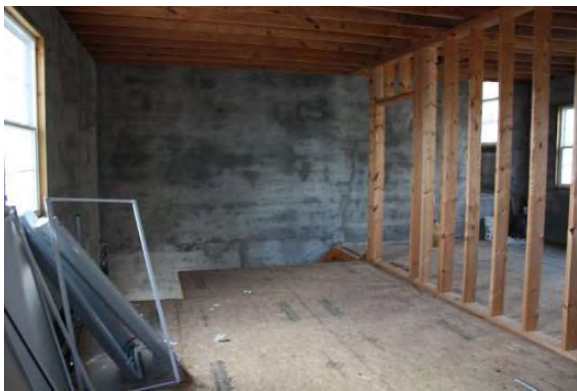
Figure 3.454, Old Jail, Second Floor, Room 202, general view looking south in the east end of the room. Note that the floor is open to the stairwell below and there is no railing, posing a safety hazard. Also note the unfinished wall framing dividing the room.

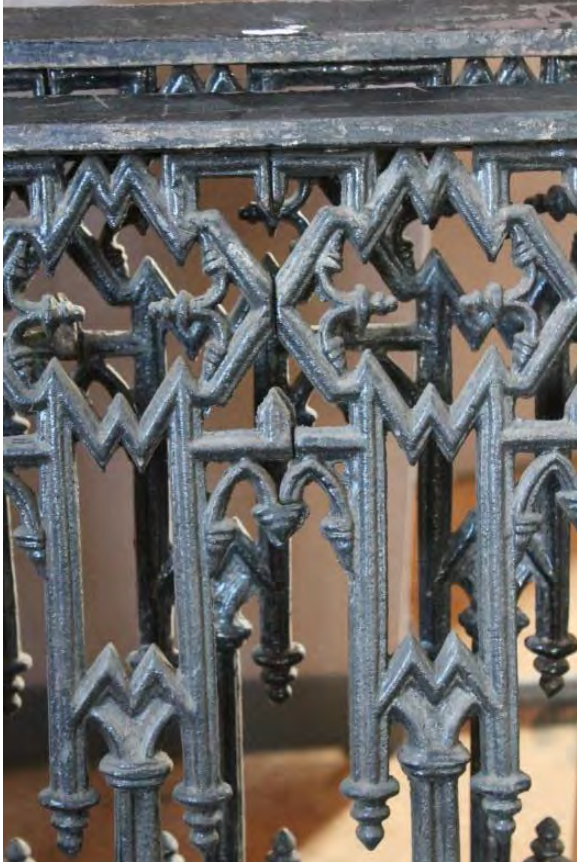
Figure 3.457, Old Jail, Second Floor, Room 202, detail view of iron railing.

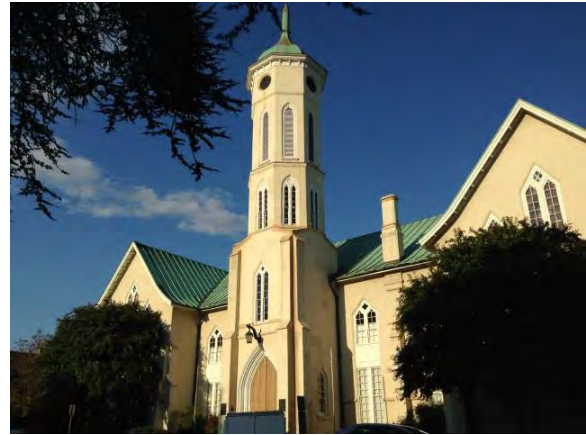
Figure 4.02: Main Façade (West Elevation) of Renwick Courthouse.

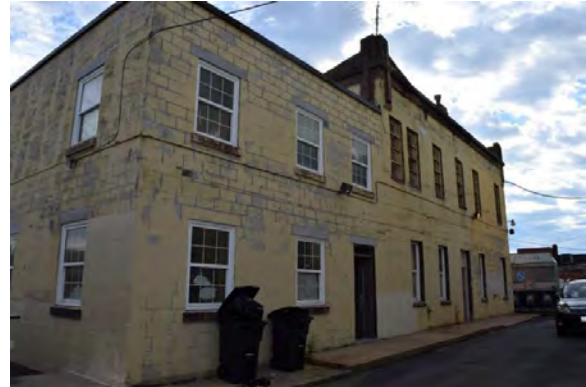
Figure 4.04: West Elevation of Historic Jail

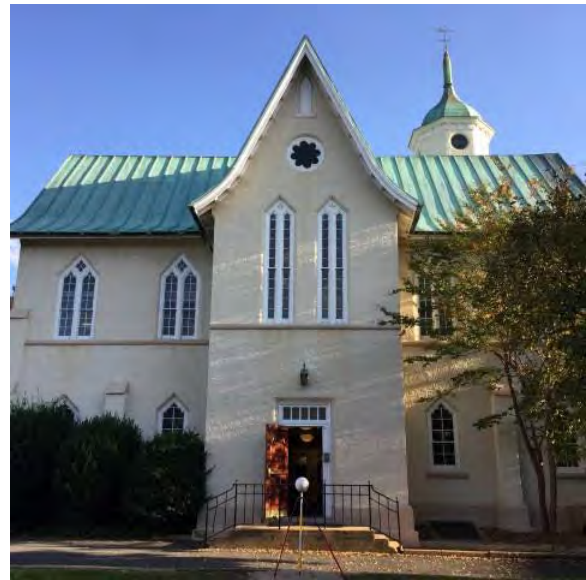
Figure 4.06: North courthouse elevation with projecting water-table.

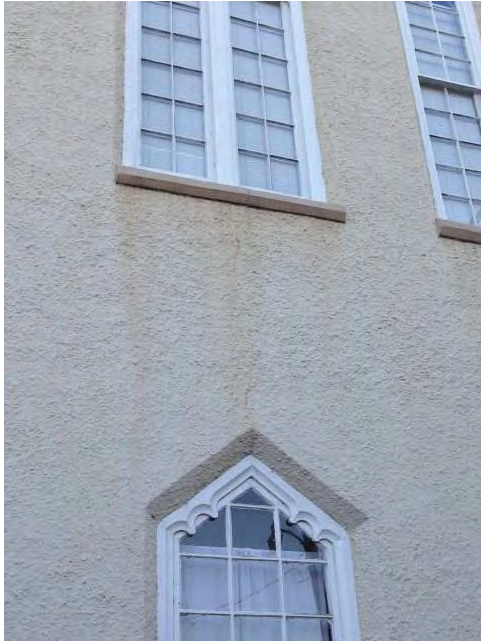
Figure 4.07: East façade with stucco cracking between windows.

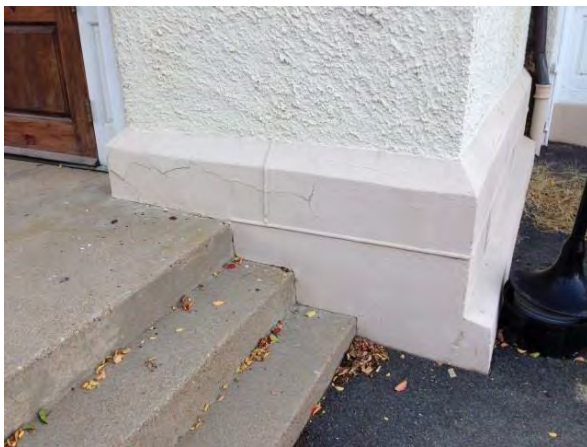
Figure 4.08: North stair to courthouse with crack in stucco near base.

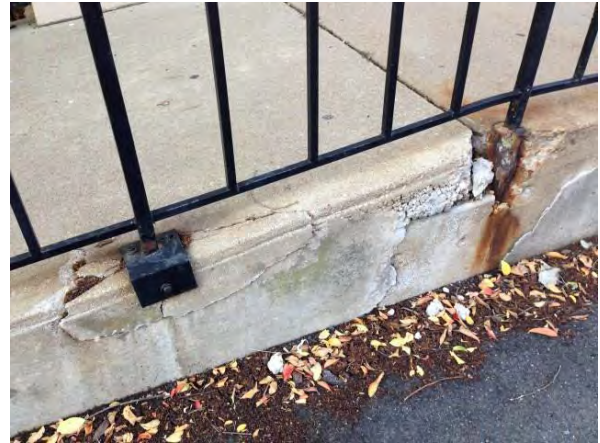
Figure 4.09: South entryway ramp with concrete spalling due to rusting railings

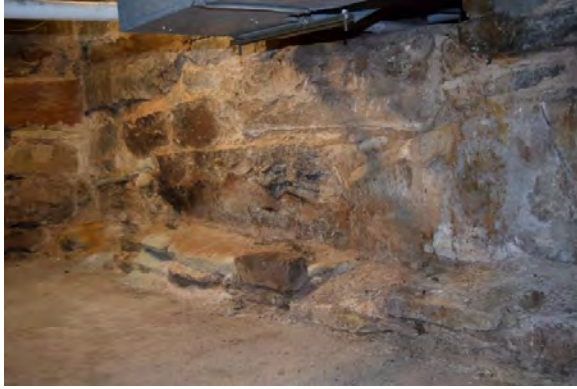
Figure 4.10: Large stone foundation walls under north wing with projecting footings at base

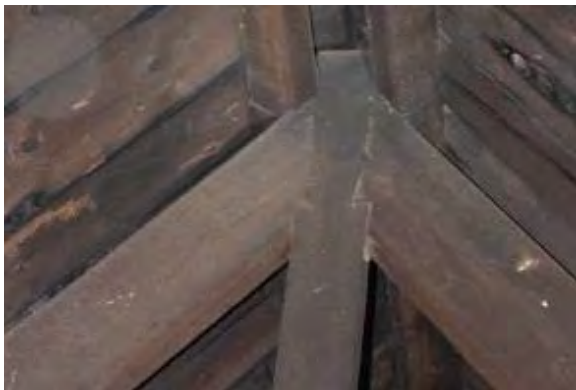
Figure 4.14: King post to top chord connection detail

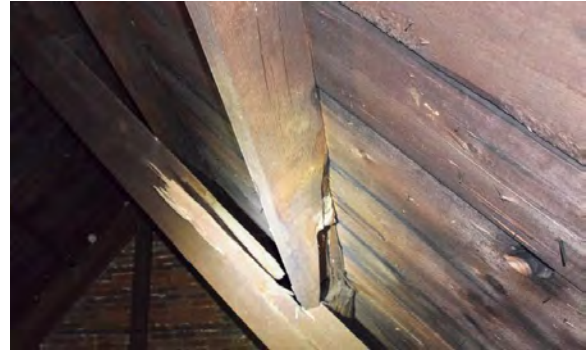
Figure 4.15: Splintered purlin and truss top chord, rumored to be due to cannon ball damage

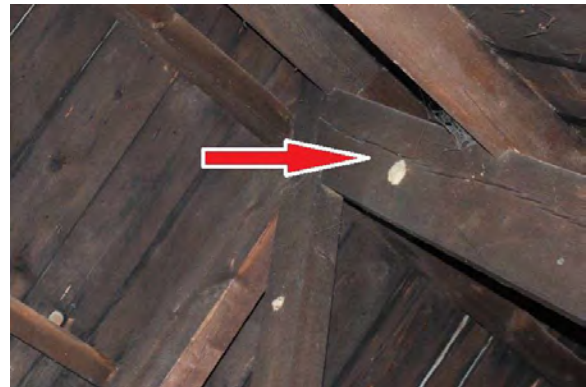
Figure 4.16: shear crack in top chord of north wing king post roof trusses

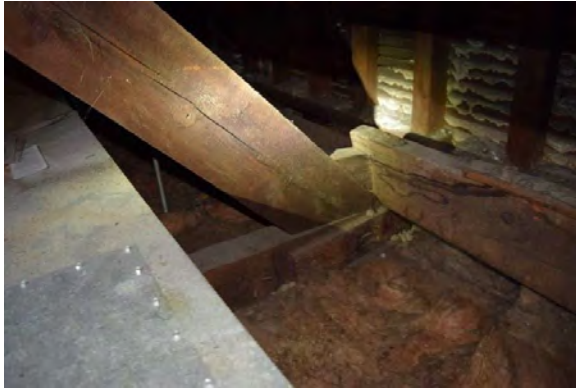
Figure 4.17: Crushing truss bearing end

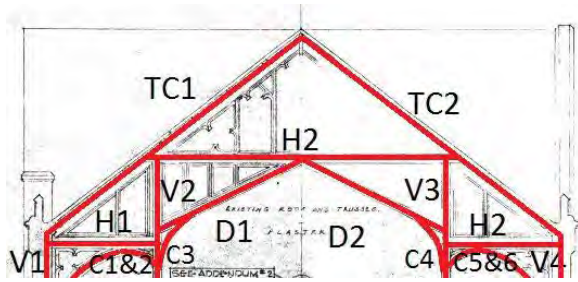
Figure 4.20: Simplified center body roof truss with member callouts

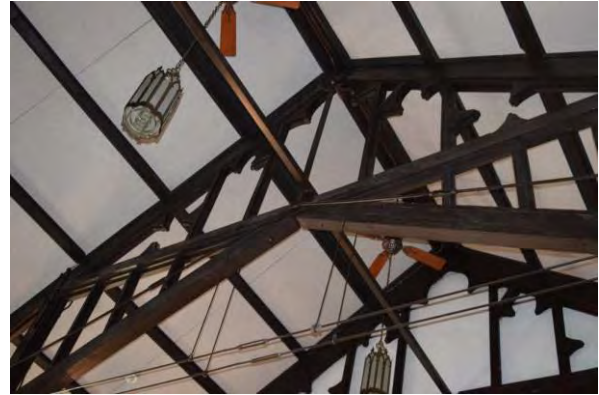
Figure 4.21: Hammer-beam trusses with tie rods. With the original configuration of the structure, the buttresses cantilevered from the first floor level to the point of intersection with the trusses. The addition of the second story floor added a bracing point to the buttresses, cutting the cantilever's span in approximately half and lowering the flexural stresses in the masonry.

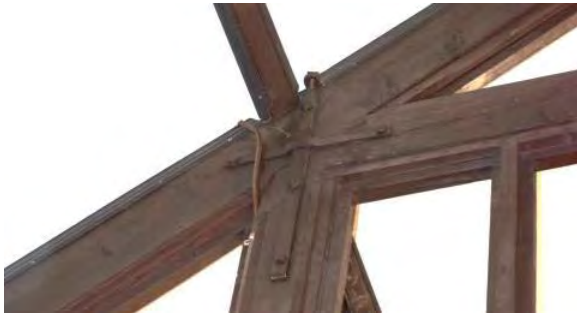
Figure 4.23: Top chord connection to collar tie and hammer post

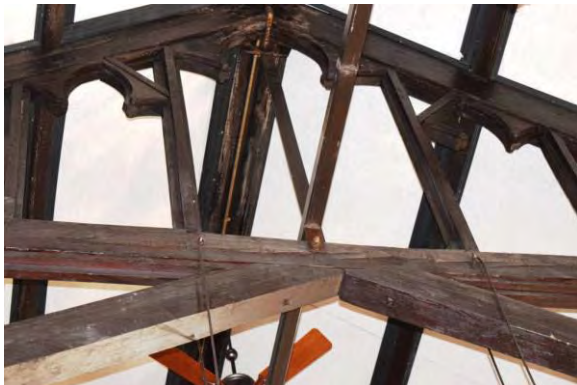
Figure 4.24: Longitudinal crack in collar tie

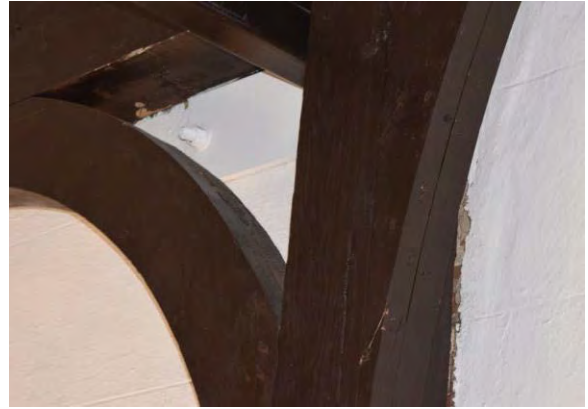
Figure 4.25: Transverse crack in collar brace

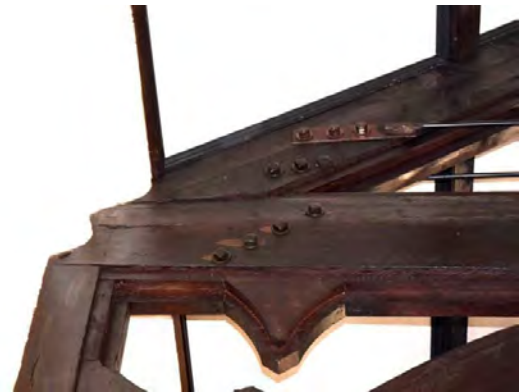
Figure 4.26: Crushing of hammer beam end and localized cracking at tie rod connection to top chord.

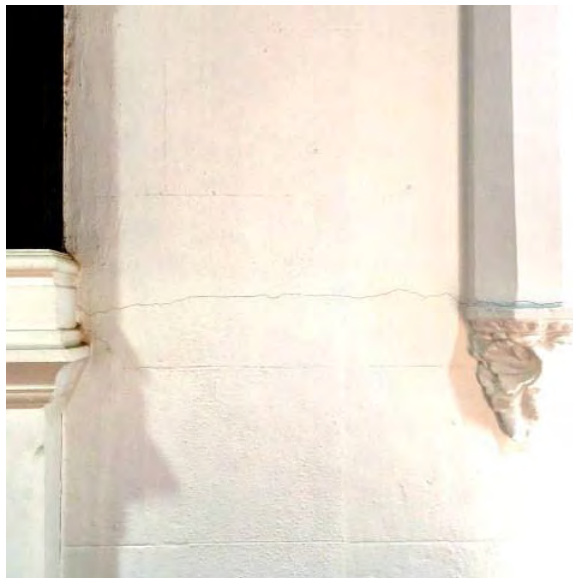
Figure 4.27: Cracking through plaster between window and truss pilasters.

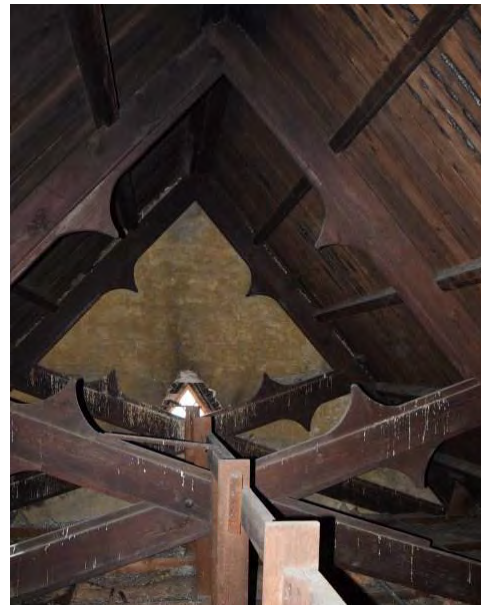
Figure 4.28: Ornate scissor roof trusses in south wing

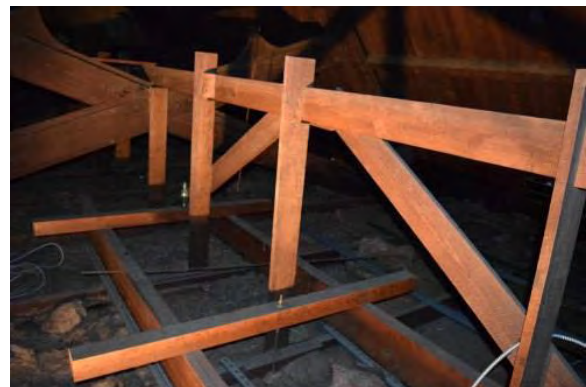
Figure 4.33: Mid-span intermediate truss supporting attic joists

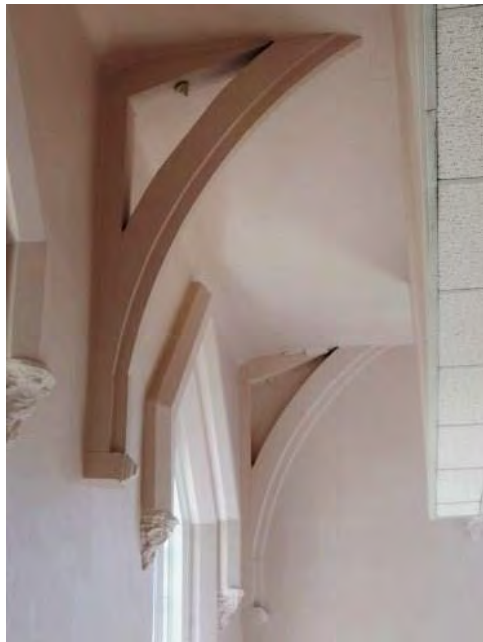
Figure 4.34: South wing scissor truss ends below 2nd floor ceiling. Note two layers of ceiling.

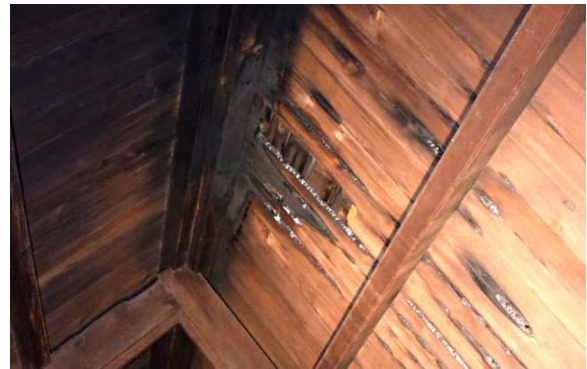
Figure 4.35: Charred roof sheathing and ridge purlins at east end of south wing

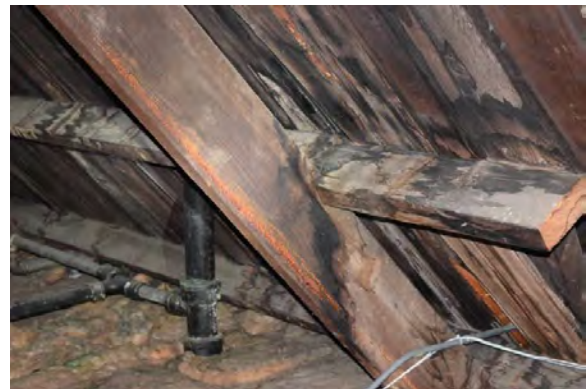
Figure 4.36: Water staining around opening of stairway opening

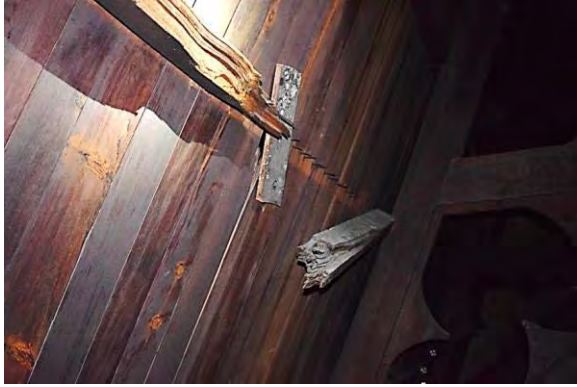
Figure 4.37: Broken purlin at center bay of trusses

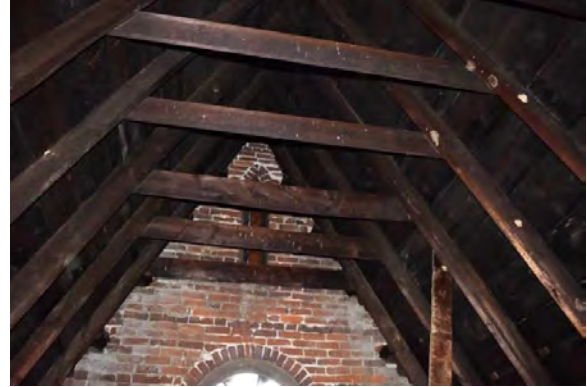
Figure 4.39: South wing stair hall roof framing

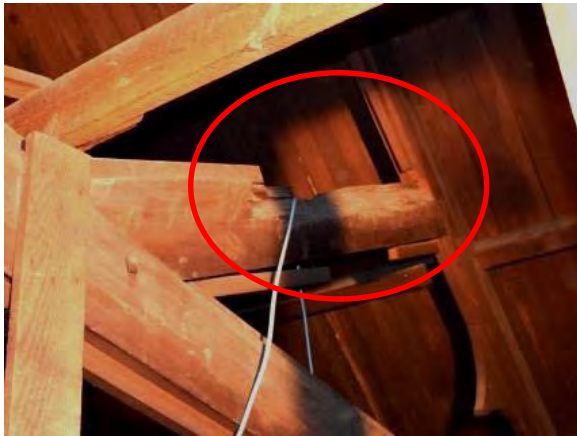
Figure 4.38: Deteriorated scissor truss brace in south wing

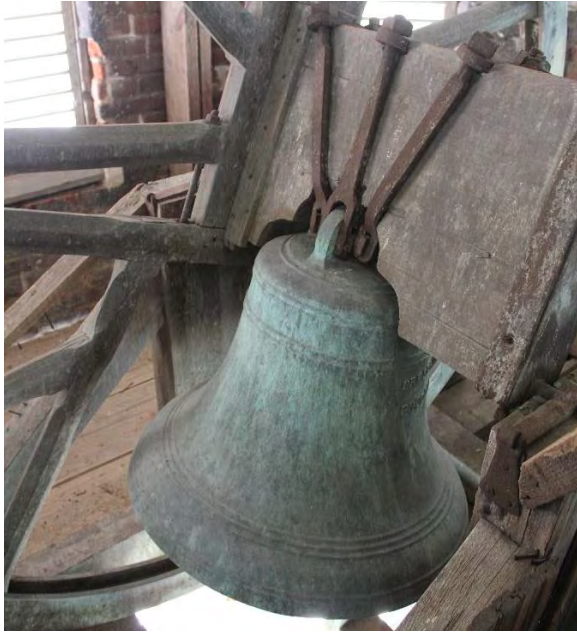
Figure 4.41: 1828 Revere Company Bell

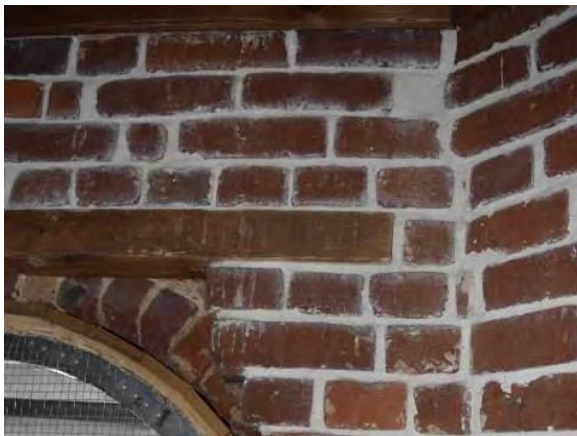
Figure 4.42: Repointing efforts at top of masonry tower

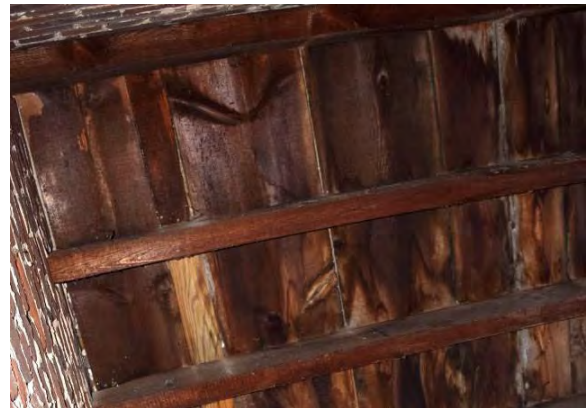
Figure 4.43: Wood bearing ends with water damage at 2nd floor framing level

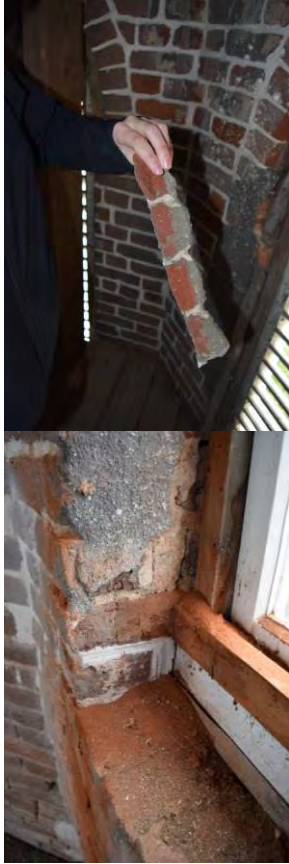
Figure 4.44: Deteriorated brick in and delaminating parging at Bell Tower window jambs

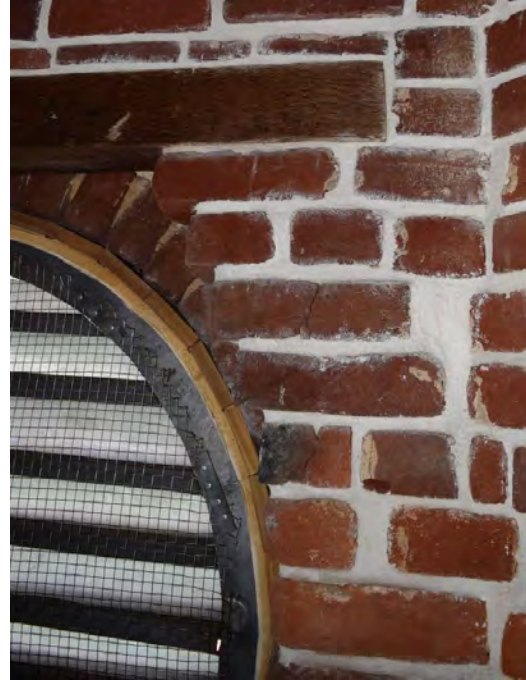
Figure 4.45: Cracking in corbelled brick jamb below wood lintel bearing

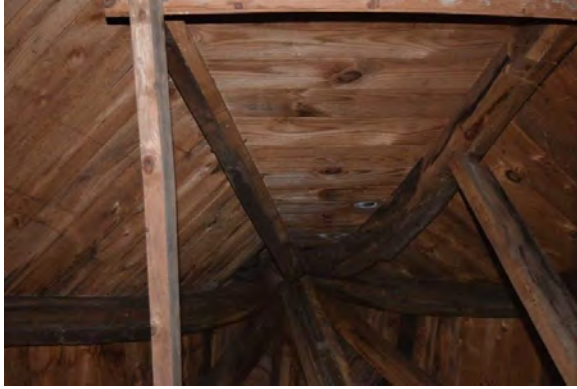
Figure 4.46: Cupola framing with water deterioration

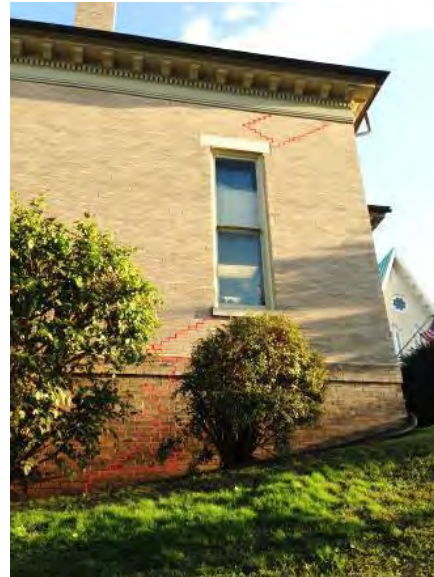
Figure 4.48: Diagonal cracking in North Façade
