Historic Structures Report
Renwick Courthouse, Wallace Library, and Old Jail
City of Fredericksburg, Virginia

Created / Last Revised:

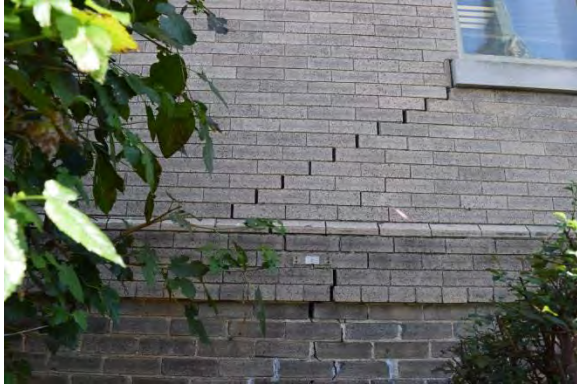
Figure 4.49: Diagonal cracking in North Façade

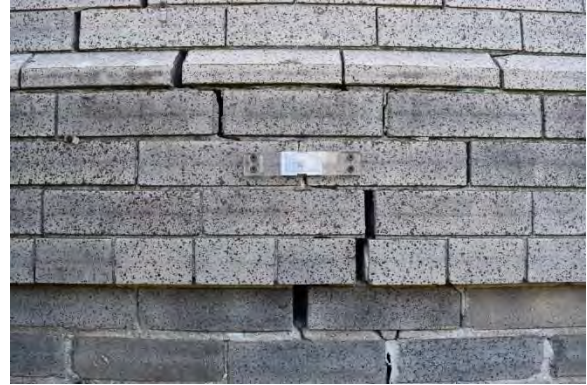
Figure 4.50: Abandoned crack monitoring

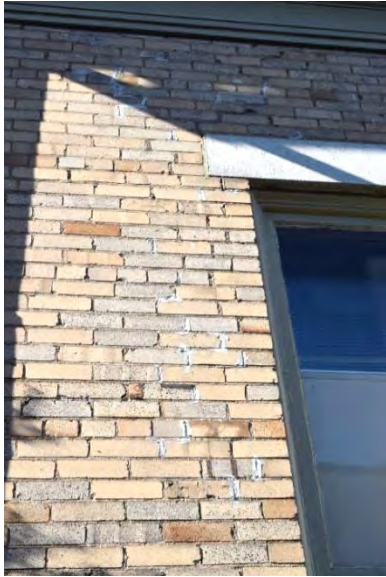
Figure 4.51: Incompatible repointing materials at south façade

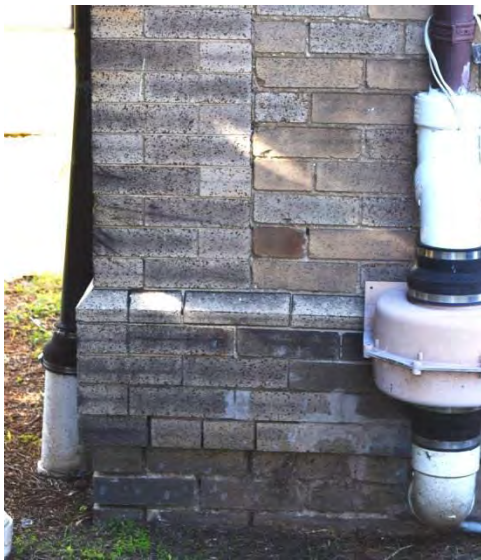
Figure 4.52: Open mortar joints at southwest corner

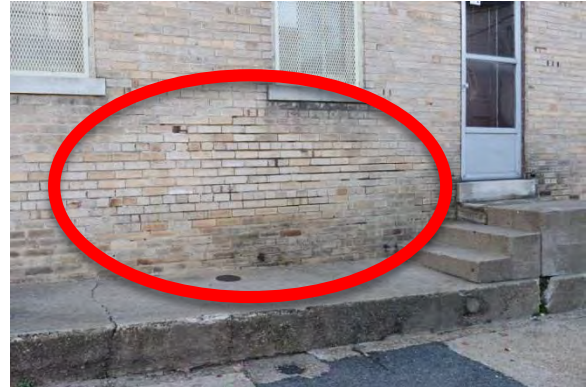
Figure 4.53: East façade with water infiltration

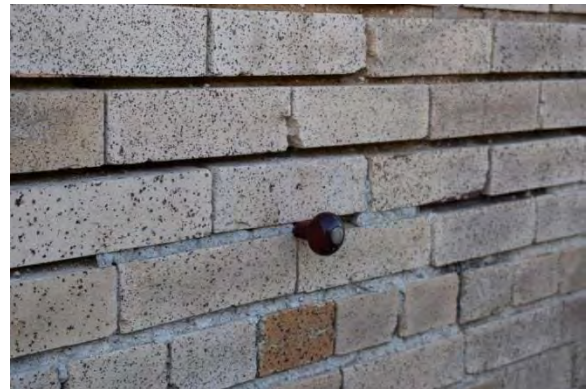
Figure 4.54: Horizontal open mortar joints at east facade of Wallace Library

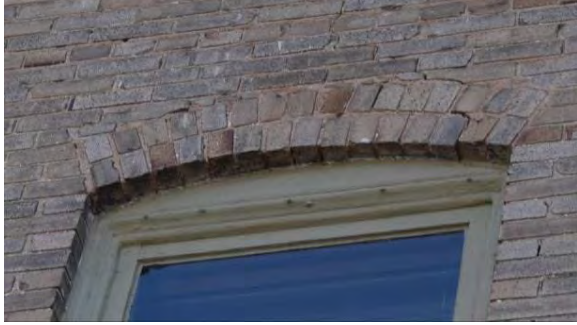
Figure 4.55: Brick displacement and joint cracks at segmental arch in east facade of Wallace Library

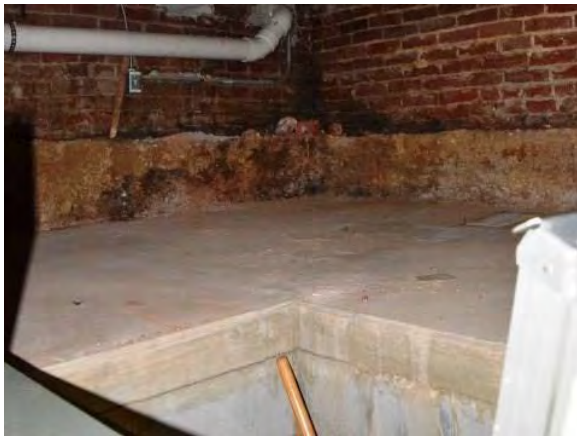
Figure 4.56: Concrete underpinning haunch in west half of basement

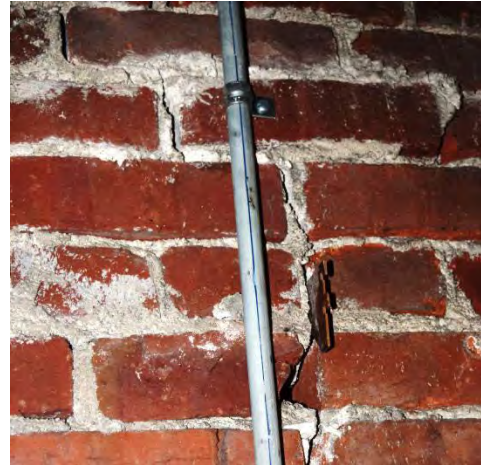
Figure 4.57: Through-wall crack on interior face of north foundation wall. Note shim inserted in crack.

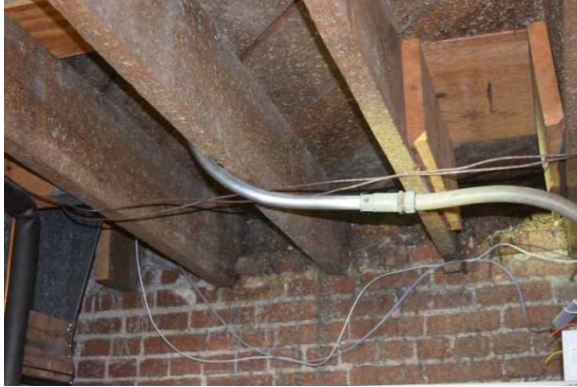
Figure 4.58: First floor framing at west end of mechanical room. Note evidence of mold.

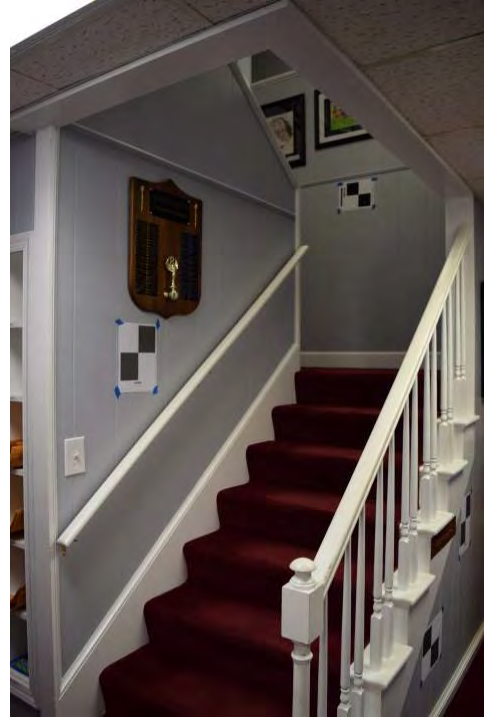
Figure 4.59: Central stair case leading to second floor

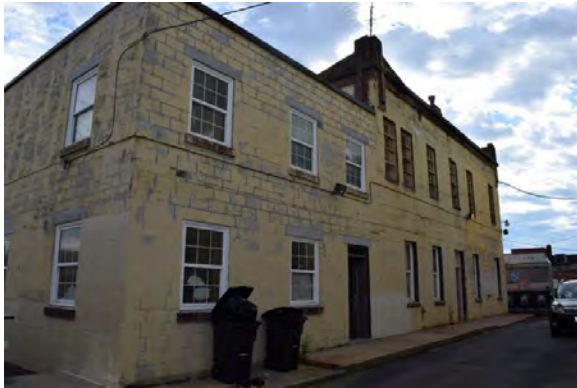
Figure 4.60: West façade of the Old Jail

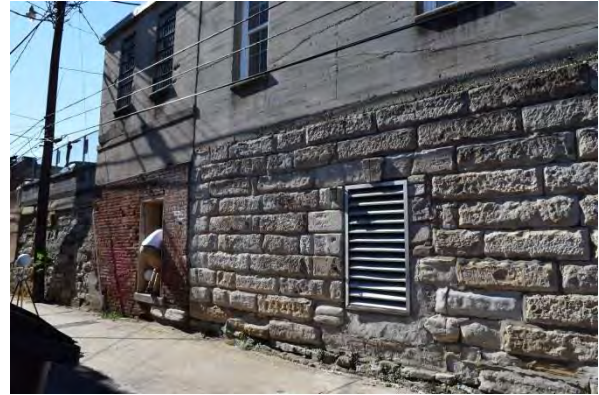
Figure 4.61: Historic brick and ashlar stone masonry foundation walls below more recent cast-in-place concrete structure above

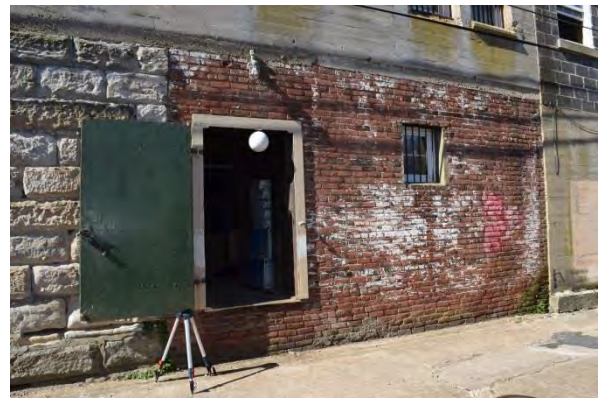
Figure 4.62: Historic brick and ashlar stone masonry foundation walls at southern and central portions and cast-in-place foundation wall at northern portion of jail

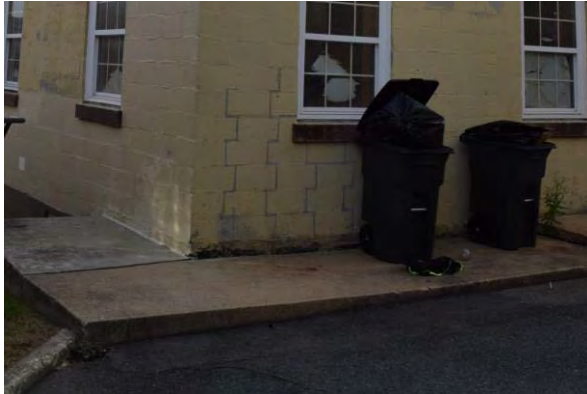
Figure 4.63: Settlement of the concrete sidewalk at northwest corner. Note also the previous repointing efforts in CMU walls.

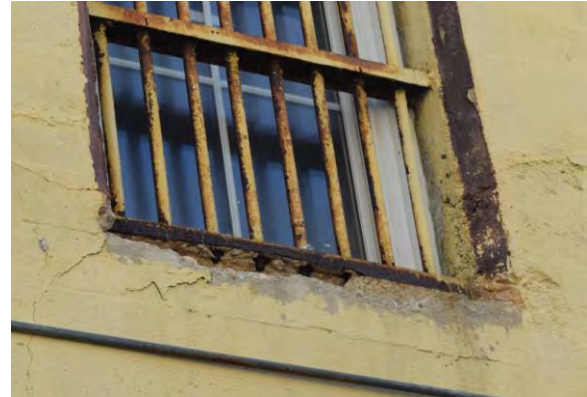
Figure 4.64: Spalled concrete and missing sill at second floor window opening on west façade

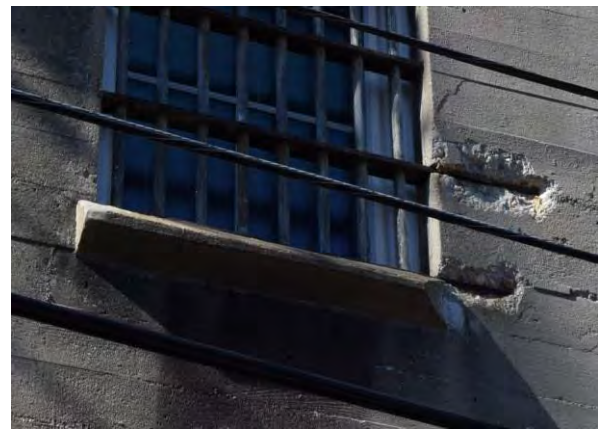
Figure 4.65: Spalled concrete around window openings at corroded bar system anchorages (east façade, 1-story extension)

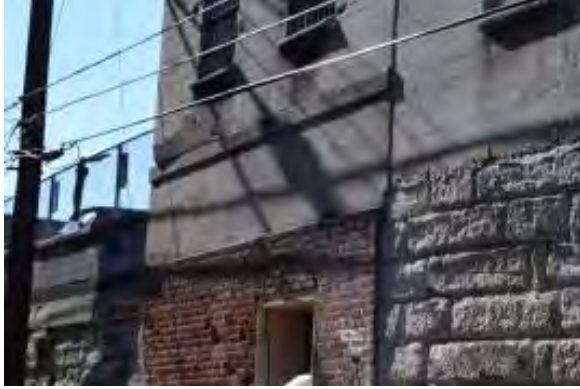
Figure 4.66: Southern section first floor slab edge visible from exterior

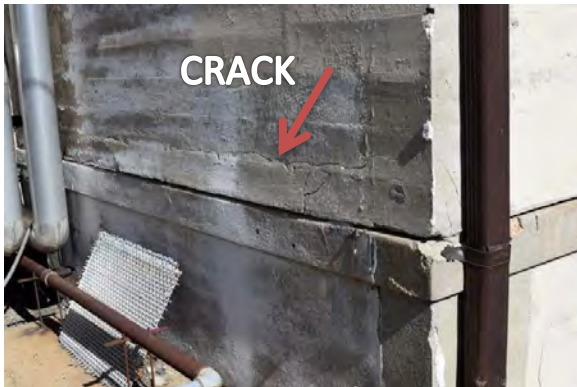
Figure 4.67: One-story extension with cracking and spalling concrete above the first floor slab edge

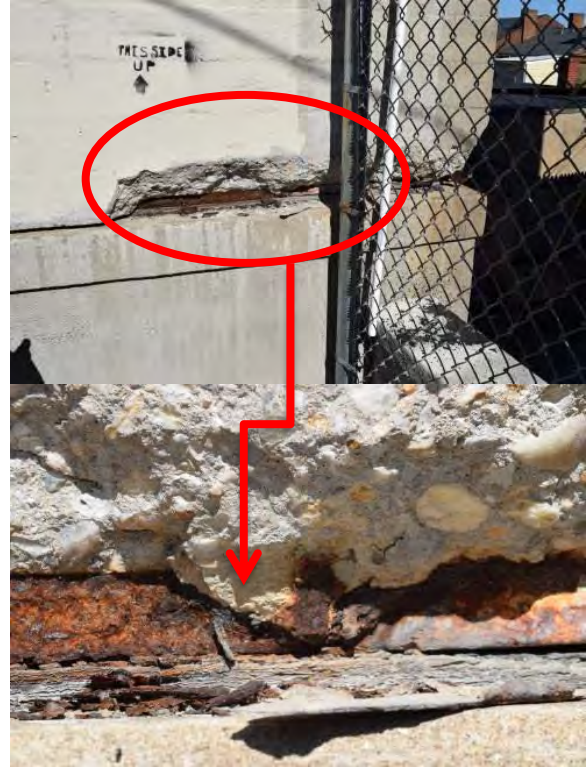
Figure 4.68: Spalling concrete and delaminated steel at southeast corner of jail

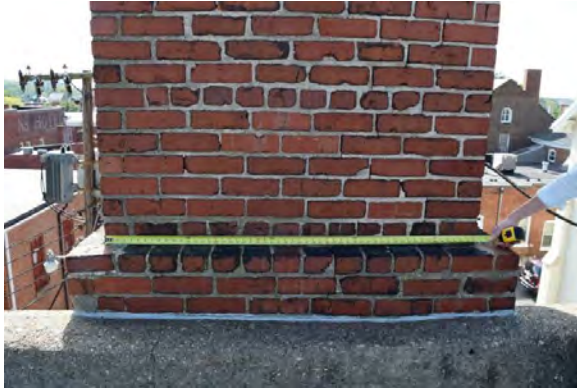
Figure 4.69: Brick chimney at south end of center building section

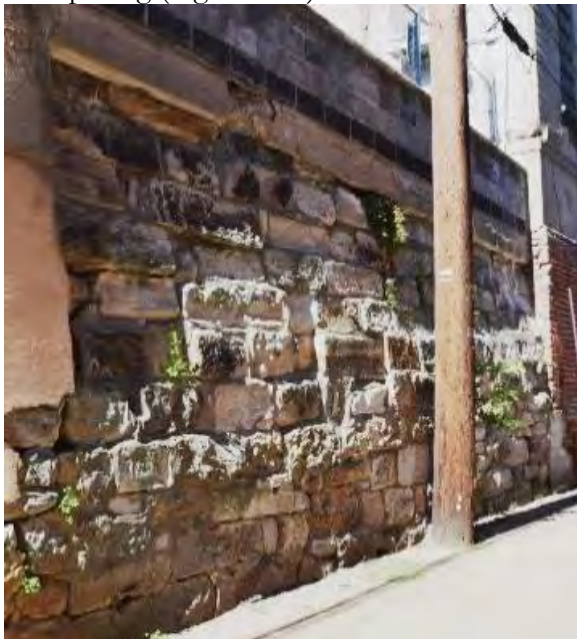
Figure 4.70: Bulging retaining wall in line with rear foundation wall of jail

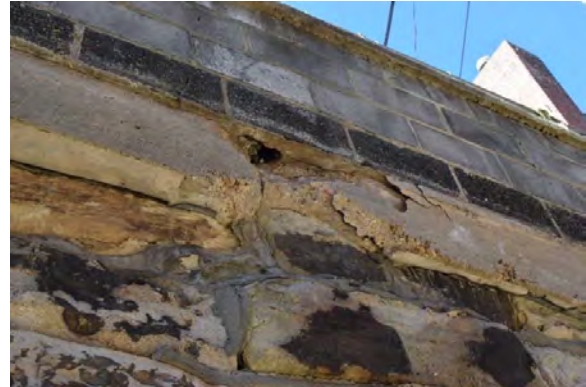
Figure 4.71: Cracked and spalling concrete at southeast retaining wall below parking lot

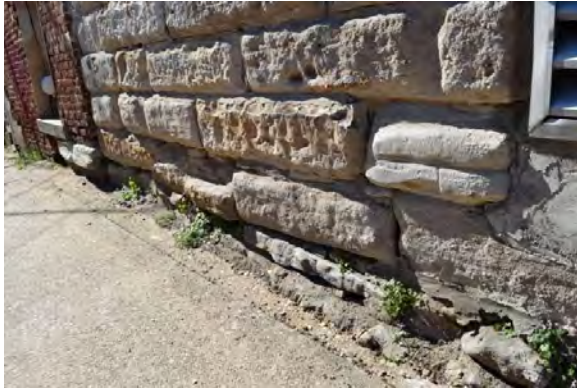
Figure 4.72: Early stone foundation wall under central portion of jail building. Note corner of louver on right.

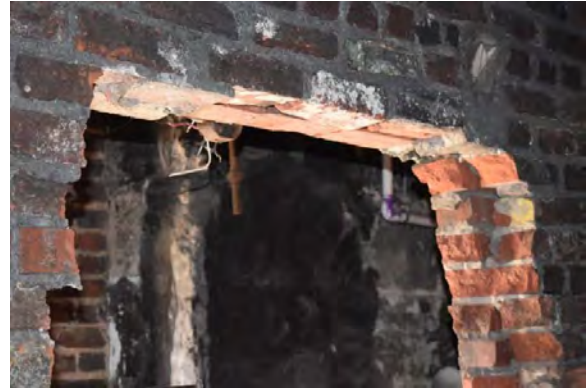
Figure 4.73: Unsupported masonry in center basement

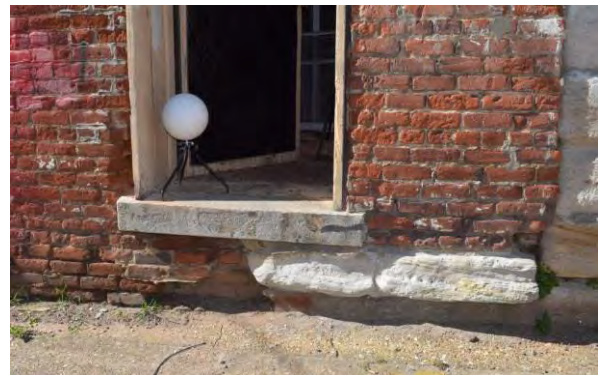
Figure 4.74: Loss of brick under threshold in foundation wall below 1-story extension

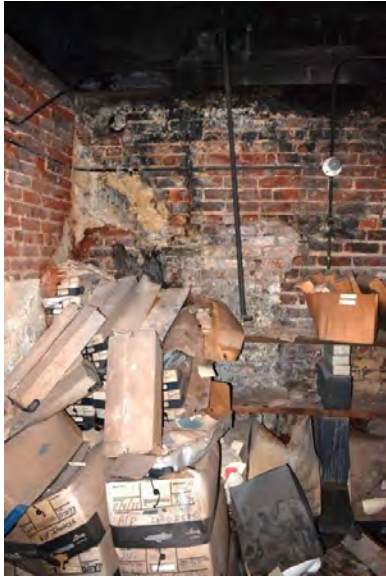
Figure 4.75: Brick foundation walls of old boiler room. Note current paper storage and moisture.

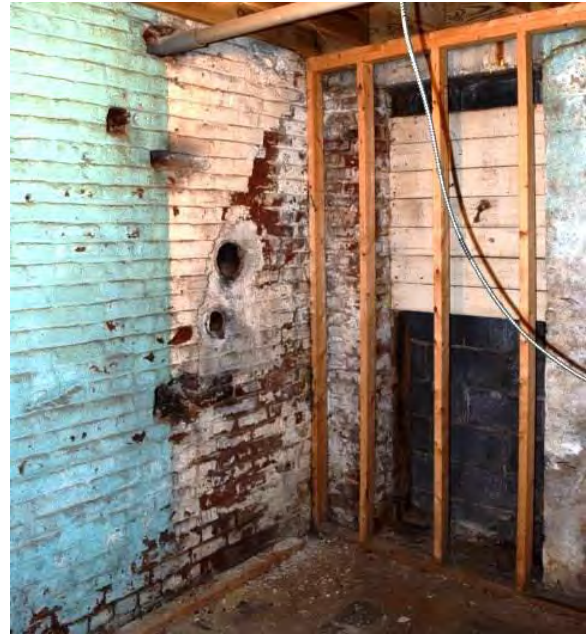
Figure 4.76: Brick foundation wall penetrations of northern jail addition. Note previous entrance to presumed tunnel with lintel distress.

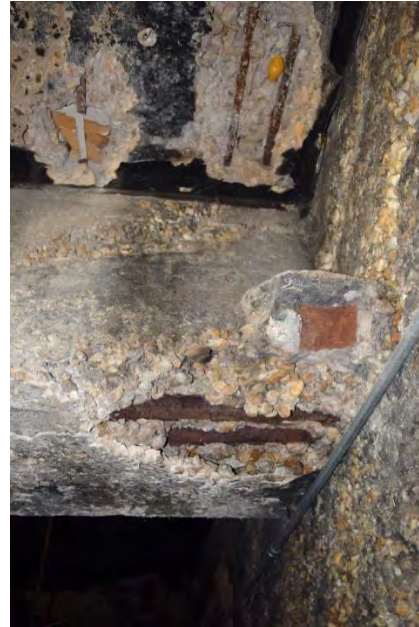
Figure 4.77: Beam 1 and exposed reinforcing

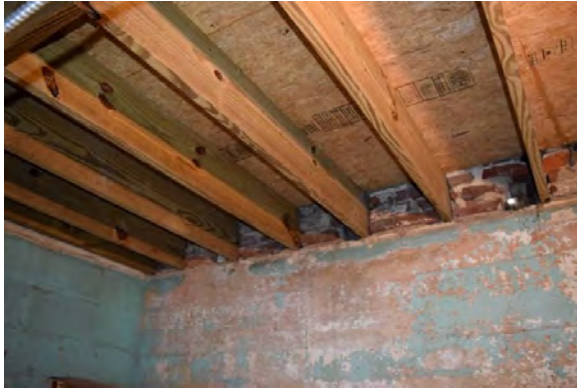
Figure 4.79: Northern addition first floor joists bearing on perimeter concrete wall

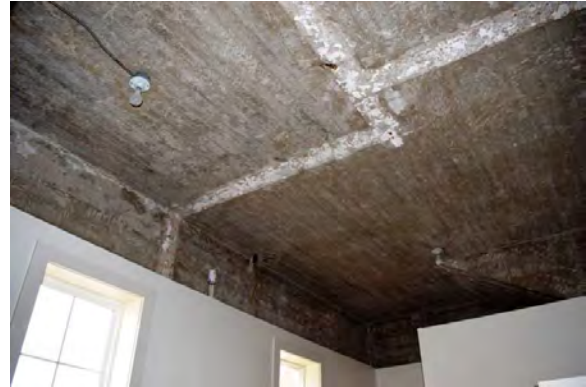
Figure 4.80: Location of removed concrete wall in cast-in-place concrete jail house

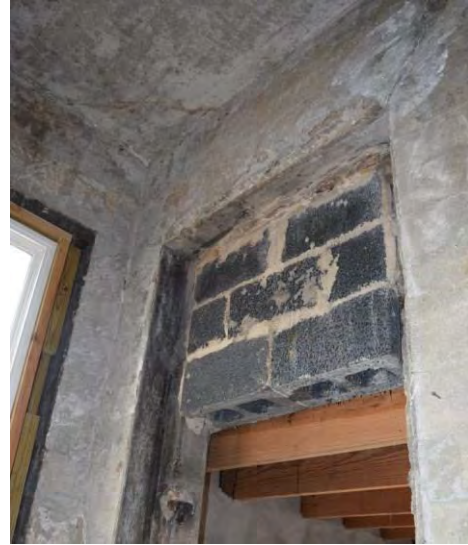
Figure 4.82: Second floor doorway between center building and northern addition

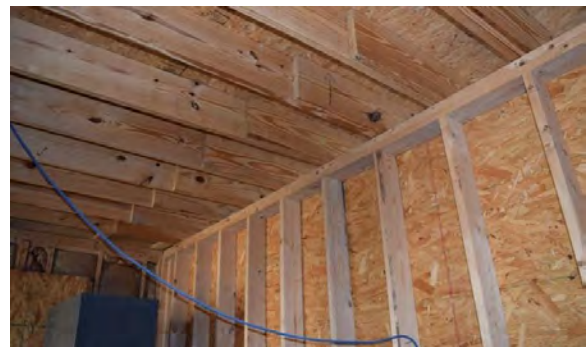
Figure 4.83: Northern Addition roof joists bearing on interior wood wall near building centerline

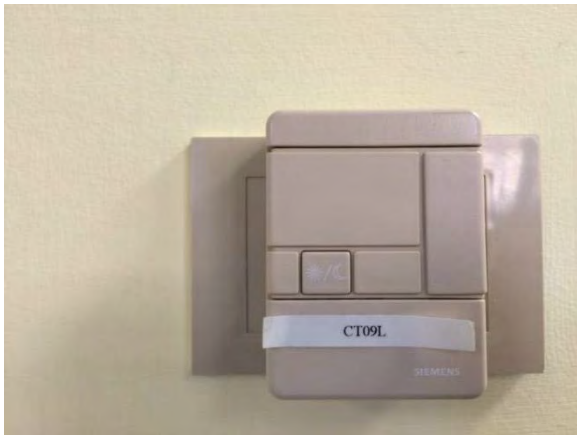
Figure 5.6: Thermostat controls.

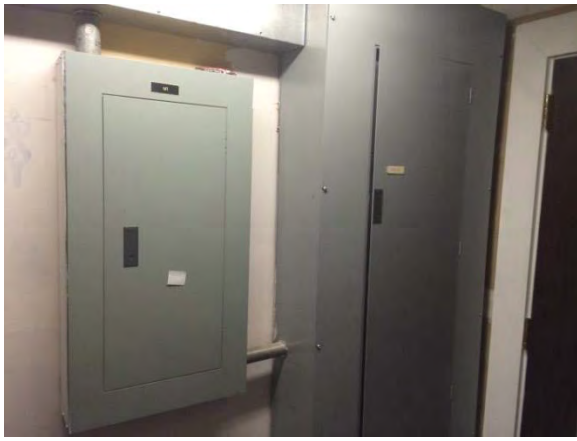
Figure 5.9: Building electrical distribution.

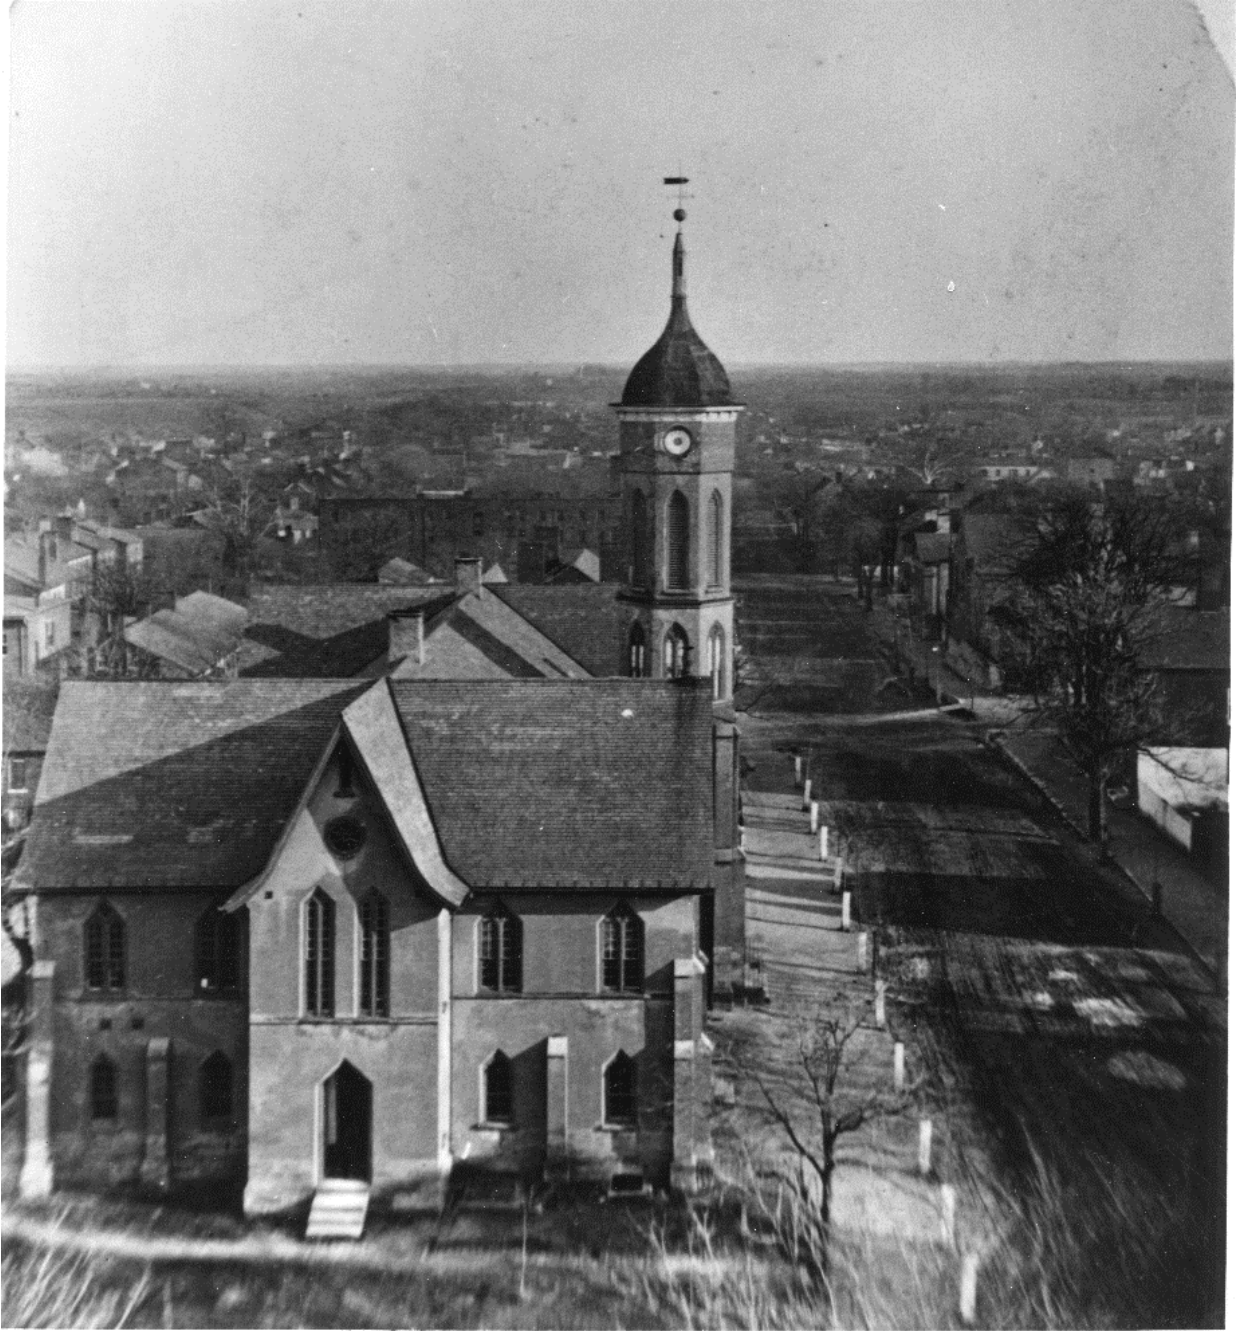
Figure 7: Fredericksburg Courthouse, photograph of north elevation taken from steeple of St. George's Episcopal Church, 1881. Courtesy Historic Fredericksburg Foundation.

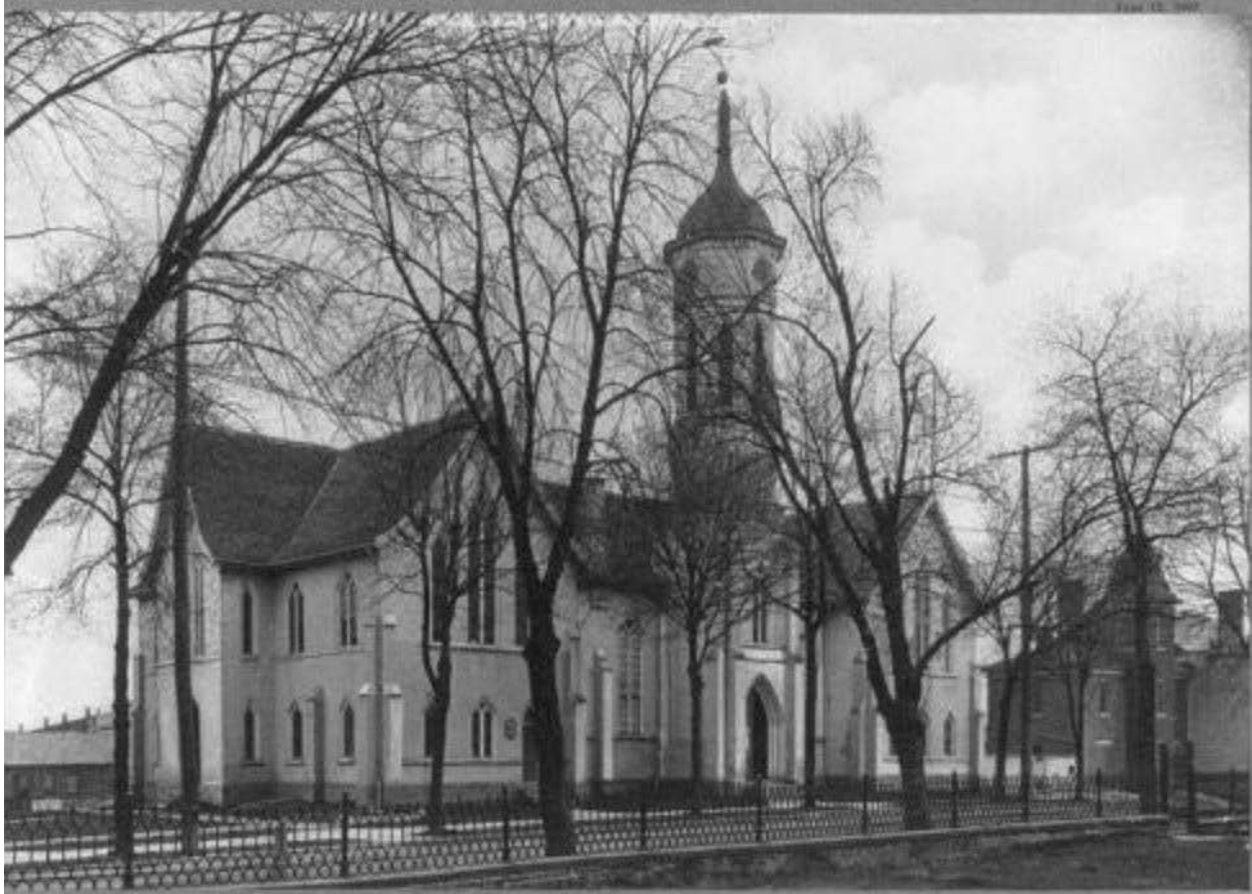
Figure 8: Fredericksburg Courthouse, circa early 20th century. Source, unknown. Located through eBay.

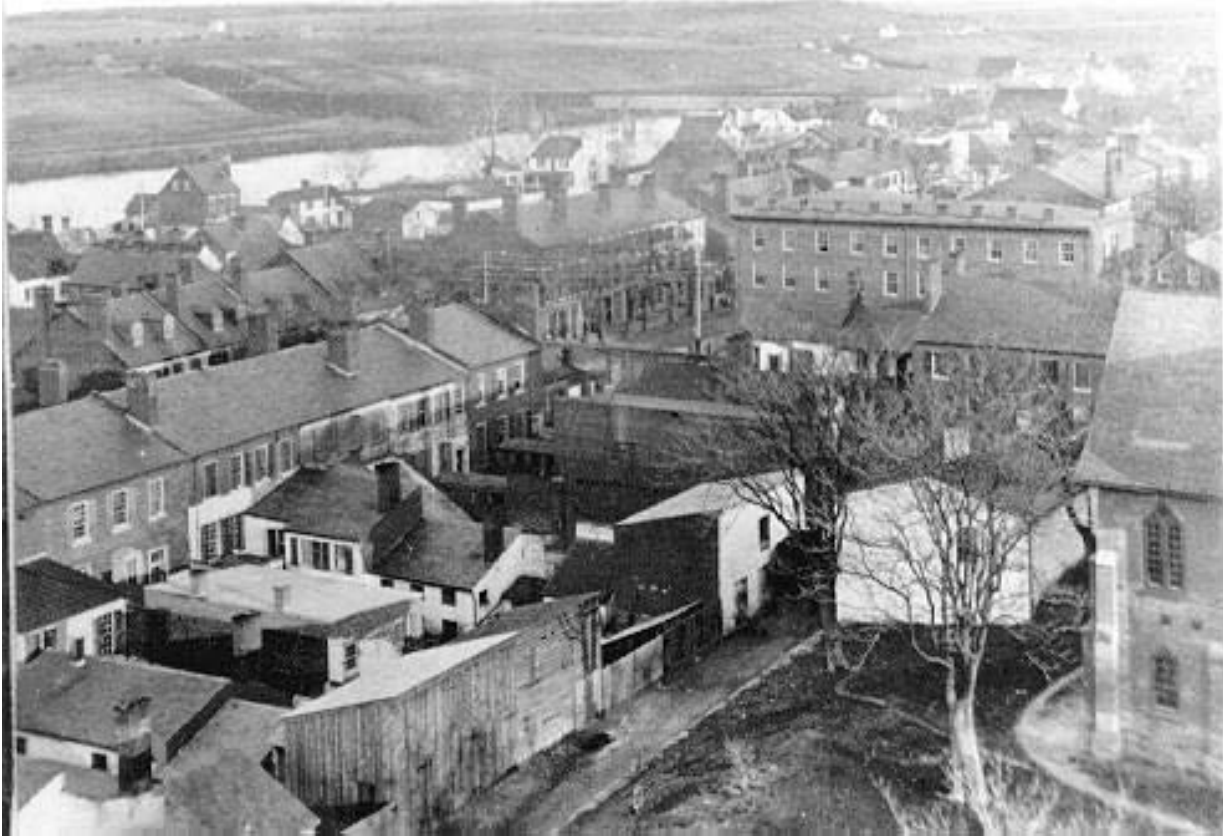
Figure 19: Fredericksburg Courthouse and Jail (at right), photograph of north elevation taken from steeple of St. George's Episcopal Church, 1881. Courtesy Historic Fredericksburg Foundation.

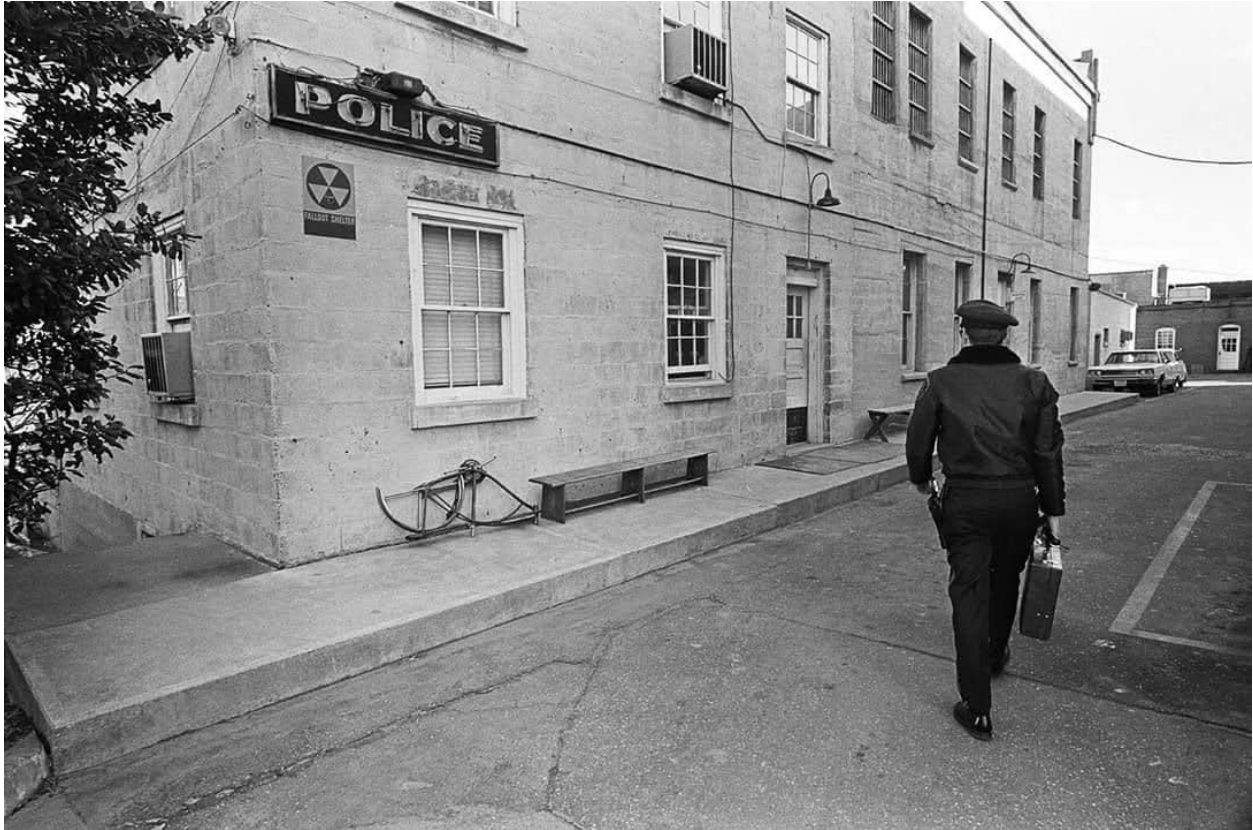
Figure 20: Old Jail, photograph of west elevation, view to southeast, ca. 1960s. Courtesy Keith Rodgers.

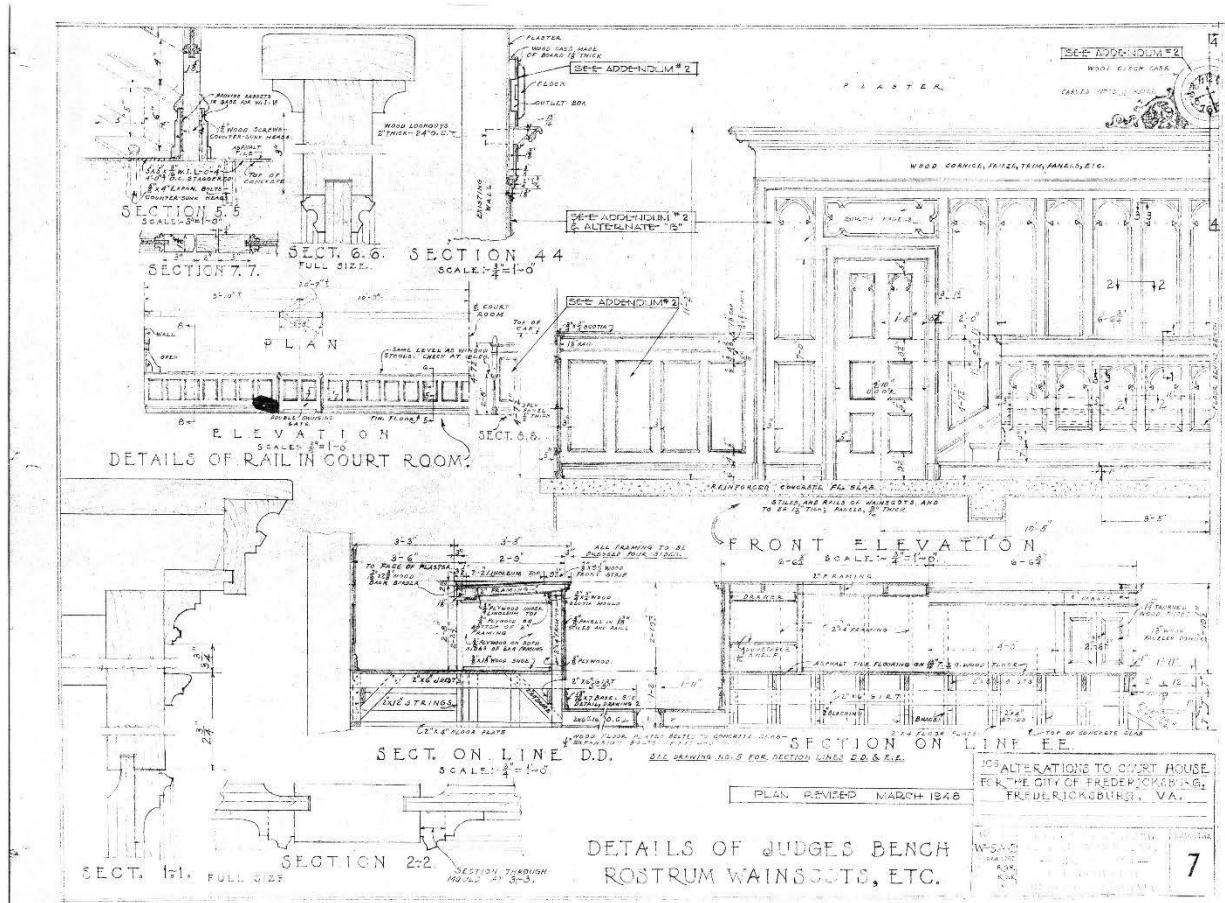
Drawing 7: Fredericksburg Courthouse, J. Binford Walford O. Pendelton Wright Architects, *Alterations to Courthouse*, 1948. Details of Judges Bench Rostrum Wainscots, Etc., Courtesy City of Fredericksburg.

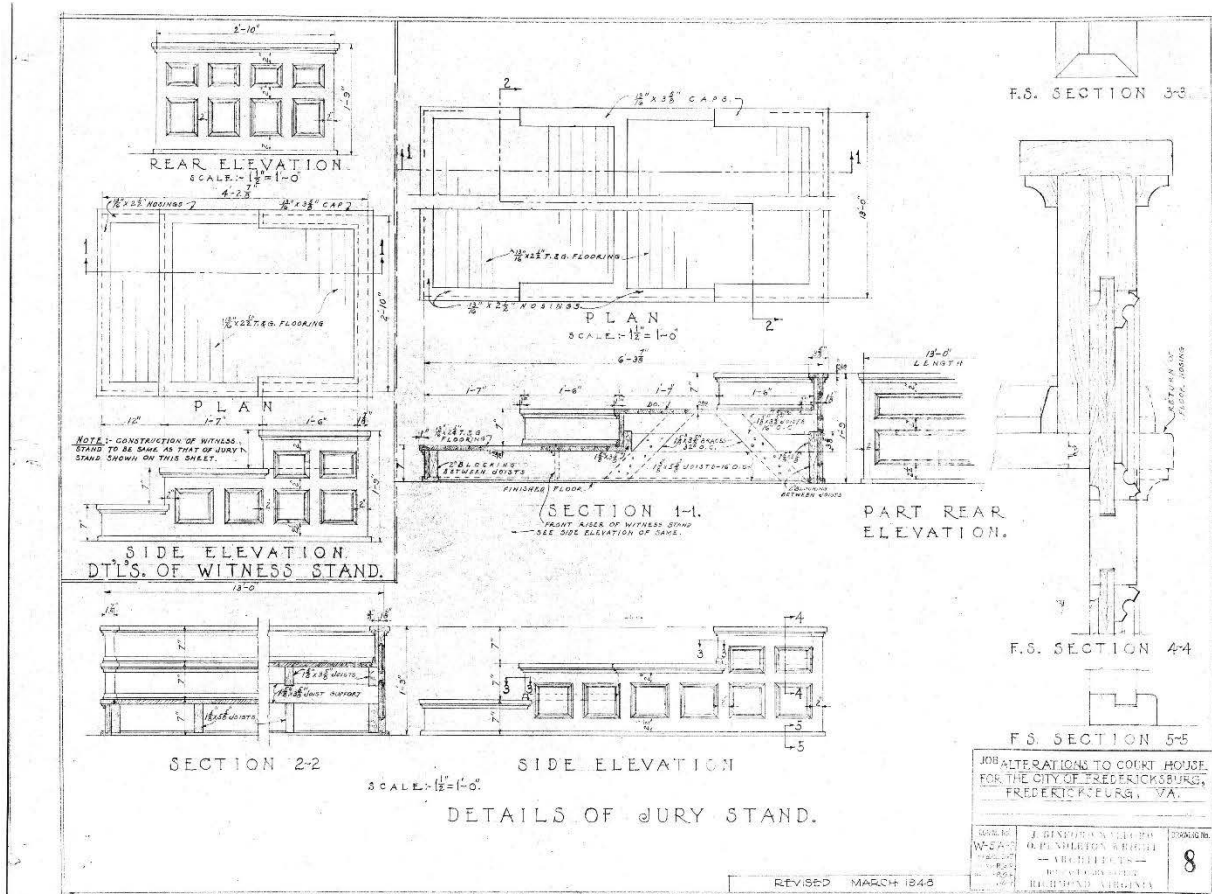
Drawing 8: Fredericksburg Courthouse, J. Binford Walford O. Pendelton Wright Architects, *Alterations to Courthouse*, 1948. Details of Jury Stand, Courtesy City of Fredericksburg.

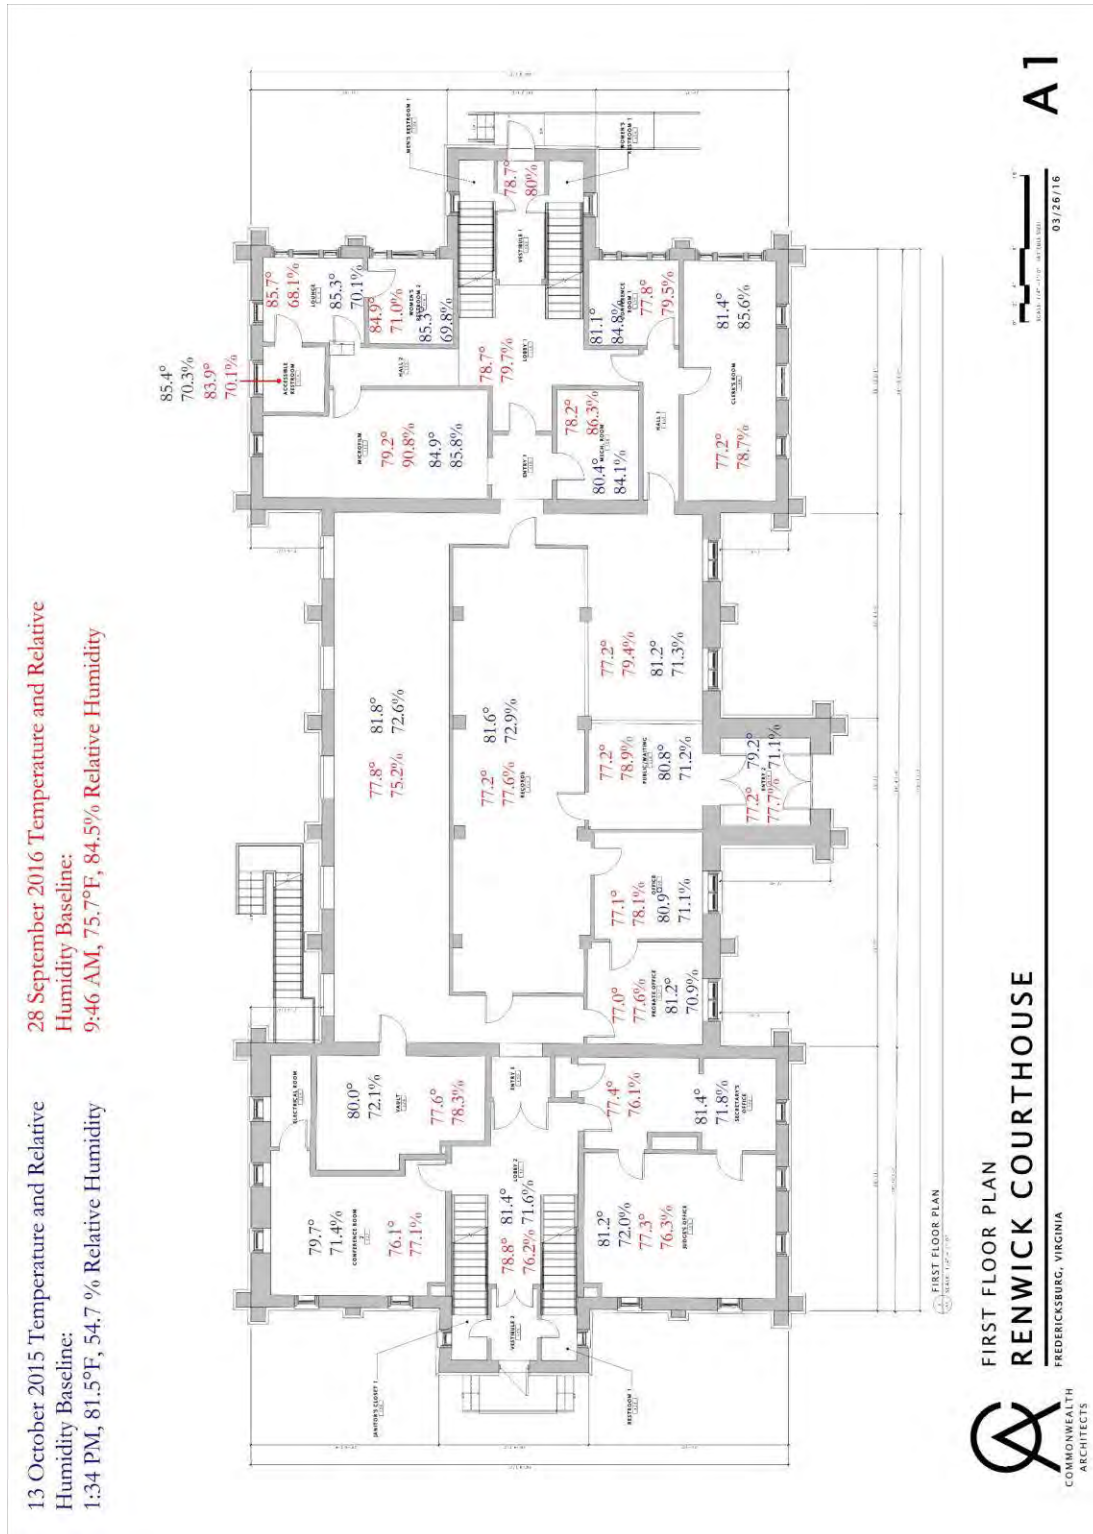
Figure 1: Renwick Courthouse, First Floor Plan.

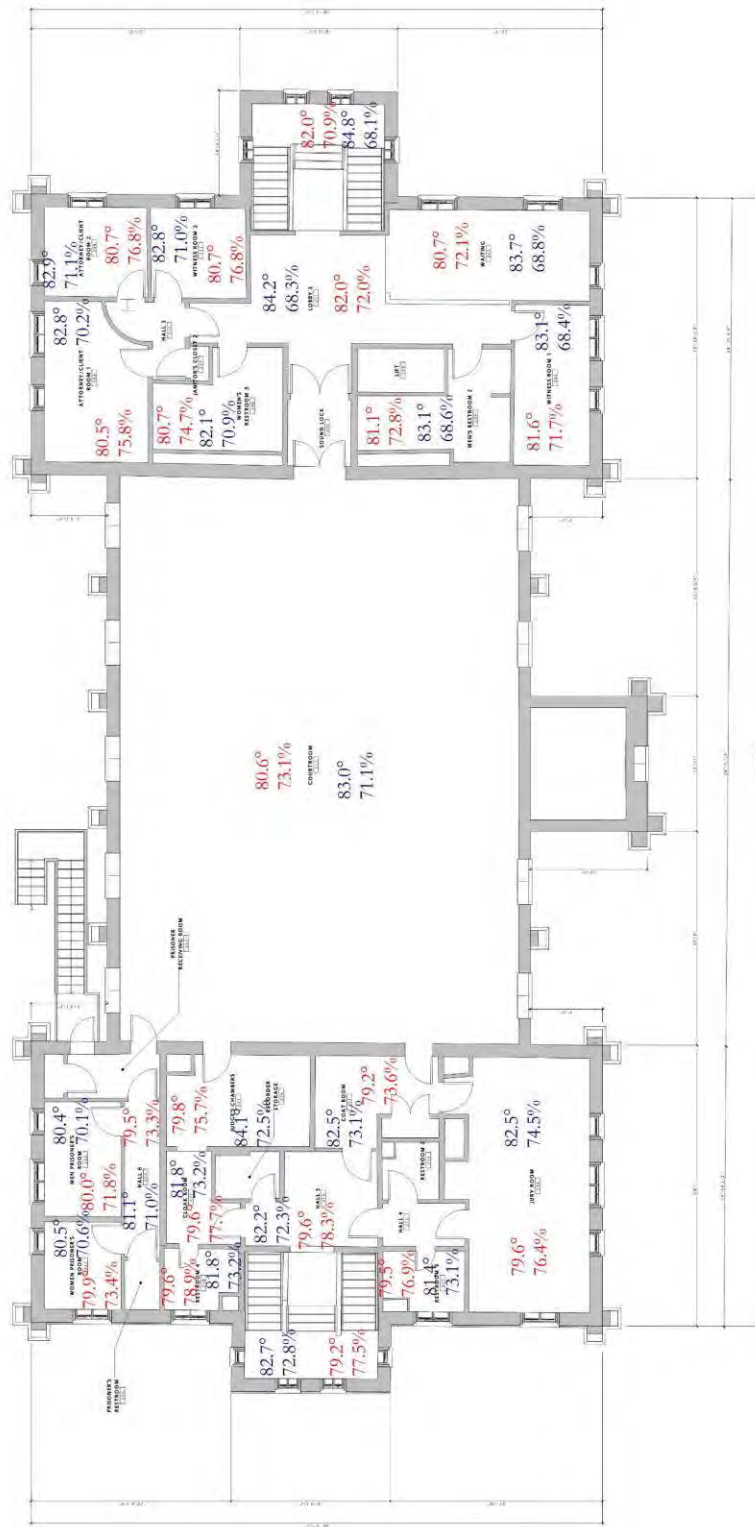
SECOND FLOOR PLAN
 SCALE: 1/8" = 1'-0"

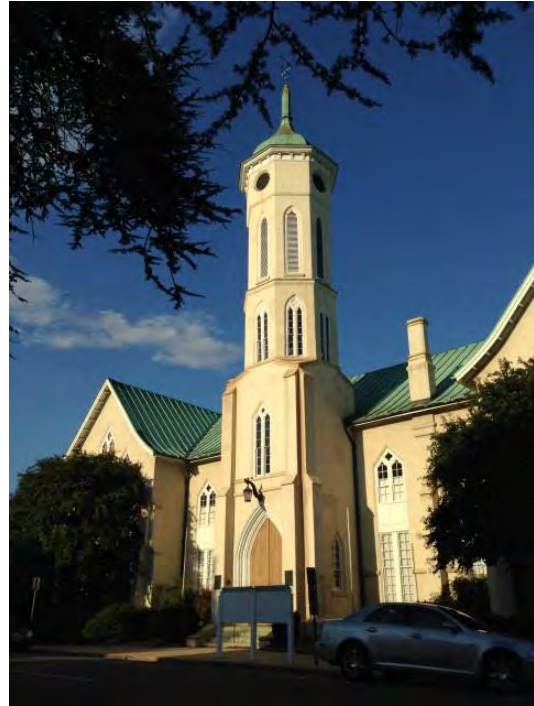
Figure 2: Historic Courthouse Bell Tower

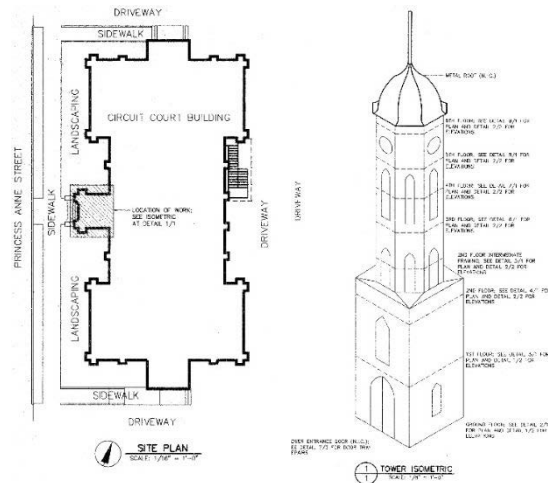
Figure 1: Renwick Courthouse site plan and isometric

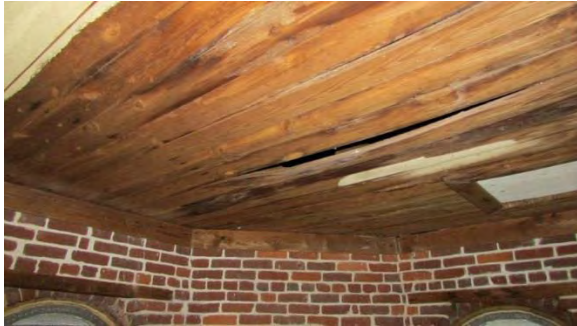
Figure 3: 5th Floor Ceiling

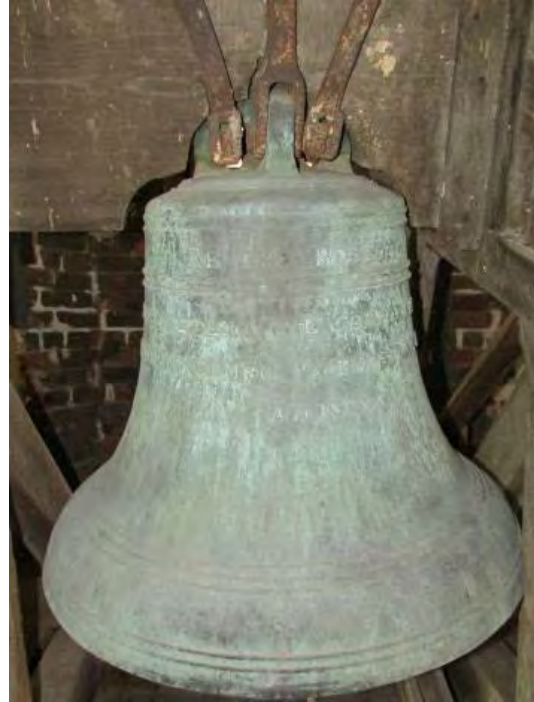
Figure 4: 1828 Paul Revere Bell Foundry cast bronze bell at 3rd floor of bell tower

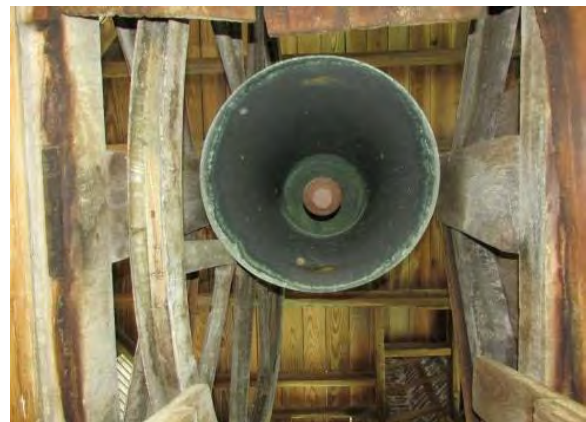
Figure 5: Underside of bell from floor below

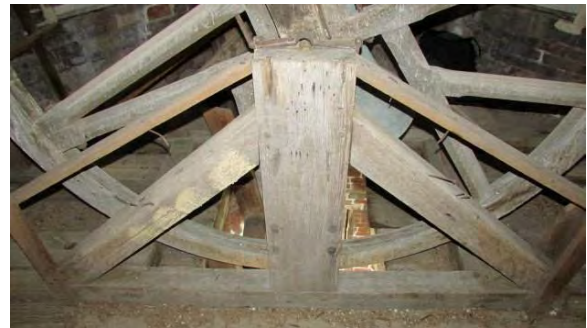
Figure 10: King post distribution truss

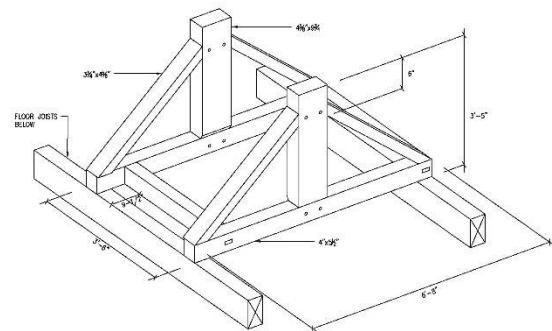
Figure 11: Isometric of bell support distribution trusses
Renwick Courthouse, Wallace Library, & Old Jail
Fredericksburg, Virginia
Historic Structures Report
28 October 2016
A10.3

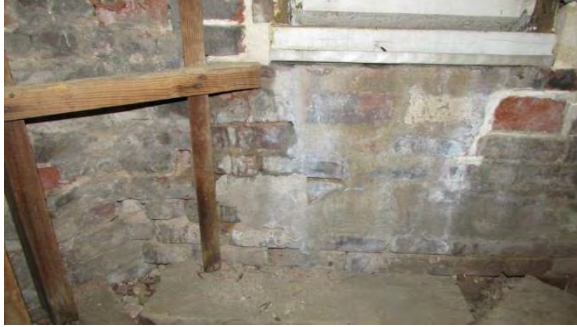
Figure 15: Masonry and wood deterioration just above the 3rd floor level

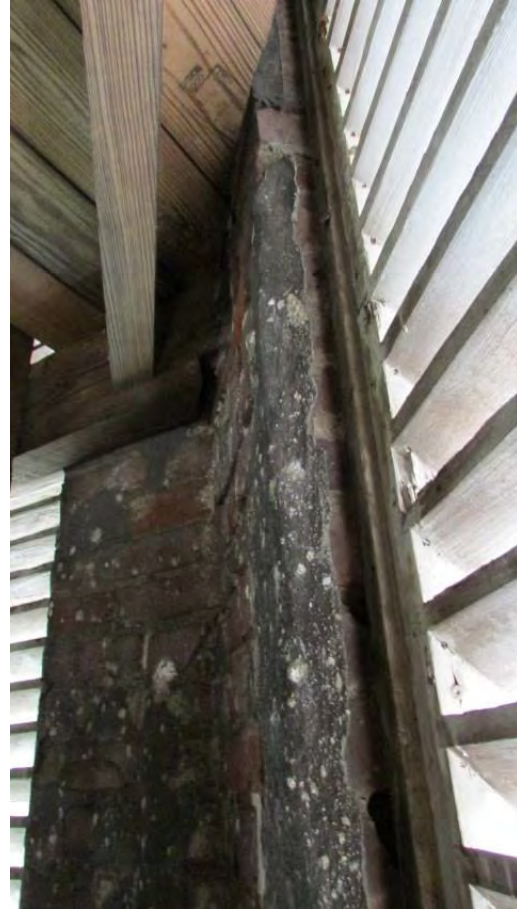
Figure 16: Weakened frame connections to jamb at louvers

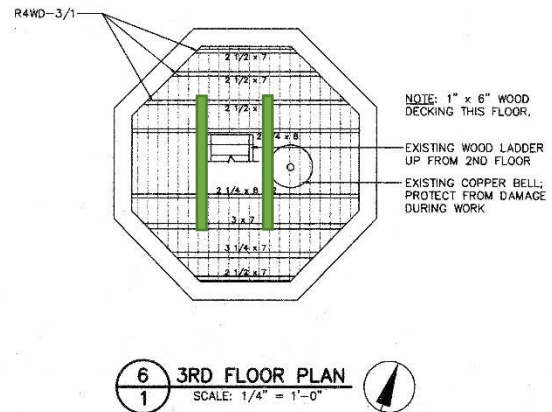
Figure 17: 3rd floor framing with bell support distribution trusses shown in green

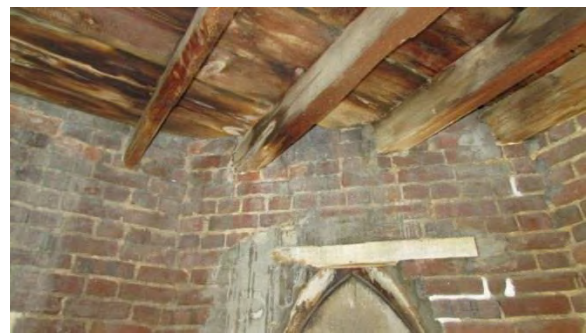
Figure 19: Bell floor joist bearing deterioration

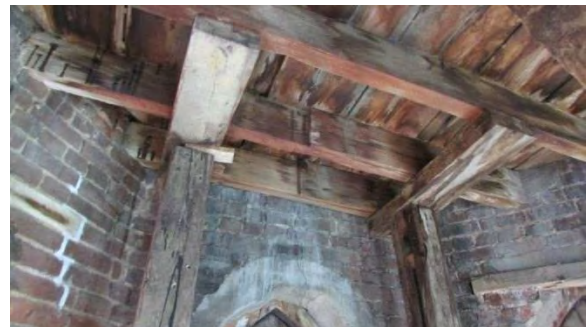
Figure 20: Bell floor framing existing showing

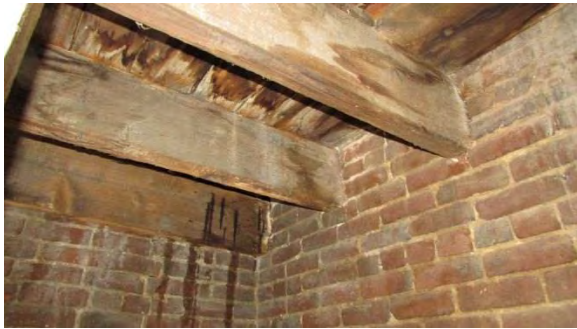
Figure 22: 2nd floor joist bearing deterioration
