Historic Structures Report
Renwick Courthouse, Wallace Library, and Old Jail
City of Fredericksburg, Virginia

Created / Last Revised:

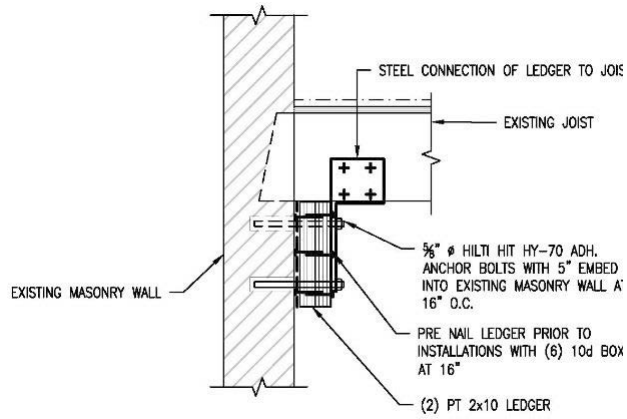
Figure 23: Retrofit Ledger Detail
